MIDDLE VENTON DREWSTEIGNTON

HERITAGE APPRAISAL, IMPACT ASSESSMENT & SUGGESTED RESOLUTION IN CONSIDERATION OF UNAUTHORISED WORKS

Dartmoor National Park
Authority

September 2014

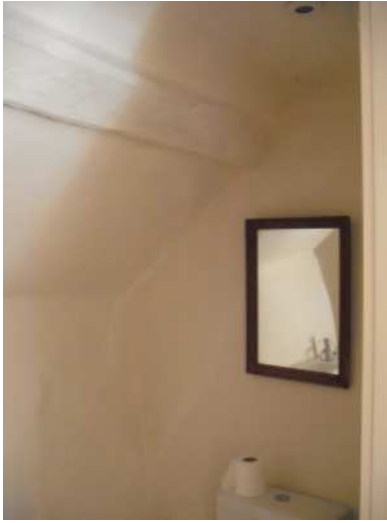
Figure 18. View into the en-suite

1. the volume of the room can still be appreciated,
2. the enclosure does not intrude as discordant block in the room,
3. no apparent physical harm is caused by the fittings,
4. a hot water cylinder was approved in this location which in all likelihood would be fitted into a cupboard.

It is found that the above points result in the en suite not causing any confusion to an understanding of the original plan form, not having any more of an impact than fitted or free standing cupboards would have on the character of the room, which could arguably be sited without the need for listed building consent, and not causing any apparent physical harm to the building other than through the provision of a hole in the wall for the drainage pipes. However there is a caveat to the acceptability of the en suite; improvements to the drainage pipes on the rear wall.

The matter of the drainage pipes is of concern and this is reviewed in para. 5.2 below. **If the drainage pipes can successfully be brought into the extension rather than being on the exterior of the building, other than perhaps a small section of soil vent pipe, the en suite is not found to harm Middle Venton's heritage significance. If the en-suite's pipes cannot be re-located within the extension, the en suite, by virtue of the additional harm that its pipes cause to the character of the rear of the building is not found to be appropriate and it should be removed.** Unlike the en suite, the bathroom is essential for the house. If the bathroom's pipes cannot be brought inside the house then they will reluctantly have to be permitted. The en suite however is a desirable but not essential

additional facility for the house and the additional harm that its pipes cause is not considered to be justified.

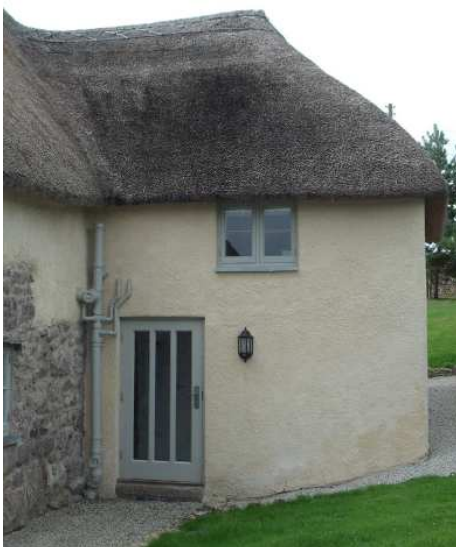
The approved scheme does not show any drainage pipes against the rear wall of the house as they now exist, figure 19. I gather from Mrs Sowrey that there was discussion with DNPA about the need for external pipes to be cast iron not PVCu, I agree with this but do not agree that the pipes necessarily have to be outside the building. **The presence of the pipes on the exterior of the building detracts from the simplicity of the elevation as shown on the approved drawings. Consideration needs to be given as to whether they can be moved inside the building as part of a remedial package of works to be discussed with DNPA and Mrs Sowrey. As noted in para 5.1 above, unlike the en suite, the bathroom is essential for the house. If the pipes cannot be brought inside the house then they will reluctantly have to be permitted.**

Figure 19. Discordant drainage pipes detracting from the simplicity of the rear elevation

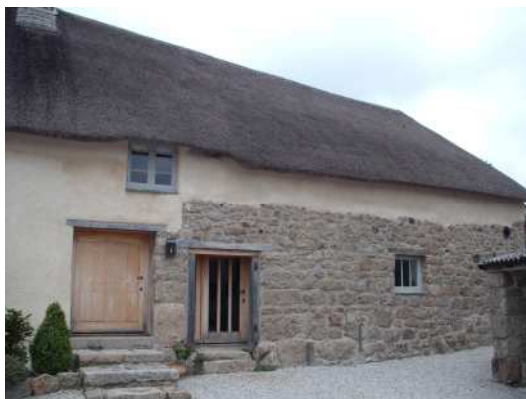
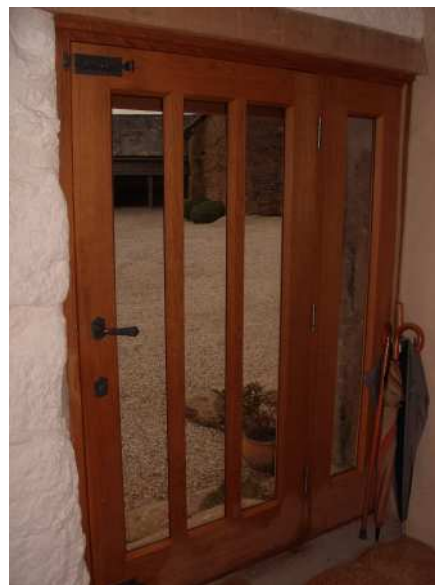
The approved scheme shows the existing door being re-hung and painted. This would leave the utility area behind the door as a fairly draughty space as the door in place in 2005 does not appear to be a well fitting, draught proofed door. What has been fitted is a triple light, glazed, well fitting door, in oak, with a fixed light to one side, figures 20, 21.

Figure 20. Shippon door

Figure 21. Current shippon door, interior

I consider that it is essential that a door similar to that which previously existed and as approved in 2009 should be fitted in place of the existing door. Details should be submitted for approval and a replacement door should be subsequently be fitted.

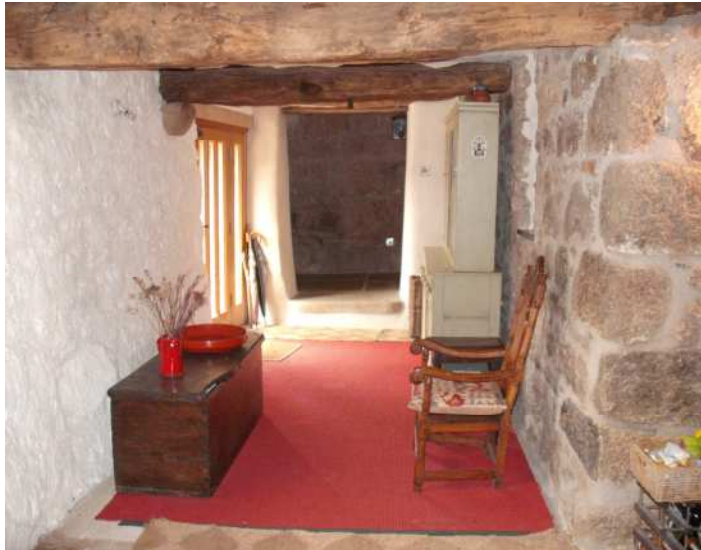
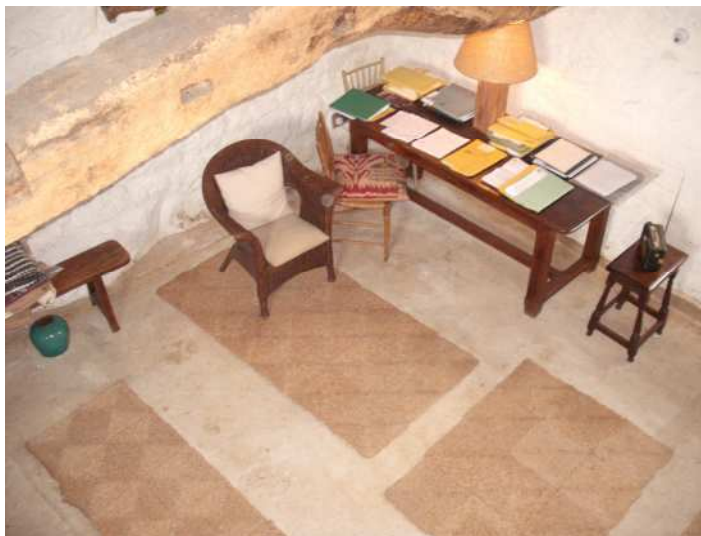
The approved scheme of 2009 shows the area between the kitchen and the front wall of the shippon as a utility area. This area is not a utility area today, it is an entrance lobby that is apparently used as an occasional dining and sitting area, figure 22. The former utility area now extends into the shippon as a continuous space, with a concrete floor at a common level. The former utility area and shippon are used as an additional room for the house, figure 23. This is not believed to be the character of either the utility space or shippon that was envisaged when the 2009 scheme was granted approval.

Figure 22. Current form of the utility area

Figure 23. Current furnishing of the shippon

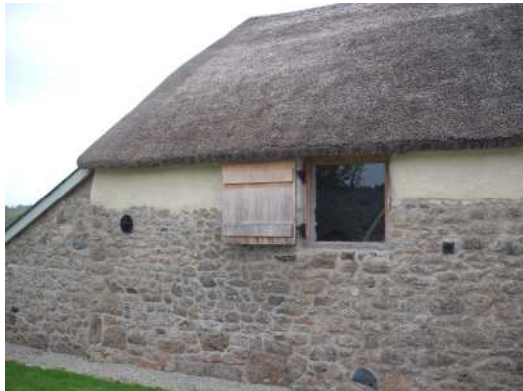
The approved scheme maintained the hayloft opening with the existing shutter opening inwards. The opening has been glazed with an outward opening shutter fitted, figure 24, both details are not as approved. The glazing helps to keep the shippon dry and draught free and it can be seen to be a glazed opening from the outside by virtue of the timber frame and the reflective glass. The shutter appears incongruous as it is not possible to operate it as it cannot be reached from inside or outside and historically it is inaccurate. **To preserve the character of the shippon the inward opening hatch door should be reinstated.** This will have an impact upon the fixed loft stairs, see the discussion with regard to this below.

Figure 24. Glazing and shutter to the hayloft

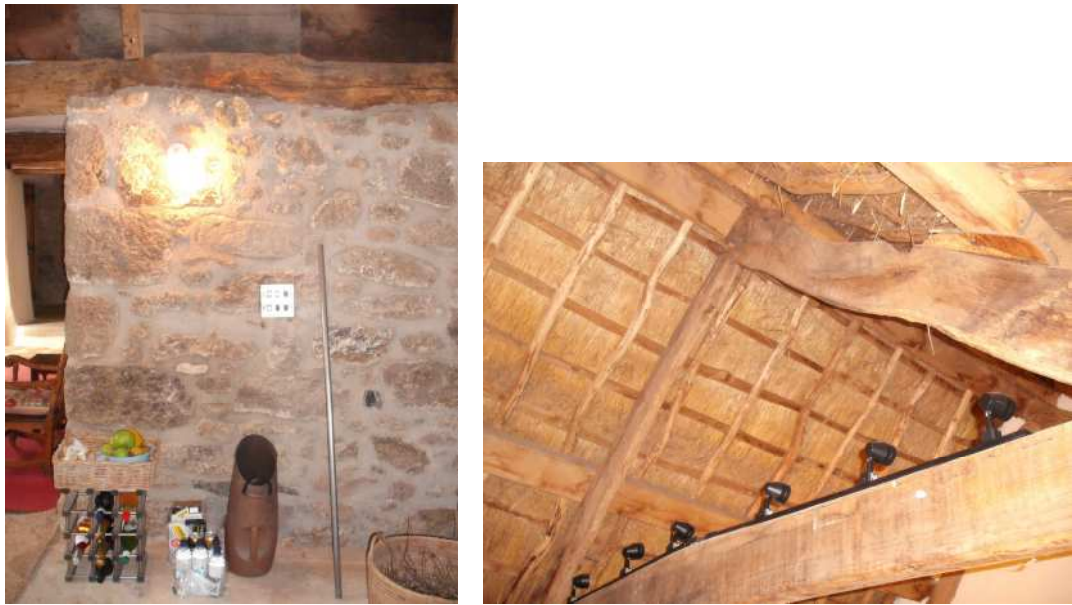
No mention is made of switches or light fittings in the 2009 application or approval. Mrs Sowrey advises that the shippon had power when they bought the building and the shippon has merely been rewired and new switches provided. The presence of power points and switches is not considered to harm heritage significance as the shippon has been used as a store for a number of years. Equally the light fittings do enable the very well preserved roof to be enjoyed so it is considered that these fittings may be left, figures 25, 26. However the overall recommendation for the restoration of the shippon includes the recommendation to remove the glazing from the hayloft opening, only permitting the hatch door to remain, whether this will make the need for external quality electrical fittings to be introduced should be considered.

Figures 25, 26. Light switches and light fittings in the shippon

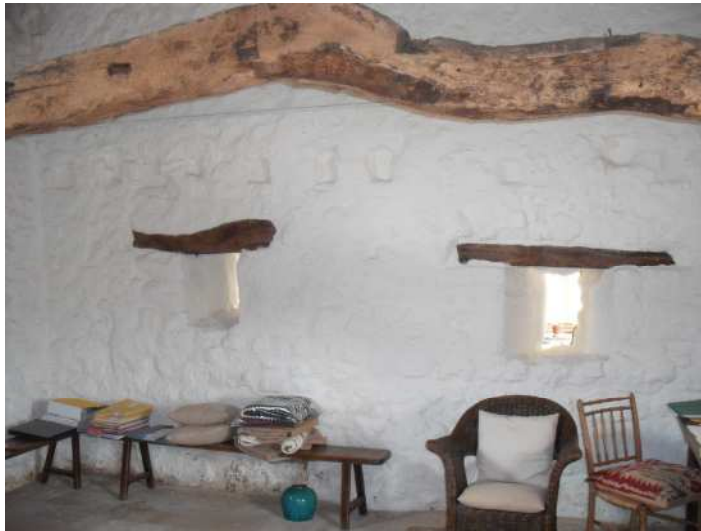
The 2009 approval advises that the hayloft floor would be reinstated with sawn planking; no mention is made of the supporting joists. There are today no joists and no floor boards over the two eastern bays of the shippon. The archaeological report comments on the unevenness of the floor joists and these can be imagined from the floor beam that still remains, figure 27. It is considered that to attempt to reinstate what must have been a very uneven hayloft floor would be extremely difficult. The fact that a floor did exist can clearly be seen from the floor beam with its sockets and the corresponding sockets in the gable wall. **With all of the other remedial work that is found necessary to restore the shippon, the replacement of the hayloft floor is not considered essential as its former presence can be readily understood, half of the shippon is still floored over, it will be technically very difficult to restore and not replacing the floor does permit enjoyment of the roof structure.**

Figure 27. Remaining floor beam with joist sockets and corresponding sockets in the gable wall

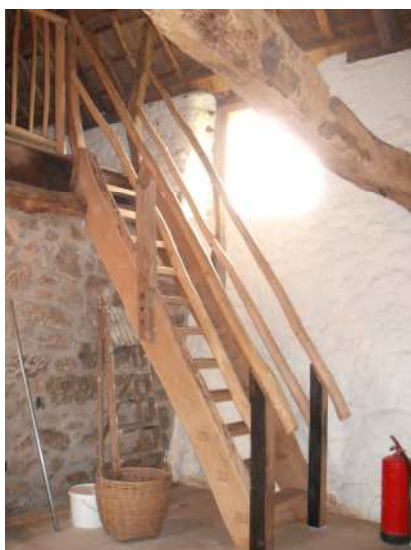
A simple ladder to the loft existed in 2005. A ladder was approved up to the loft in 2009. What has been fitted is a set of steps fitted with a handrail with a handrail fitted along the edge of the hayloft, figure 28. The steps and handrail are considered to be a piece of excellent craftsmanship and apparently vestiges of the floor joists are used in its construction, albeit without approval. **While not historically correct their presence is not found to harm the heritage significance of Middle Venton and they are not considered to confuse the interpretation and legibility of the shippon. However where the steps are currently located they would stop the inward opening loft hatch from opening fully. This would not have happened with the approved scheme as no handrail was envisaged. It is recommended that either the steps are moved and the handrail altered to permit the historically correct hatch door to work properly, opening inwards, or the right hand rail is moved to permit the hayloft door to open.**

Figure 28. Steps and handrails

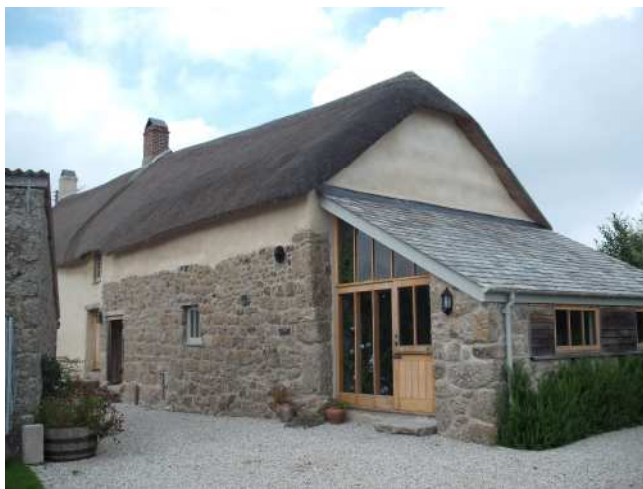
The 2009 approval permitted the reconstruction of the remains of walls beyond the gable wall of the shippon as a shed within which the plant for the ground source heat system would be located. The plant has instead been located in the C19 animal house in the yard without the benefit of prior approval. The shed has under-floor heating installed. The shed is used as a garden room. The glazing to the front elevation of the structure was approved by application 13/543, figure 29, further to it being fitted in place. With the under-floor heating and absence of any heating plant the 'shed' is now in use as an additional room for the house, albeit separated from it by the shippon. **Overall the alterations to the shed and its use as a heated garden room could be approved by whatever means is considered appropriate if it is approved as part of a balanced group of works to restore Middle Venton's heritage significance.**

Figure 29. The heated garden room approved as a shed

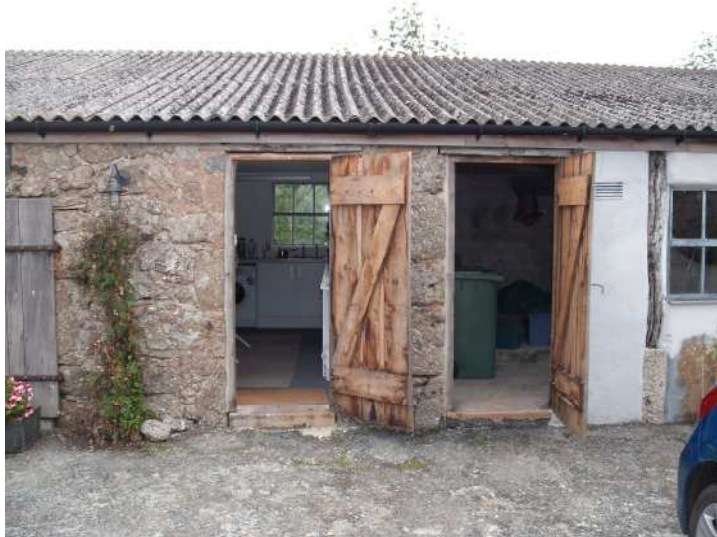
No approved alterations for this building can be found. The uses introduced to the building include utility, bin store, plant room, general storage and car port, figure 30. **The alterations to accommodate the changes are not considered to harm the heritage significance of Middle Venton. The re-location of the utility area from the shippon removes the need for drainage in that part of the longhouse. The uses give the building a use and it will therefore be maintained. It is recommended that the current arrangement is accepted by whatever means is considered appropriate subject to a control over any future further domestication.**

Figure 30. The converted part of the C19 animal house
