North Brentor

Conservation Area Character Appraisal

Dartmoor National Park Authority January 2011

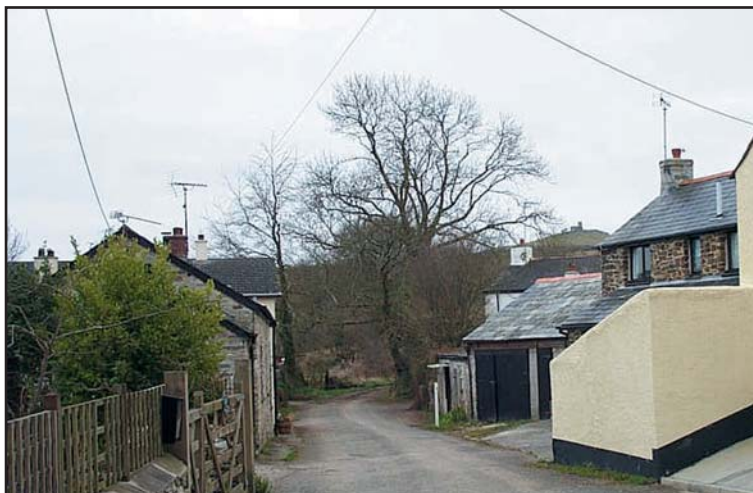
Fig 2 Buildings relate to the street in a variety of ways

The character of North Brentor is very varied. Although most buildings are traditionally constructed in stone, the relationship with the street is diverse. Some properties are built tight to the street, some set back behind gardens or down subsidiary tracks. Many are aligned parallel to the street, others show gable ends and a few are sited obliquely. The overall effect is somewhat jumbled, with its own distinctive character.

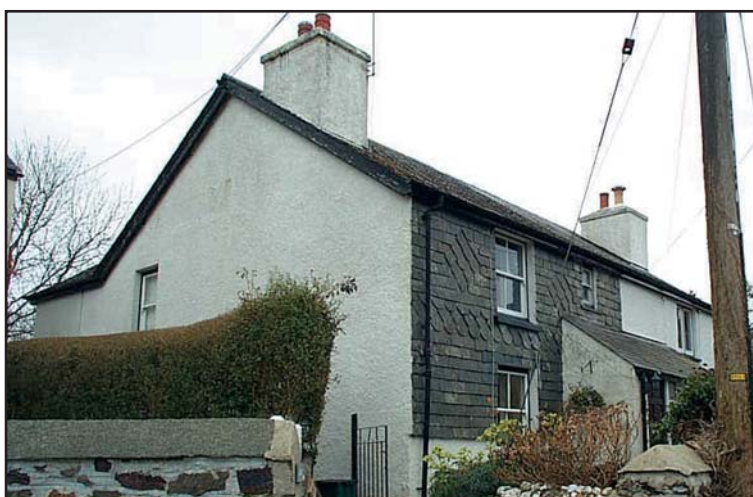
Fig 3 Render and stone are the main materials but there is some slate hanging

Dwellings are mostly two storied, stone-built but usually rendered or painted and there is some slate hanging. Chimneys are a feature of most dwellings – brick built and rendered. Brick is used for quoins and lintels on many buildings of the later 19th and early 20th centuries. Slate is the traditional roofing material, with clay ridge tiles and cast iron gutters. There has been much replacement of natural slate with artificial products and of metal rainwater goods with plastic, often of an inappropriate colour and profile. Dormers are not a characteristic feature, though a few have been inserted in recent times.

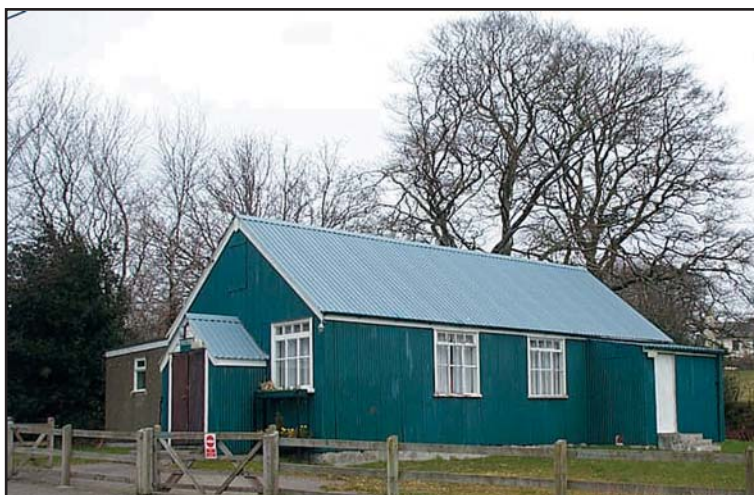
Fig 4 The Parish Hall

Corrugated iron makes a contribution to the character of the Conservation Area. The parish hall is the most obvious example, but the old slaughterhouse and the group of outbuildings adjacent to the east derive much of their character from the survival of rusty old corrugated iron. The small shed, like the parish hall, is an example of early 20th century pre-fabrication and both have historic interest from that perspective.

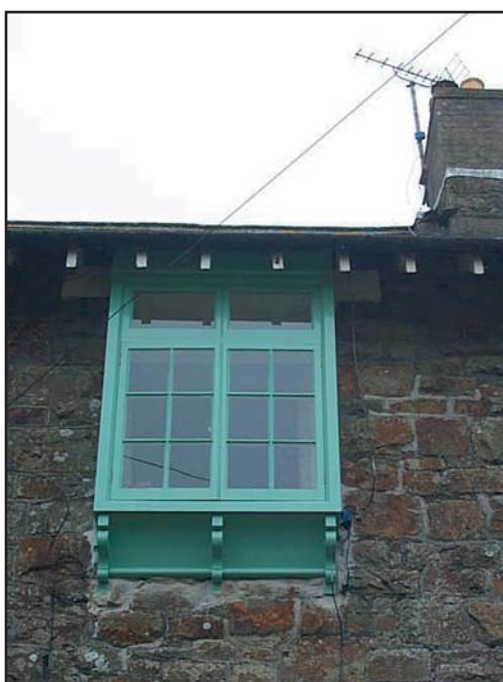
Fig 5 The unusual casement window design at Greystones

There is a mix of casement and sash windows in the village. Casements are generally seen on earlier and/or humbler dwellings, though a rather eccentric casement design was favoured on the late 19th century Greystones Cottages. Sashes are found on more aspirational double-fronted homes such as Gill House and on later cottages such as the row that includes the Old Post Office. The survival of historic fenestration is patchy and where replacement windows have been installed it has usually been in a style that fails to relate to the original units. This applies to a number of timber windows as well as metal and PVCu.

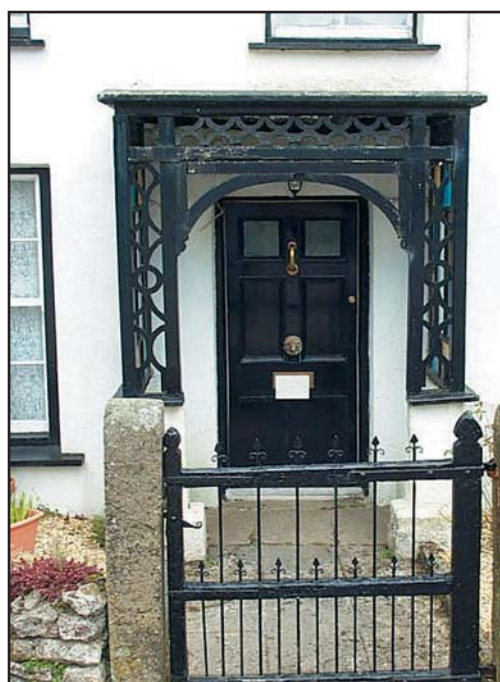
Fig 6 The porch at Gill House

Panelled doors are prevalent, some part-glazed, but there are also boarded doors. Porches are fairly common, most are simple gabled structures. None is more attractive than the decorative example on Gill House.

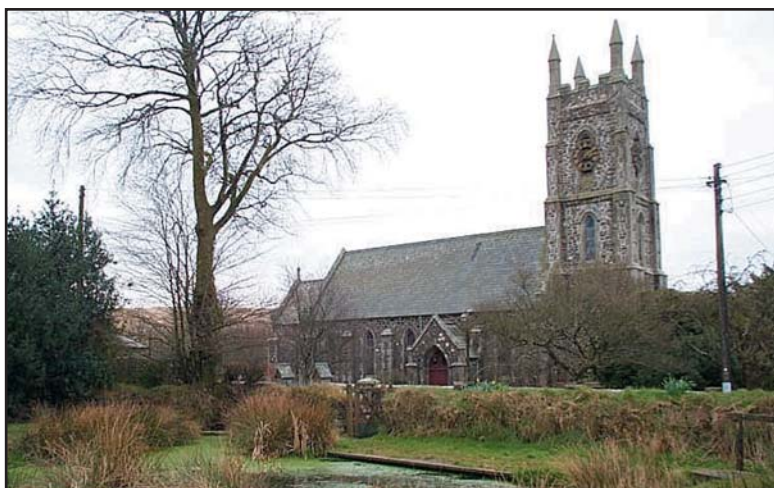
Fig 7 Christ Church

Christ Church: Grade II

Built in 1856, presumably as a replacement for the chapel of ease, (to the Church of St Peter in Lamerton), that had been built in 1825. Financed largely by Mrs Isabella Holwell, it was designed by Richard Gosling of Torquay in an eclectic gothic style. It provides a fine focal point which can be seen in many views within the village and far beyond.

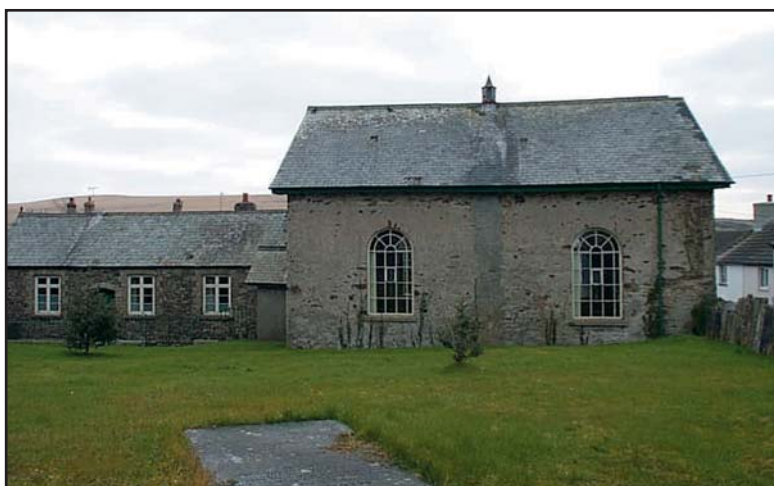
Fig 8 The Methodist Chapel

Methodist Chapel: Grade II

A good and unspoilt example of a non-conformist chapel; it was built in 1841 and extended in the early 20th century. It is located on the triangular plot at the intersection around which the settlement grew. The south east elevation is slate hung with unusual large brownish slates that were probably quarried locally.

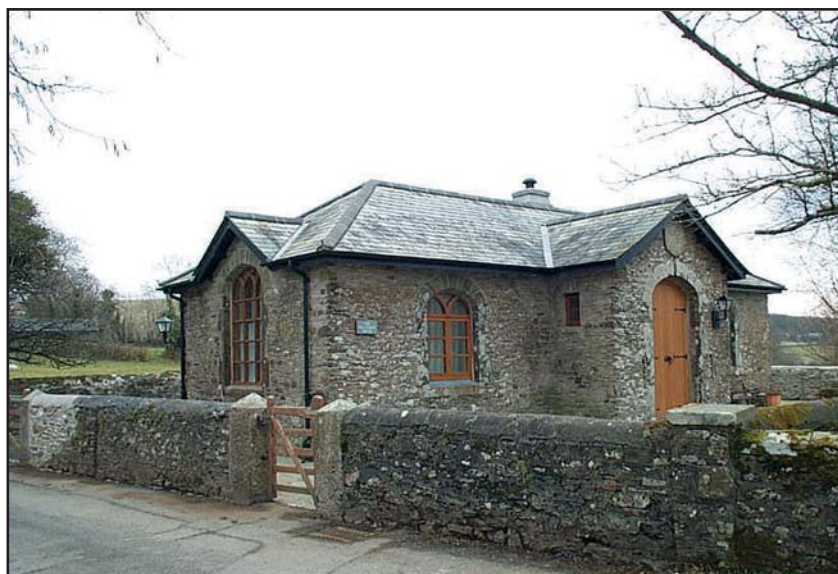
Fig 9 The former school

Former School: Grade II

This is a fine example of a purpose-built National school. It is attractively proportioned and well constructed, with understated Tudor details. After it ceased to operate as a school it became the church hall.

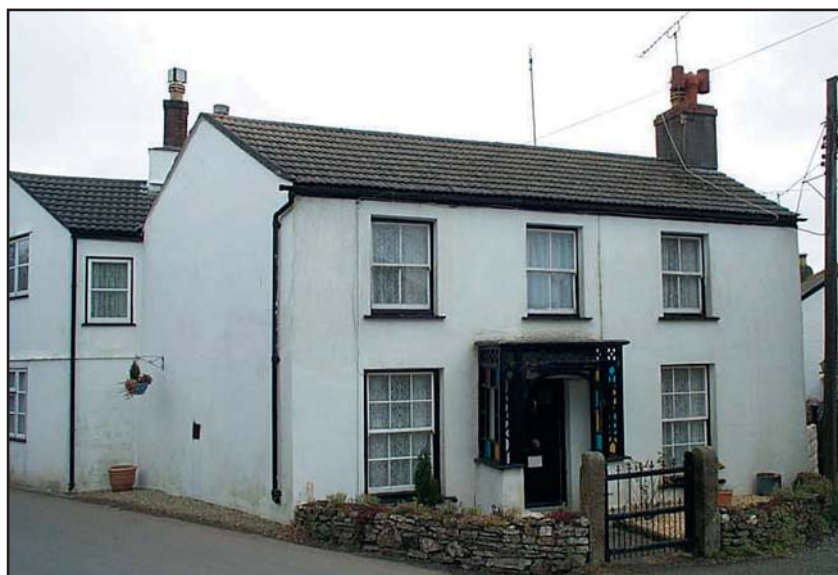
Fig 10 Gill House

Gill House: Unlisted

Prominently located as the village is entered from the west, this is a good and unspoilt example of a modest late Georgian house. In the context of North Brentor, however, it is a fairly substantial home.

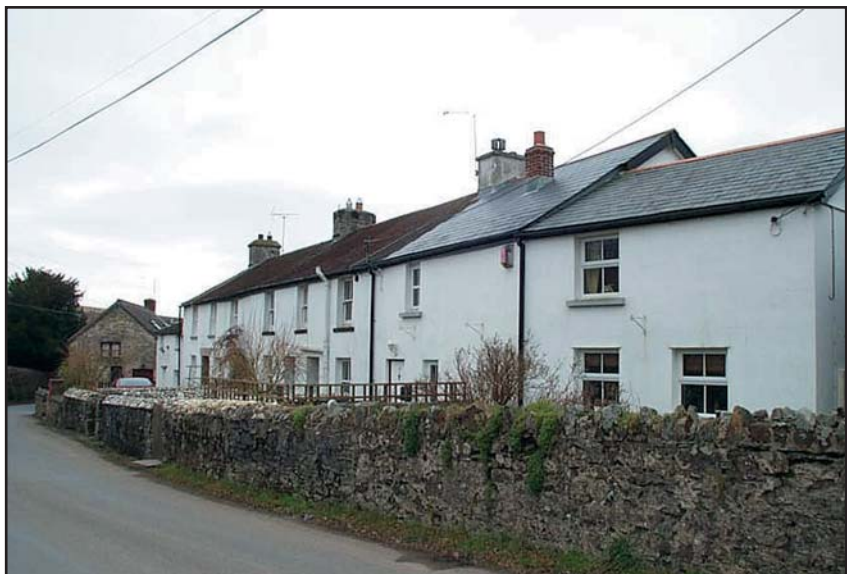
Fig 11 An attractive row of cottages

Row of cottages including the Old Post Office: Unlisted

A good row of 19th century cottages forming a group with the church opposite. All but one had their original windows at the time of survey.

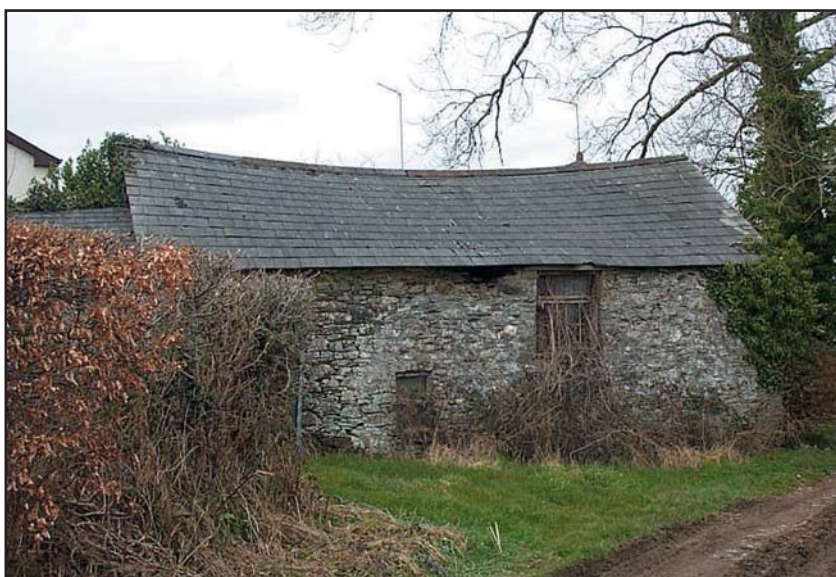
Fig 14 One of the older surviving outbuildings

Outbuilding on Dark Lane: Unlisted

On the south western edge of the Conservation Area is one of the oldest outbuildings surviving intact, probably dating from the late 18th century. It can be seen on the tithe map [\[Map 2 page 7\]](#) and by virtue of its position on this ancient green lane it is an important structure.

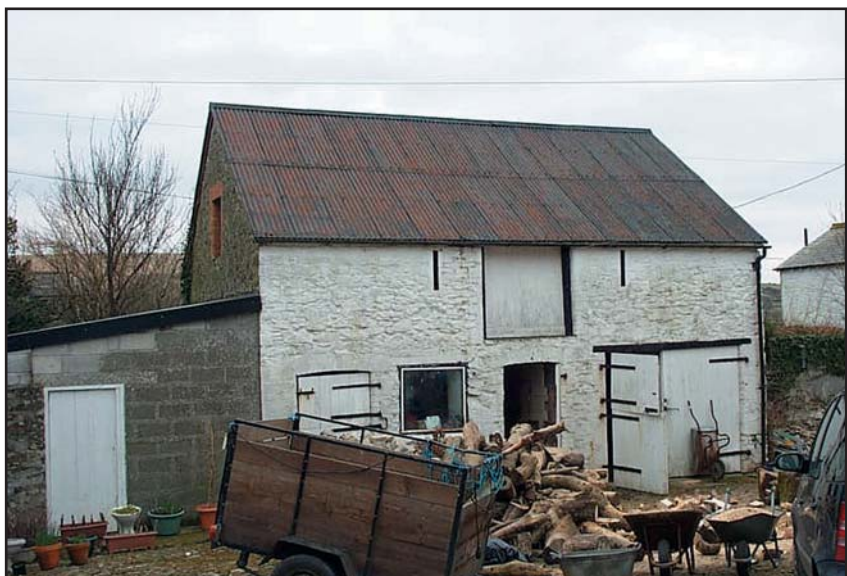
Fig 16 A nice stable and coach house

Stable block to rear of Gill House: Unlisted

At the back of a nice courtyard this is a good example of a stable block associated with a dwelling. It dates from around the beginning of the 20th century.

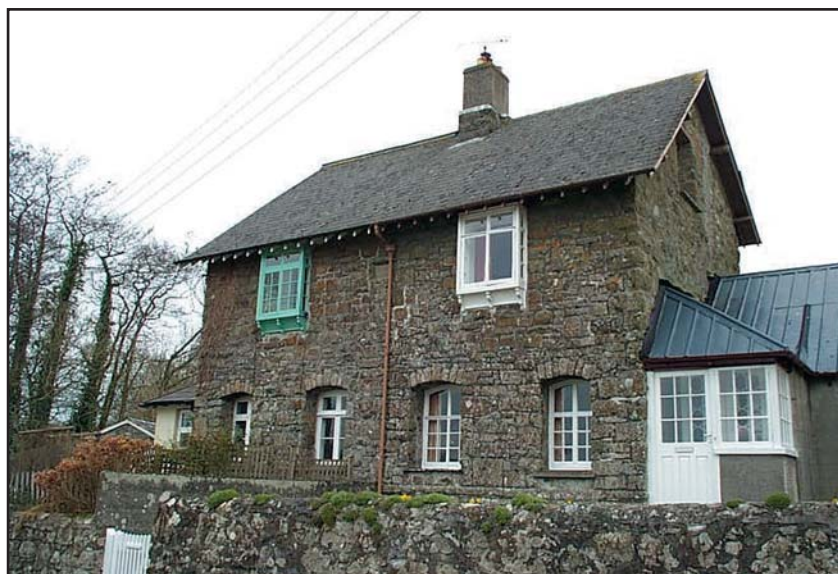
Fig 17 Good Victorian domestic architecture

Greystones and Nutshell: Grade II

Dated 1886 this pair of cottages exhibit a degree of architectural design otherwise unseen on dwellings in North Brentor. They are notable for that reason and reflect the change in social character that came with the railway.

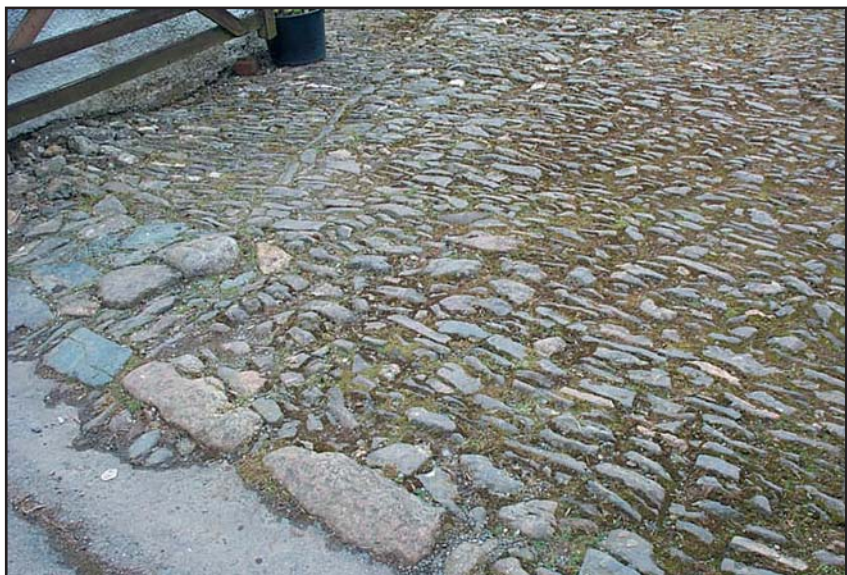
Fig 19 The cobbled yard at Gill House

There is a notable absence of street furniture such as signs, street lighting and the like. It is hard, however, to find a pleasing view in North Brentor that is not in some way diminished by the intrusive presence of overhead wires and cables. The general lack of pavements reflects the rural character of the Conservation Area, though a number of properties are fronted by stark concrete – notably at Chapel View. The most attractive survival of historic paving is in the courtyard behind Gill House. A small patch of cobbles survives outside Heatherlands.

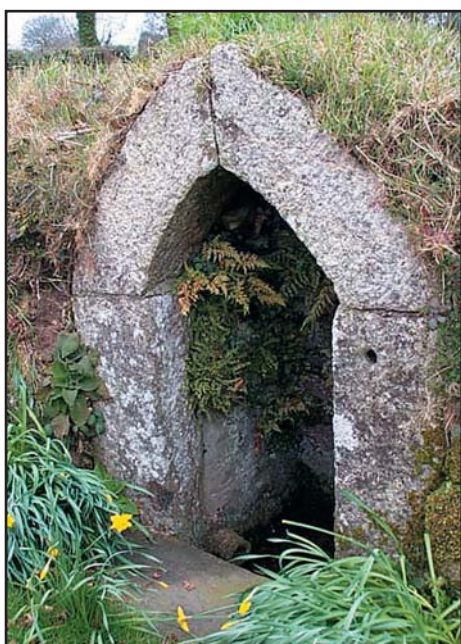
Fig 20 The well head

The influence of water is ever-present, especially in the central green spine - from the moss-draped stones on the walls, to the running water in the gulleys and the village pond opposite the church. The well head east of the war memorial is one of the most distinctive character features of the village and is complemented by the pyramid capstone dated 1883 on the conduit pipe a little way to the south east.

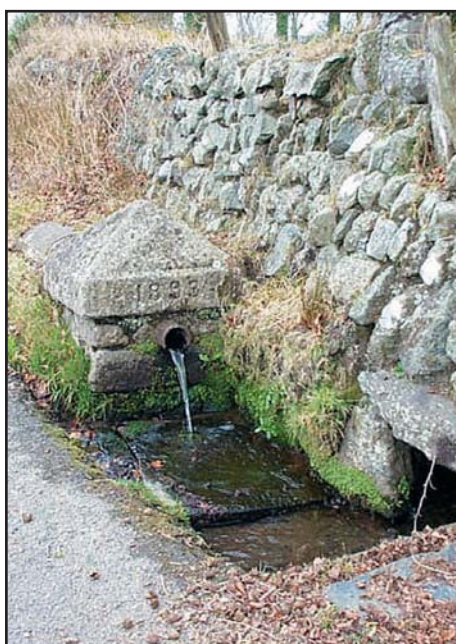
Fig 21 Conduit with datestone

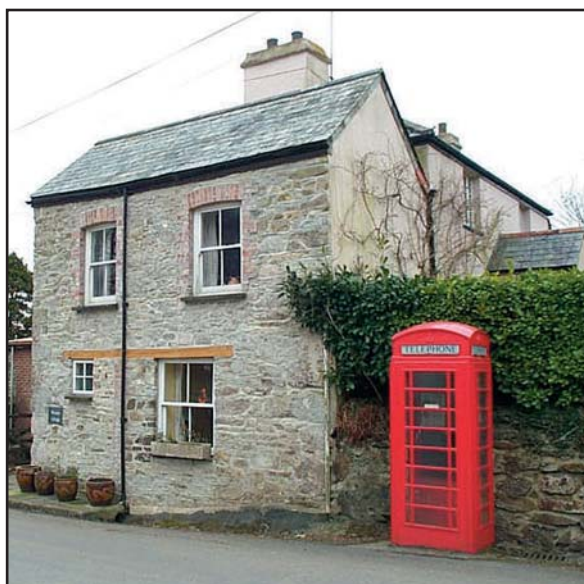
Fig 22 The K6 telephone kiosk

On the other side of the road there is the red K6 telephone kiosk and the post box marks the location of the former Post Office. The key focal point is, however, the war memorial. Located in the middle of the T-junction it is unavoidable and has a strong, direct relationship with Christ Church.

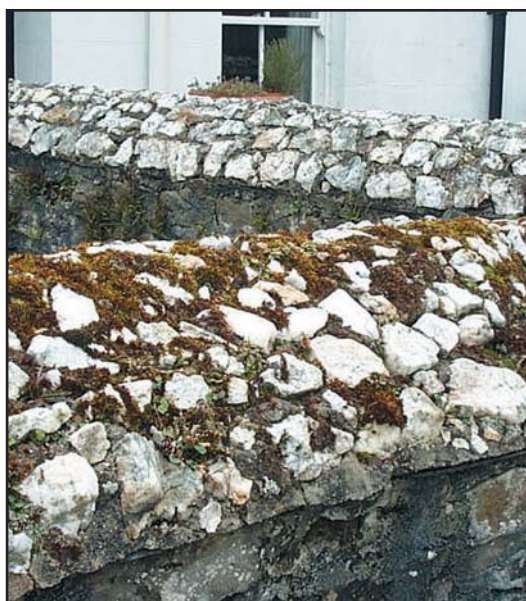
Historic enclosure is provided mainly by rubble stone walls. Garden walls are generally laid in lime mortar and some have a decorative capping of white veinous quartz – likely to have been a by-product of the mining activity in the area. A number of granite gateposts survive, some are plain, others more decorative. A few good iron gates may be seen and the property immediately west of the chapel has bold iron railings. Field boundaries are more often laid dry in banks and are sometimes coursed. In recent years there have been a number of timber boarded and panelled fences erected that invariably detract from the street scene.

Fig 24 Rubble stone wall with white quartz capping

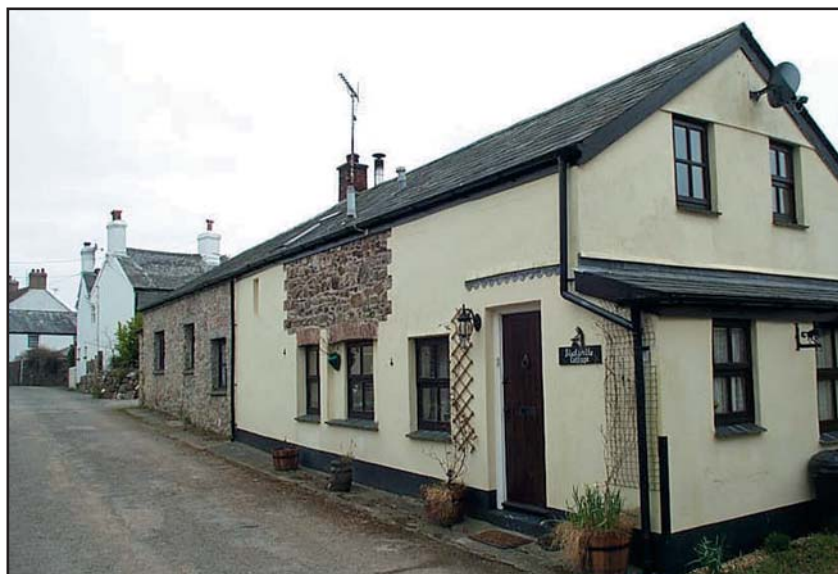
There has been very little modern development in North Brentor – the bungalow Lowermead is the most obvious example. The older part of the village has seen a lot of conversion of former outbuildings that vary in quality. Several appear to have involved a considerable amount of reconstruction and there has been the introduction of render and even dormers. This has inevitably meant a loss of character for individual buildings and many of the more intimate views in this part of the settlement.

Fig 36 Some conversions have involved significant alterations
