Horrabridge

Conservation Area Character Appraisal

Dartmoor National Park Authority September 2011

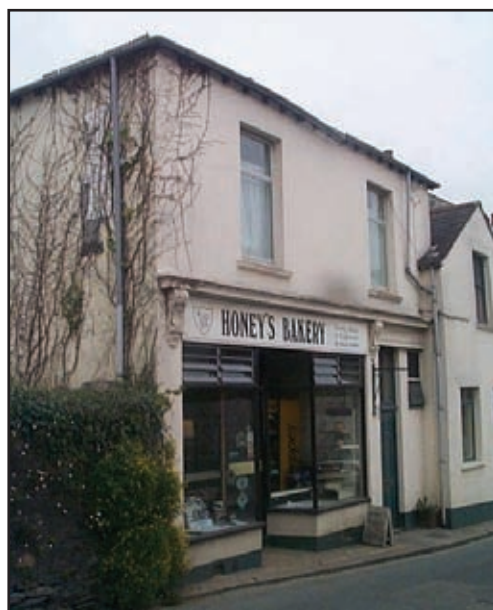
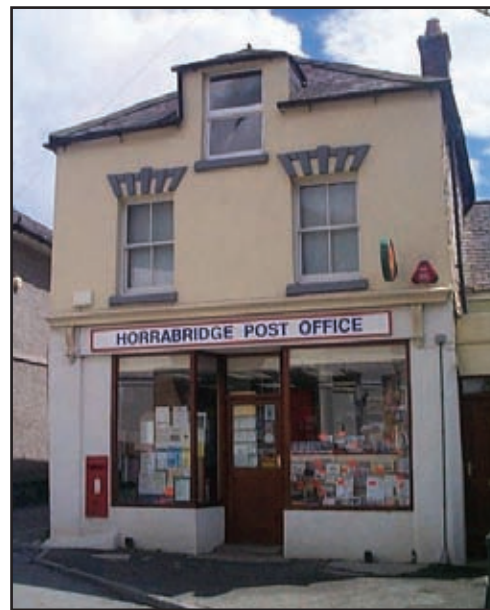
Figure 4 Shop front, Station Road

Figure 5 Shop front, Commercial Road

There is a good selection of shops within the Conservation Area which are mainly located together in Station Road and Commercial Road. All however, have much altered shop fronts which reflect the fashion and corporate needs of today's retail trade [Figures 4 - 5 above].

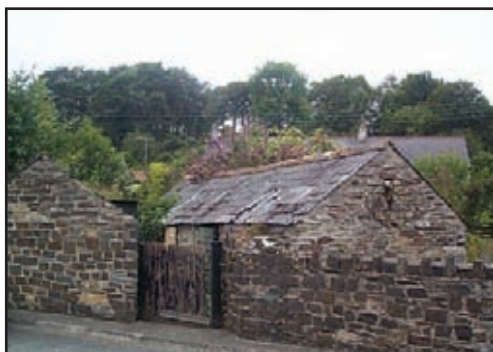
Figure 6 Pighouses, Chapel Lane

Some non-domestic buildings like the pighouses [Figure 6 above] near the bridge adjacent to Chapel Lane and the now converted Smithy [Figure 7 above] in Station Road also survive.

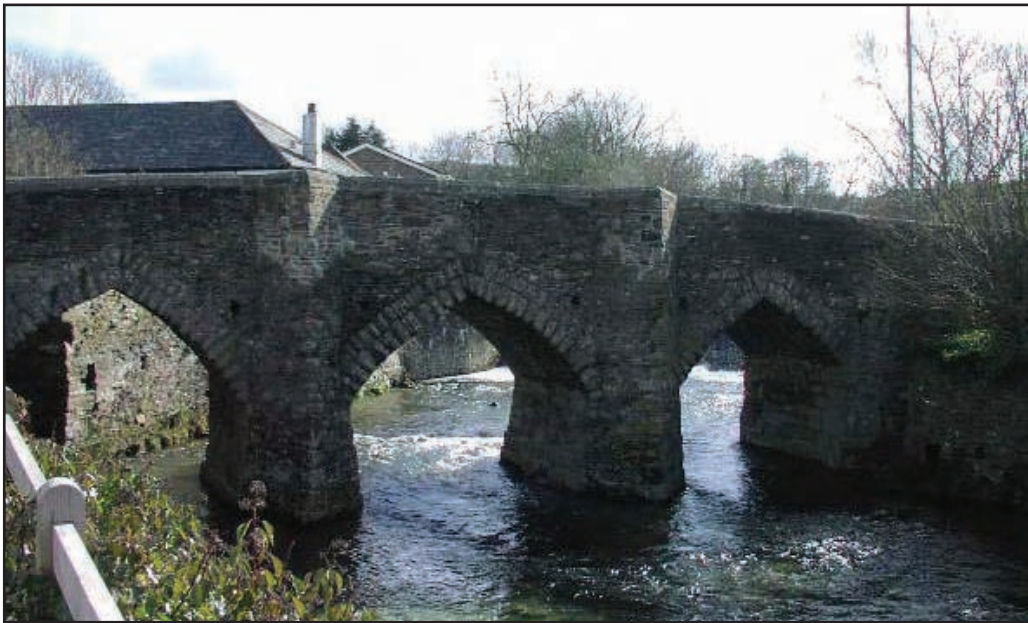
Figure 9 Horrabridge Bridge

Horrabridge Bridge: grade I

This bridge over the River Walkham dated cAD1400 consists of squared granite rubble footings supporting three spans each with irregular pointed arches and two triangular cutwaters. The total span of the bridge is 17 metres with refuges for pedestrians. To the west is a large central block of granite within the masonry wall which contains drainage holes at road level. The structure is also a scheduled ancient monument.

Little survives of Horrabridge's medieval roots today apart from the Grade I listed bridge [Figure 9 page 17], thought to date to around 1400, fragments of the Chapel of John the Baptist, and some typically medieval property boundaries. These lie mostly to the south of the river on the eastern side of the main street, although some appear to the north.

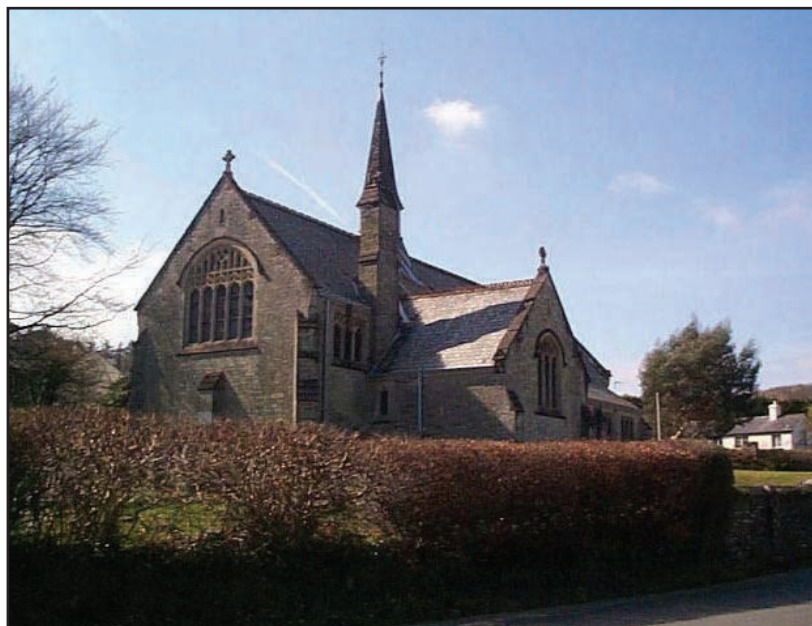
Figure 10 Church of St John the Baptist

Church of St John the Baptist : grade II*

Originally built at the entrance to the south end of the village in 1893 it has now become a little side-tracked by virtue of the new road link to the A396. Designed by G. H. Fellows Prynne in his typically free Gothic style it is a simple chapel contained by a long sweeping roof and lit by windows of decorated perpendicular tracery. A few fragments of the medieval Chapel of St John the Baptist still survive, the present church being built on this important chapel site. The boundary walls, gates and lantern are also listed.

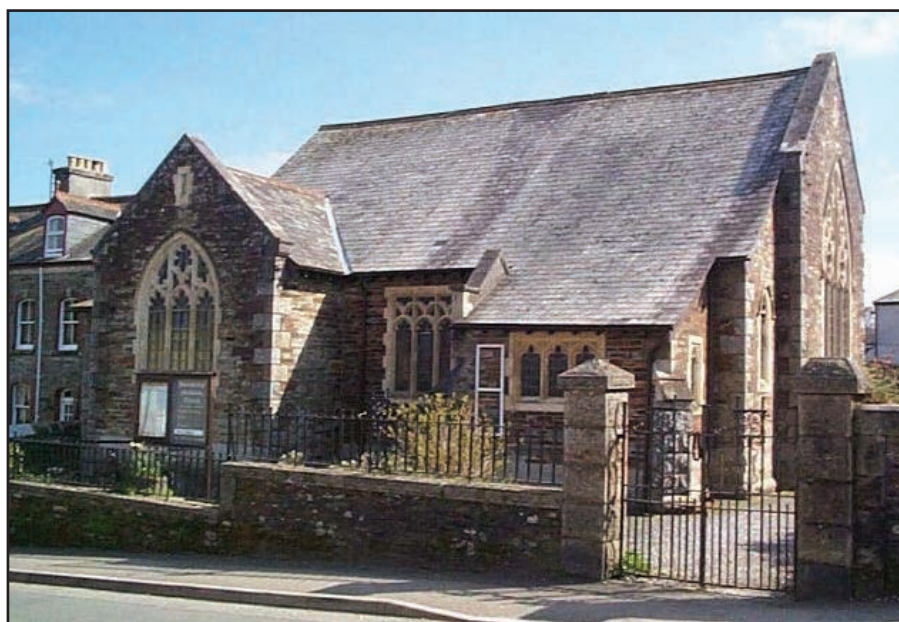
Figure 11 Methodist Church

Methodist Church: grade II

This church probably stands on, or adjacent to, the site of the possible medieval market place. Built in 1910 it is of a more ambitious style than that of the Church of St John the Baptist. Elaborate decorated windows contain stained glass in the art nouveau style.

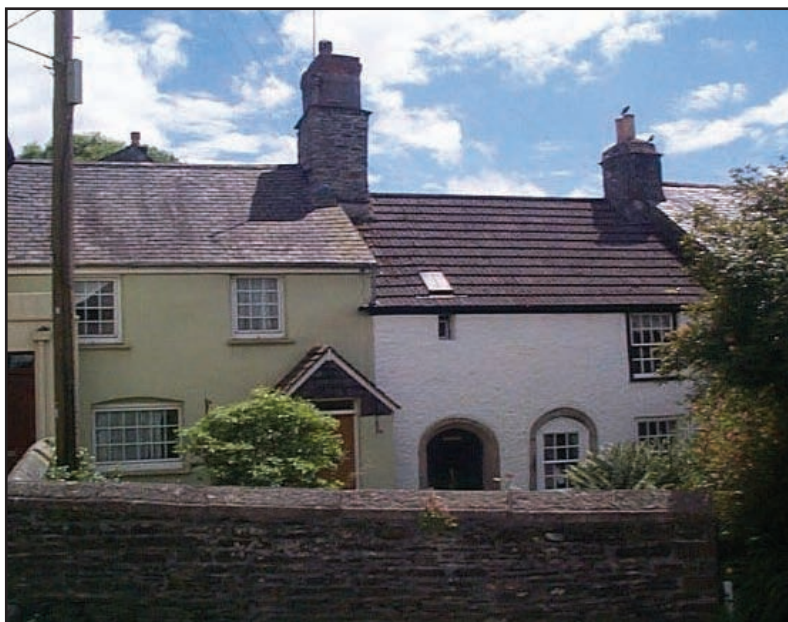
Figure 12 Coles Cottage and Weirside, Commercial Road

No1 Coles Cottage and Weirside: grade II

Originally one house with mid sixteenth century origins it was subsequently altered and extended in the mid 19th and 20th centuries. It is the only domestic building to be listed in the village and contains some notable features.

Few early houses in the village survive in anything like their original form. The best example is situated on the north bank of the river being once a house [Figure 12 page 19] and now converted into two cottages. Other houses may well have had similar origins, particularly those which make up the centre of the village and around the possible market place.

The Conservation Area probably contains buildings whose fabric dates from as early as the sixteenth century, although only one has been identified as such [Figure 12 page 19] and listed to denote its historic interest. It was possibly a three room and cross passage type house typical of the Dartmoor vernacular building. Others may still survive although probably they are not now intact.

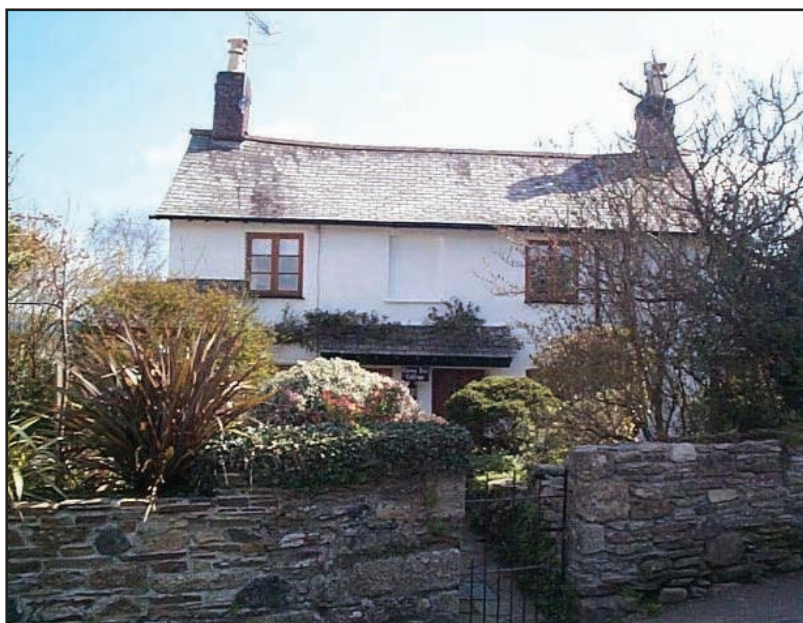
Figure 13 Cherry Tree Cottage, Station Road

Cherry Tree Cottage, Station Road:

This isolated domestic building probably dates from about the 18th century and appears on the c.1840 tithe map. The form and scale of the cottage is typical of vernacular buildings to be found in the village at that time, and the front of this cottage together with 29 Station Road gives an indication of the alignment of buildings shown on the 1906 OS map. The house has a good front garden boundary stone wall with a metal gate.

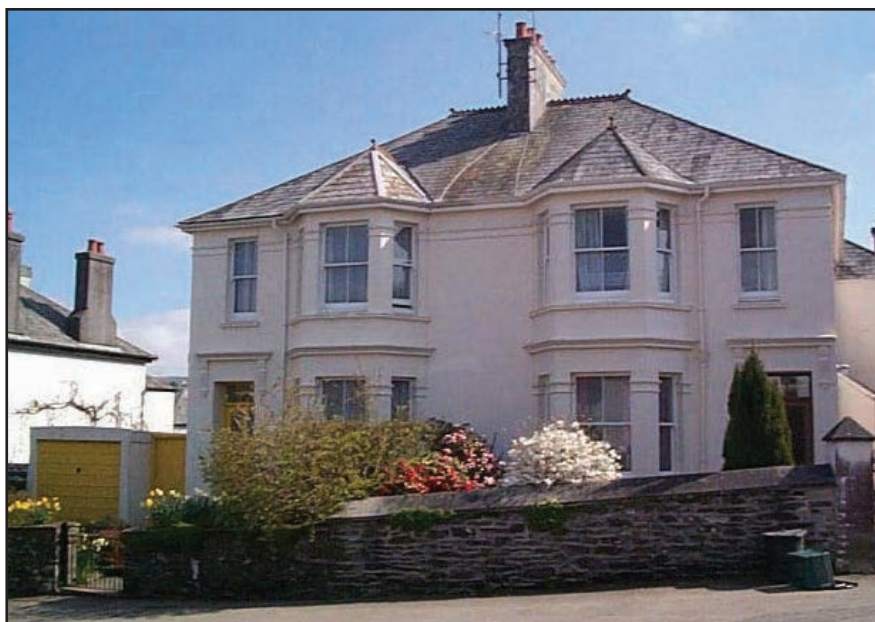
Figure 14 47 and 49 Station Road

47 and 49 Station Road:

This pair of early 20th century villa type houses were built as a part of a redevelopment phase in this part of the village. They are a good unspoilt example of Victorian domestic architecture. With projecting bays under

half-hexagonal roofs, mouldings, string courses, wooden sash windows and doors, natural slate roof coverings and shared chimney stack. All of these features contribute significantly to quality and authentic appearance.

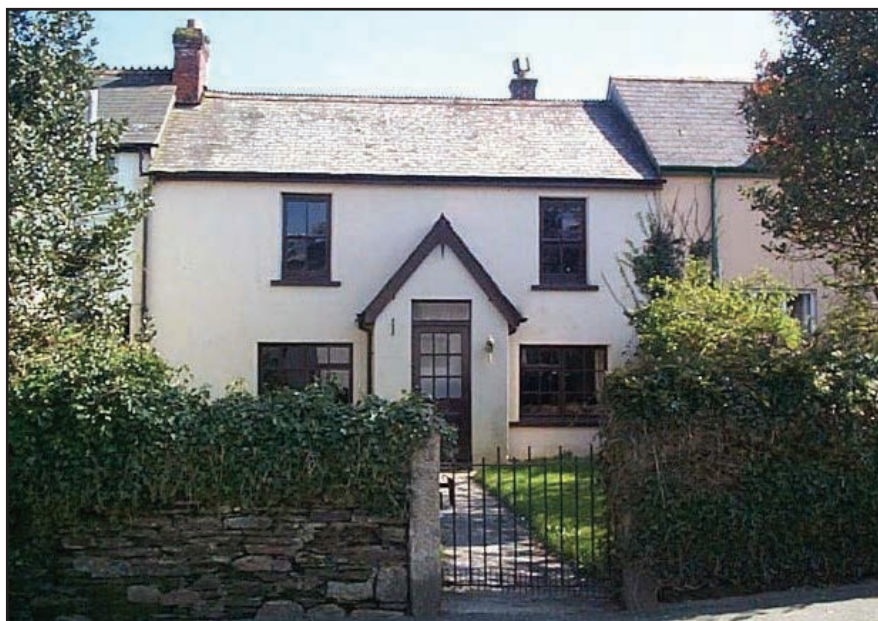
Figure 15 29 Station Road

29 Station Road:

One of a range of cottages, probably dating from the 17th century, once fronting onto the probable market place and perhaps part of a larger earlier building with a cross passage. Although remodelled to create a symmetrical frontage about an entrance porch, the simple appearance of the house with its walled front garden and metal gate give a distinctive character.

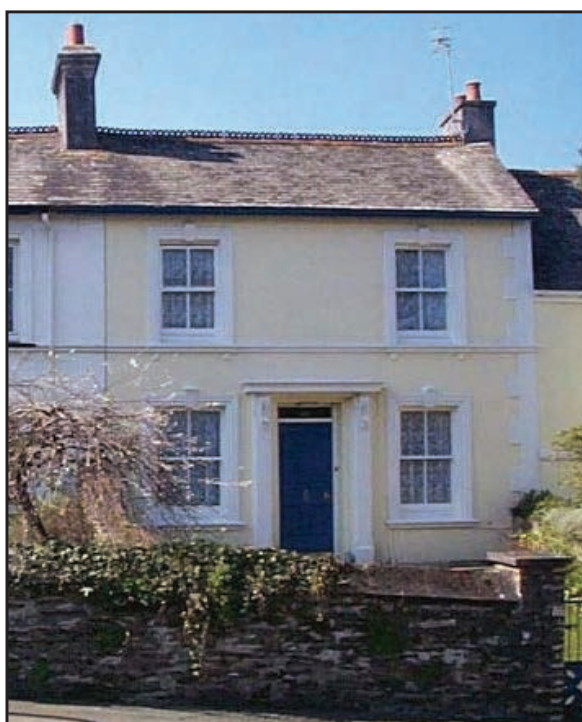
Figure 16 42 Station Road

42 Station Road:

This late 18th century terraced cottage still retains its original appearance and is sensitively presented. Original decorative wall and window opening details, original door and window joinery, and slate roof covering with decorative ridge tile, all provide a good authentic feel to this otherwise modest cottage.

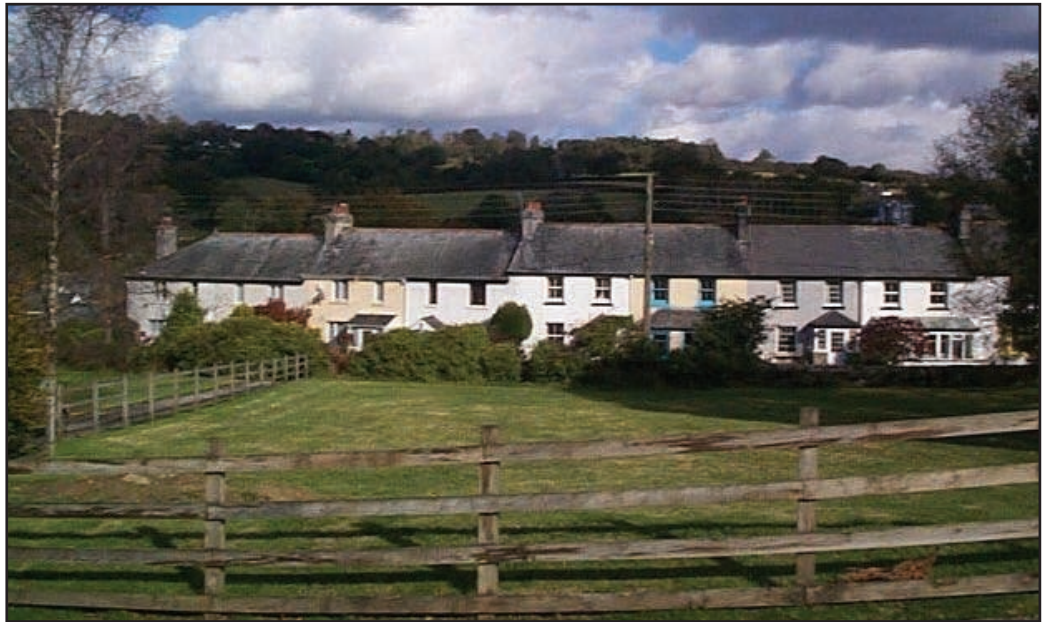
Figure 17 South View Terrace

There are a series of good terraces within the Conservation Area which are characteristic of the vernacular tradition for the village. An example is South View Terrace [Figure 17 above].

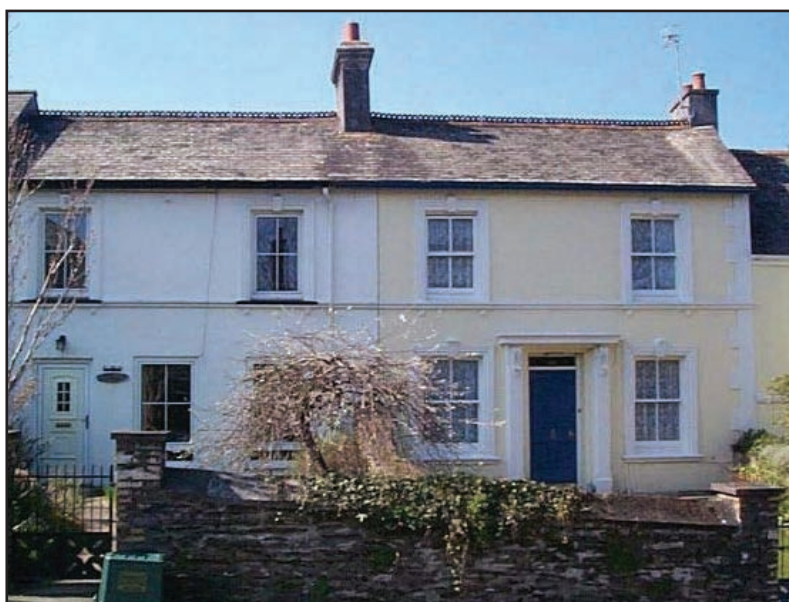
Figure 18 Loss of detail: a once matching pair of cottages, the left hand one has been considerably altered during 20th century

Loss of detail is a major concern in the Conservation Area. Inappropriate and insensitive alterations to window and door openings, loss of natural slate roof coverings and decorative render details to walls, replacement of wood windows and cast iron rainwater goods with pvcu material, and removal of chimneys all lead to the erosion and loss of historic fabric. [\[Figures 18 and 19 page 23\]](#). This process of change directly affects the character and appearance of Horrabridge's historic buildings and in turn the special interest of the Conservation Area.

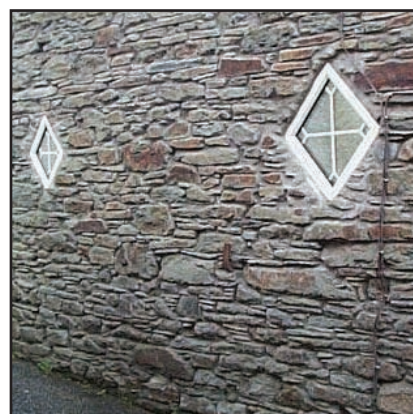
Figure 19 Loss of detail: inappropriate PVCu windows

Of those that survive, wooden windows are mainly sliding sash in form, although some wooden casements also remain. However, most windows in the Conservation Area are plastic pvcu types. These, combined with other changes, have significantly eroded the village's historic character and appearance.

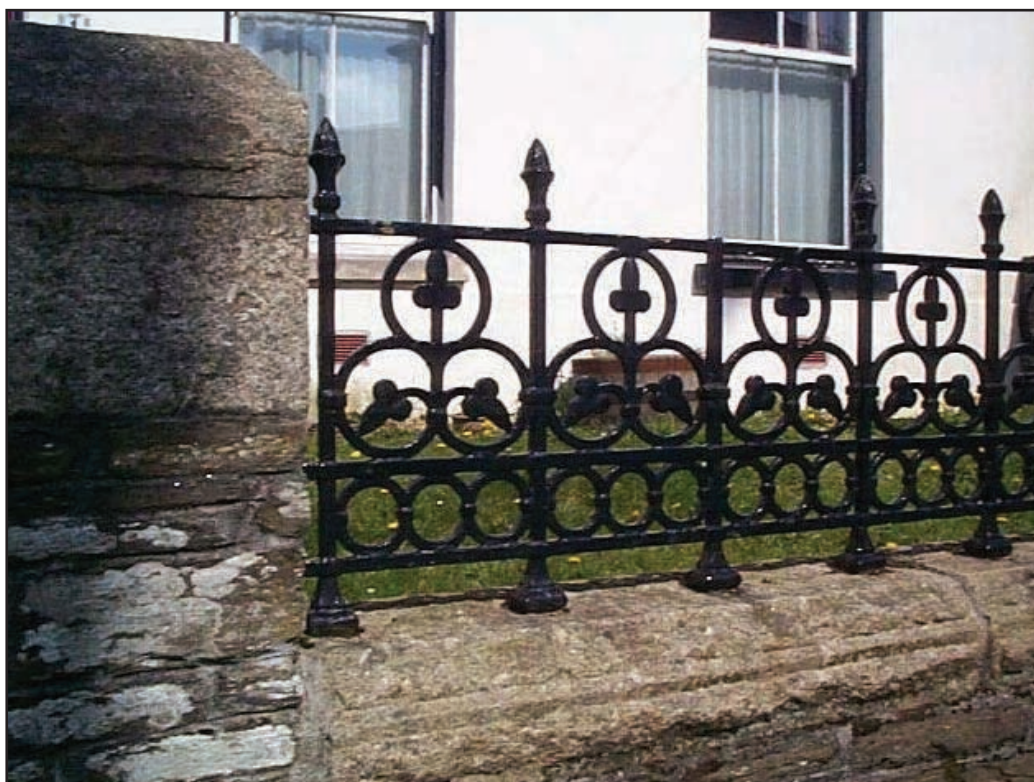
Figure 20 Decorative cast iron railings

Many properties, both secular and non-secular, have front boundary walls built in local stone and some are topped with granite copings. These are a particular feature and seem to be based on the earlier bridge wall construction. Some stone boundary walls are plain and others have crenellations or other types of copings in lieu of granite. Additionally, many of these walls incorporate iron gates and railings each with varying degrees of decoration. See [Figures 13-16 pages 20-21](#) relating to notable buildings, and [Figures 20-22 pages 24-25](#) relating to local details.

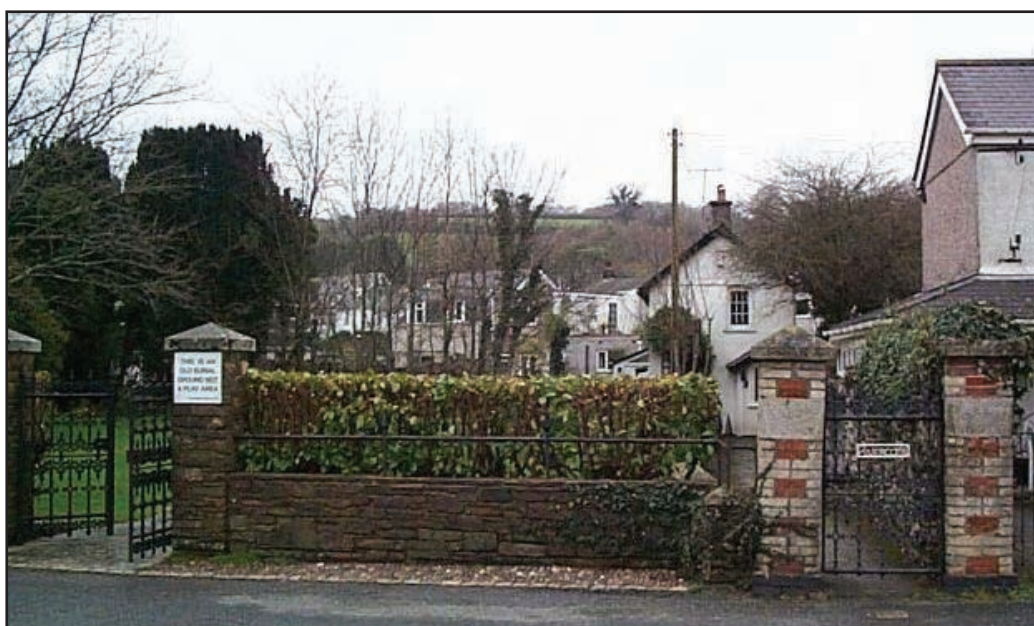
Figure 21 Stone boundary wall and gate piers, decorative cast iron gates and railings, decorative brick gate piers. Cobblestone path and kerbs

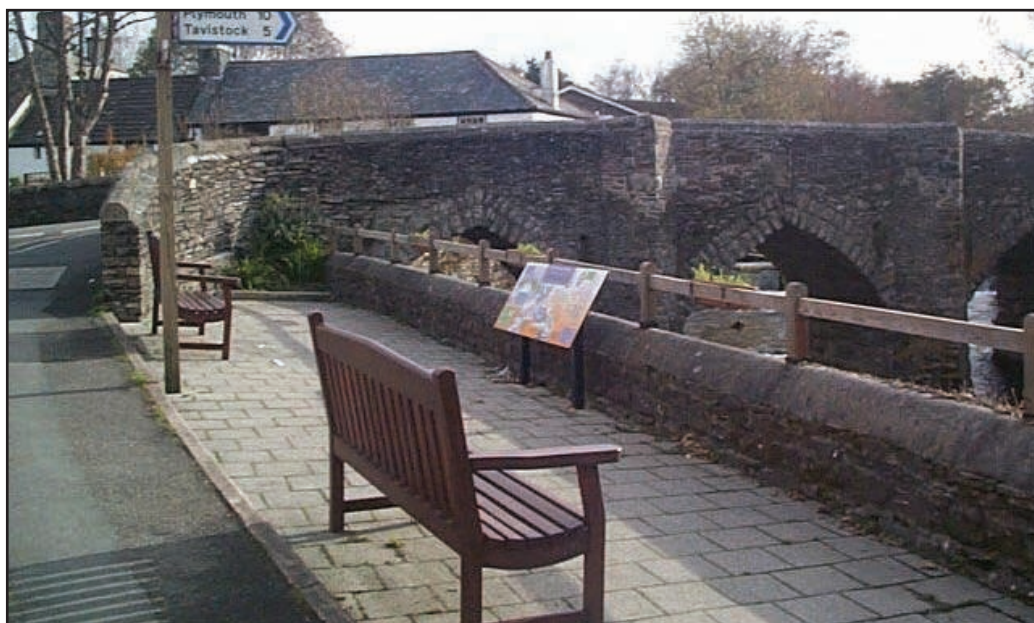
Figure 22 New paving, wooden seats and protective railing

A good example of street furniture is the paved seating area [\[Figure 22 page 25\]](#) to the north and downstream of the bridge adjacent to Whitchurch Road. An example of the poor provision and arrangement of street furniture [\[Figure 23 page 25\]](#) is the pavement 'clutter' outside Cherry Tree Cottage.

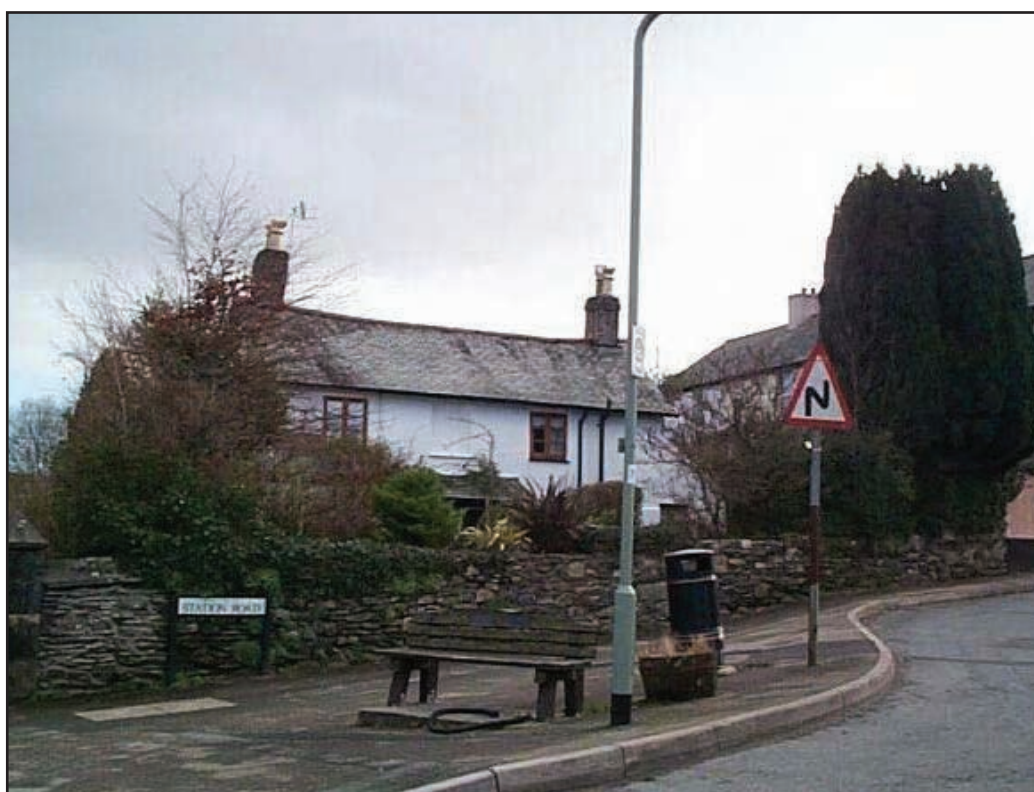
Figure 23 Street clutter on pavement outside Cherry Tree Cottage, Station Road

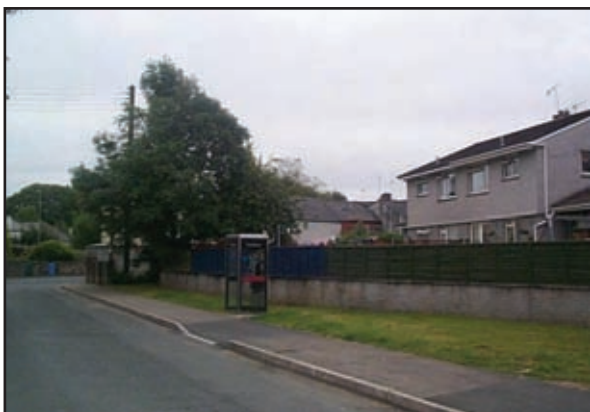
Figure 28 New housing development, outside Conservation Area, Chapel Lane

The village of Horrabridge has grown into a significant settlement by virtue of modern housing development, particularly to the south of the river. Within the Conservation Area itself only a small amount of new domestic buildings on scattered, isolated sites has occurred, including some change of use to existing buildings. The impact of this modern housing development has been to urbanise the overall appearance of the settlement whilst eroding the architectural and historic character of the village itself [Figure 28 below].

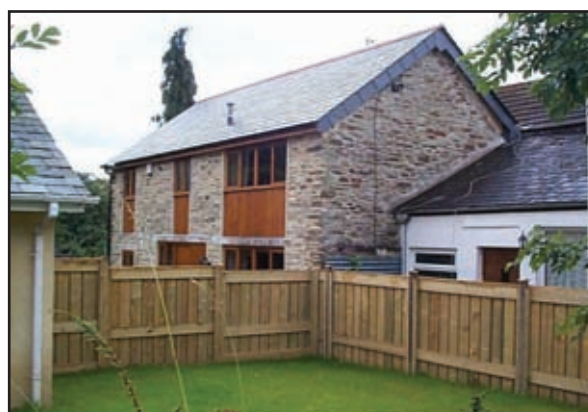
Figure 29 Recent conversion to form new dwelling, Bedford Road

This loss has significantly eroded the quality of the village environment and the value of Conservation Area designation has to be questioned. So much modern development in recent years has damaged the very heart of the village environment against which designation was intended to protect. However, some examples of good design and quality building conservation work can also be recognised [Figure 29 below].
