Lustleigh

Conservation Area Character Appraisal

Dartmoor National Park Authority January 2011

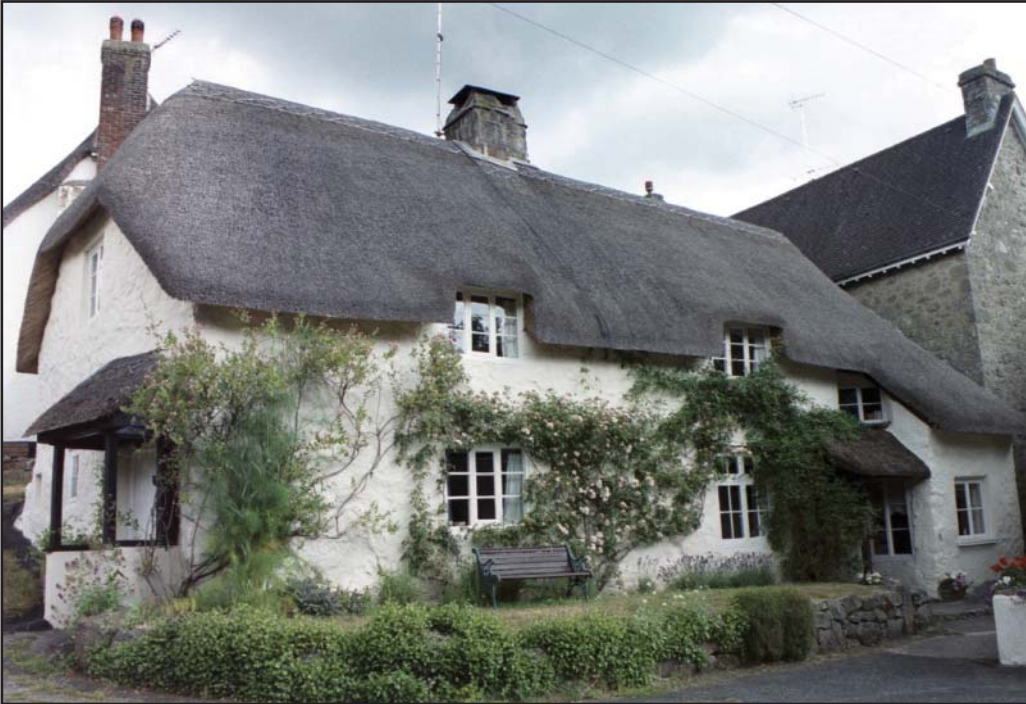
Figure 2 Littleholm, built in the 16th century, displays the principal characteristics of the earlier, vernacular, type.

The principal characteristics of the earlier type [Figure 2 page 13] are based on vernacular traditions, including their proportions, which are generally long and low; their walls of granite and cob, which are mostly rendered and colour-washed, or colour-washed directly so that the patterning of the material beneath shows through; and their roofs of thatch, which are now mostly finished with a flush ridge that follows the long-established Devon tradition. (The ornamental block-cut ridges, which are still in evidence, derive from Norfolk traditions and represent a 20th century introduction).

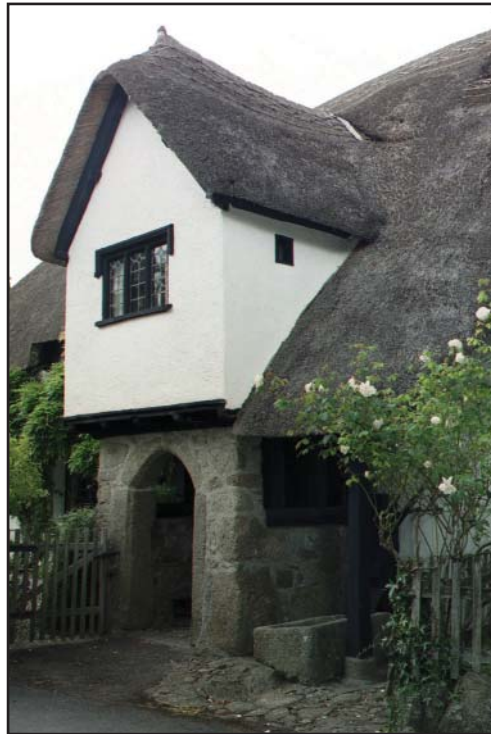
Figure 3 The 2-storey porch of Wrayland Manor

two storey height that reflects the high status of the house. [Figure 3 above].

Original door and window openings are mostly spanned by narrow-looking timber lintels, while projecting, purpose-made window sills are often absent. For the most part, the windows themselves are of painted timber with side-hung flush-fitted casements, but while glazing bars are used to divide most of them into small panes, a significant number are leaded in either diamond or rectangular patterns. This practice appears to have become established during the earlier half of the 20th century, either simply to recreate a more medieval appearance or as part of a conscious attempt to revive vernacular traditions in the manner of the Arts and Crafts movement which was then popular. Whatever the case, the style has become a characteristic feature of the village, especially in Wrayland [Figures 3 and 4 above] but in the centre too [Figure 5 page 15].

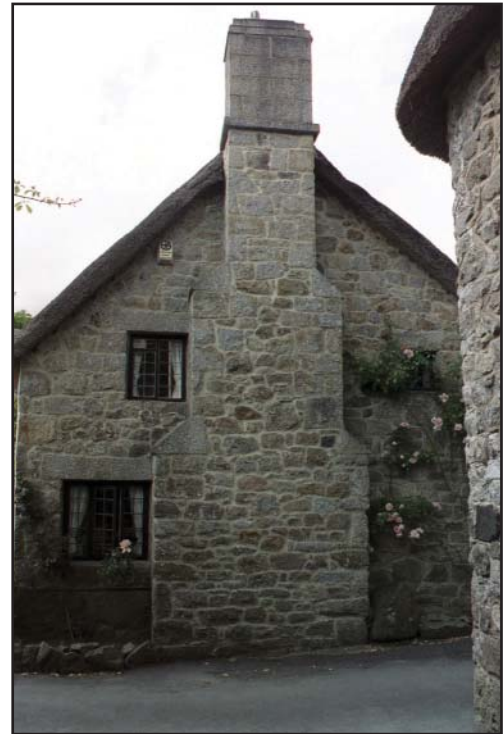
Figure 4 The gable stack and leaded windows in the style of the 16th century added to Wrayland Manor in the 20th century.

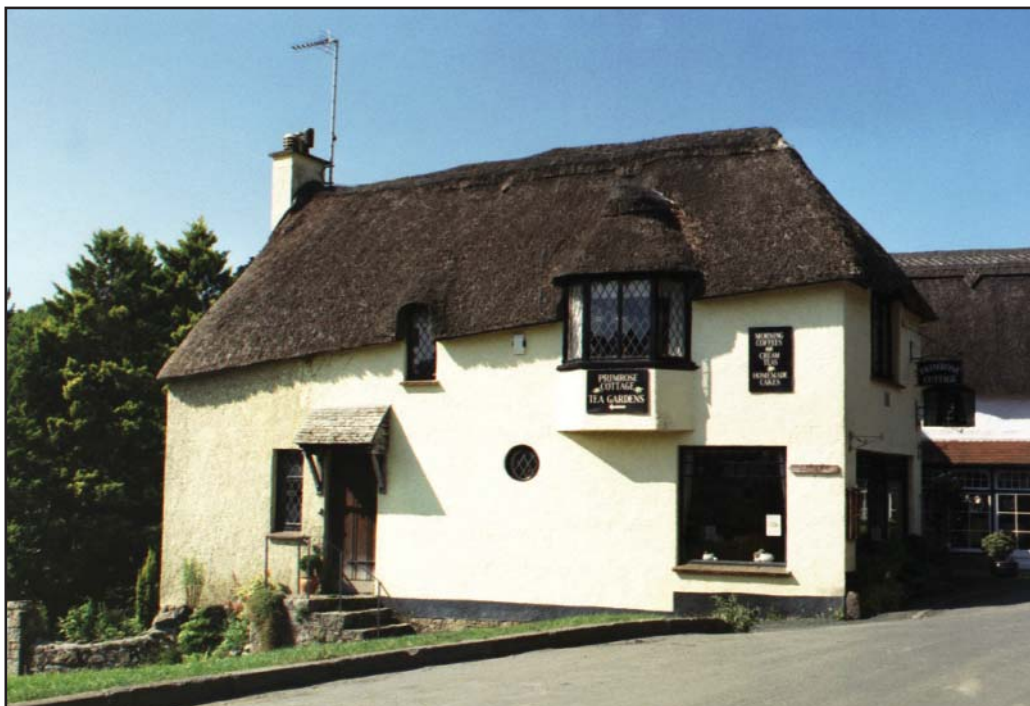
Figure 5 Primrose Cottage with its Arts and Crafts bay window and leaded lights

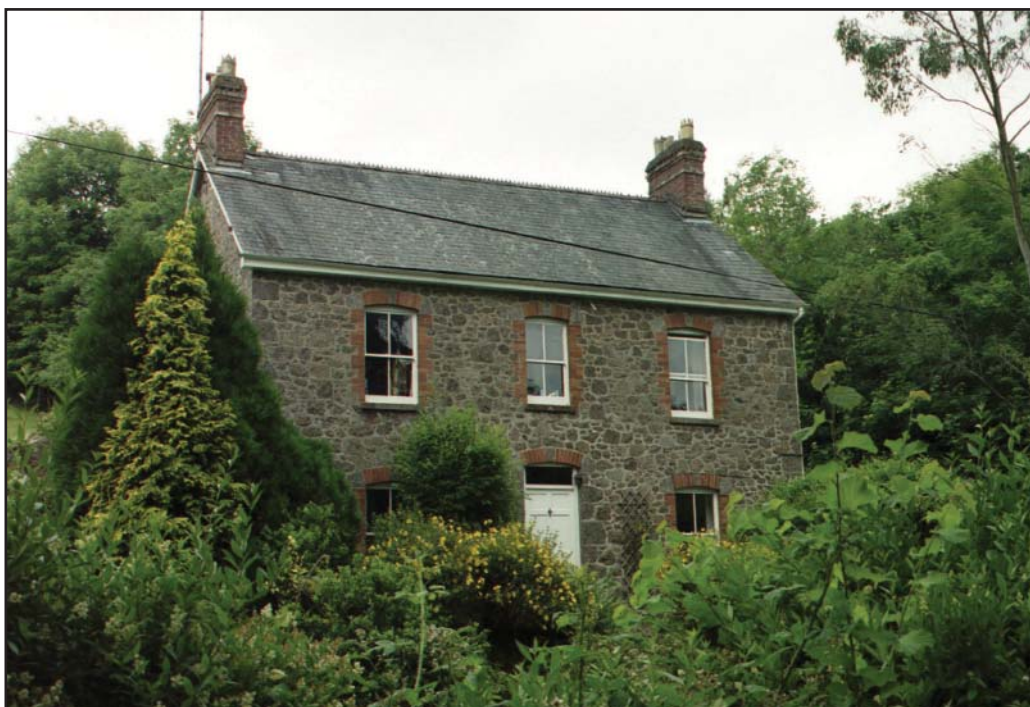
Figure 6 Wreyland Villa, built in the 19th century, displaying nearly all the characteristics of the more recent type.

The other, more recent, building type has characteristics that contrast in almost every way [Figure 6 page 15]. With the exception of Melrose Terrace and the new post office, which are constructed of exposed or rendered brick, their walls are of exposed granite rubble with the openings for windows and doors dressed in red or yellow brickwork. Decorative bargeboards and ridge tiles are a common feature of roofs, which are invariably gabled and clad in regularly sized slates [Figure 17 page 25]. Windows are again of painted timber but instead of being small-paned or leaded casements, they are typically vertical-sliding sashes with a 2 over 2 pattern. Their form and proportions create a vertical emphasis on principal elevations, which are consciously designed to

produce a well-ordered, sometimes symmetrical, appearance. The shafts of chimney stacks above roof level are often elegant red brick affairs with battered caps surmounted by red or yellow clay pots.

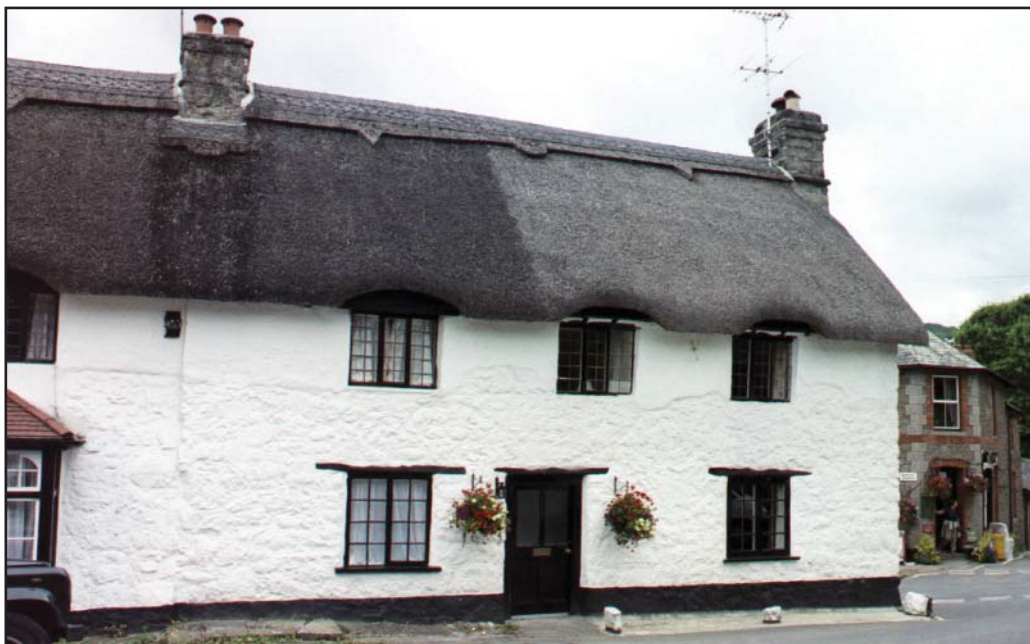
Figure 8 Spring Cottage

Part of a longer row that is very prominent on the lane encircling the church, this 16th or 17th century cottage displays many vernacular characteristics, most notably the narrow timber lintels, the painted walls (mostly over granite but cob towards the top), the granite stacks and, not least, the thatched roof.

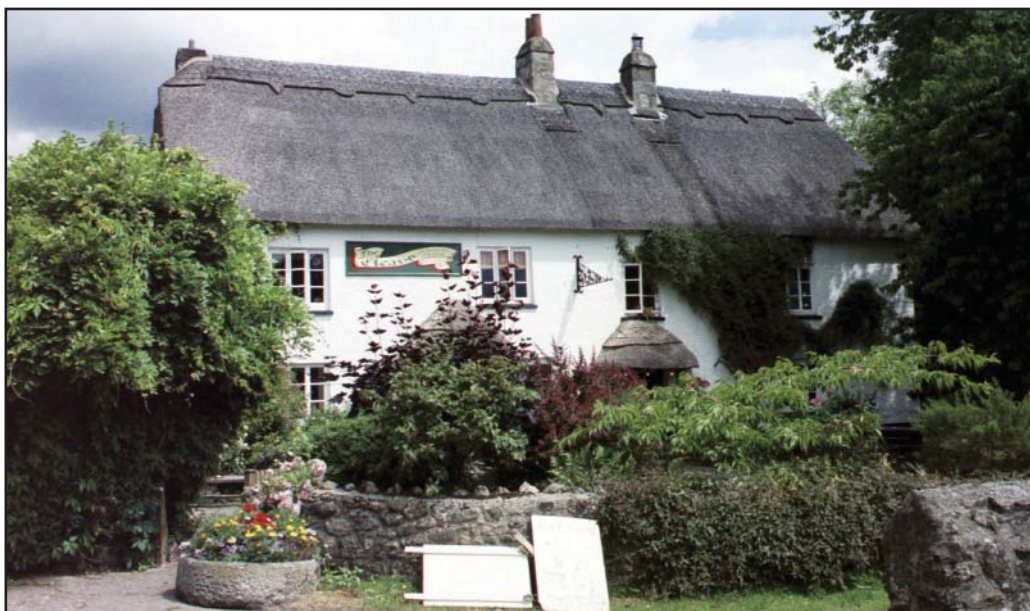
Figure 9 The Cleave (called Gatehouse on the Tithe Map)

A building with quite different characteristics front and rear. The front range is clearly vernacular, being built as a farmhouse in the 16th century. The range at the rear, however, with its slated roof, brick stack and sash windows, is clearly late 19th century and was probably added at the time the farmhouse became an inn.

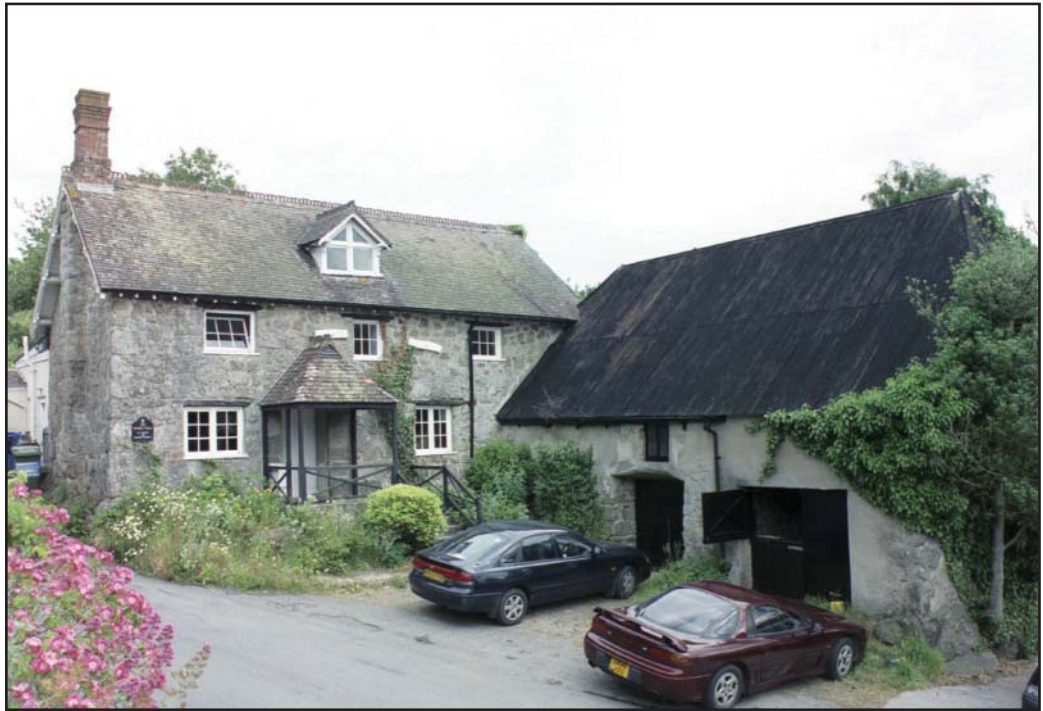
Figure 10 The Church House and adjacent Barn

Although 16th century and originally thatched, the vernacular character of the Church House was somewhat transformed late in the 19th century when it was thoroughly refurbished and gained many of the characteristics of that age – in particular its gabled and tiled roof, decorative ridge tiles and the brick shaft added to the granite stack. The 17th century barn adjacent was also originally thatched, but under its corrugated iron roof it has survived as one of the very few farm buildings in Lustleigh not to have been demolished or converted.

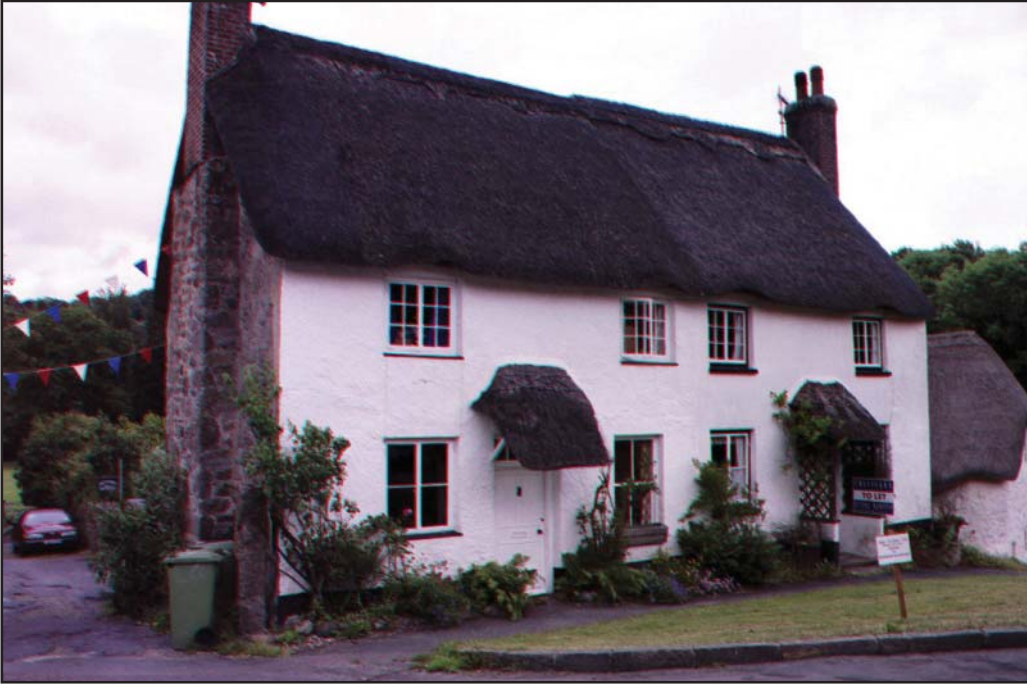
Figure 11 The Pair of Cottages on the east side of the green

The evidence of former openings in the rear suggests these cottages were created out of a barn, probably around the middle of the 19th century. It has a mix of styles; some vernacular, such as the rendered and painted front, thatched roof and small porches; and some later, such as the brick stacks, exposed granite walls to sides and rear, and a sash window as well as a fanlight window over the door.

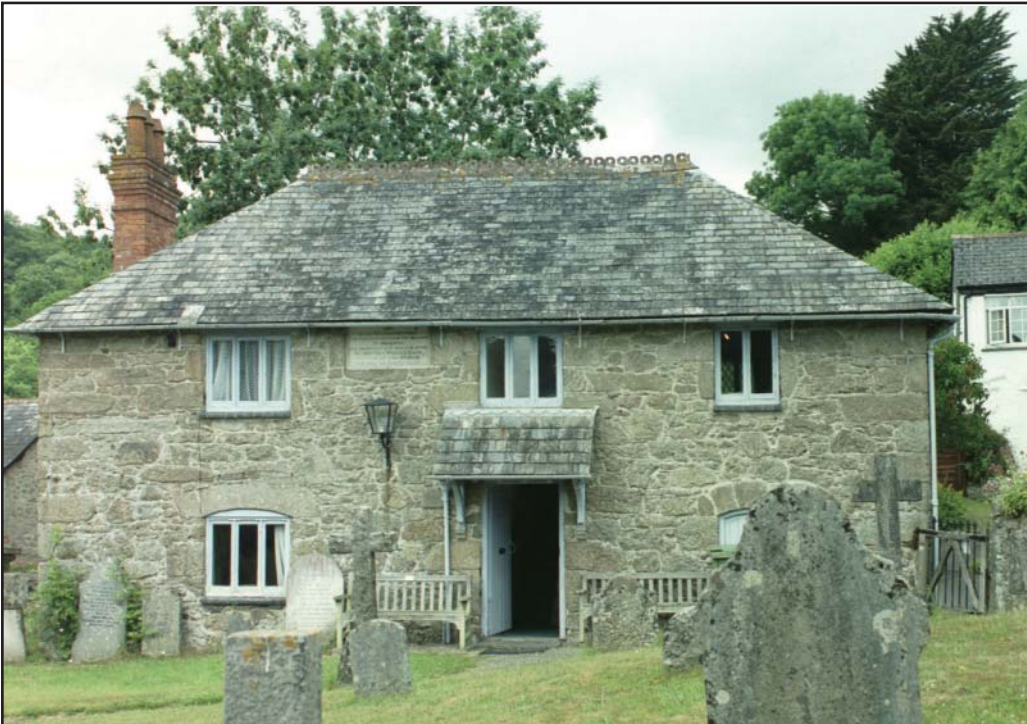
Figure 12 The Old Vestry

Although built as a school-come-vestry (in 1825), it has a domestic scale and appearance which harmonises with the setting. Its squat proportions, casement windows and door canopy tend towards the vernacular, while its exposed granite walls, slated roof, decorative ridge tiles and very impressive brick stack have a closer affinity with the later type. In addition it has a few characteristics that are quite uncommon, including the hipped roof ends and the stone dressings to the window openings – not unlike those of the church.

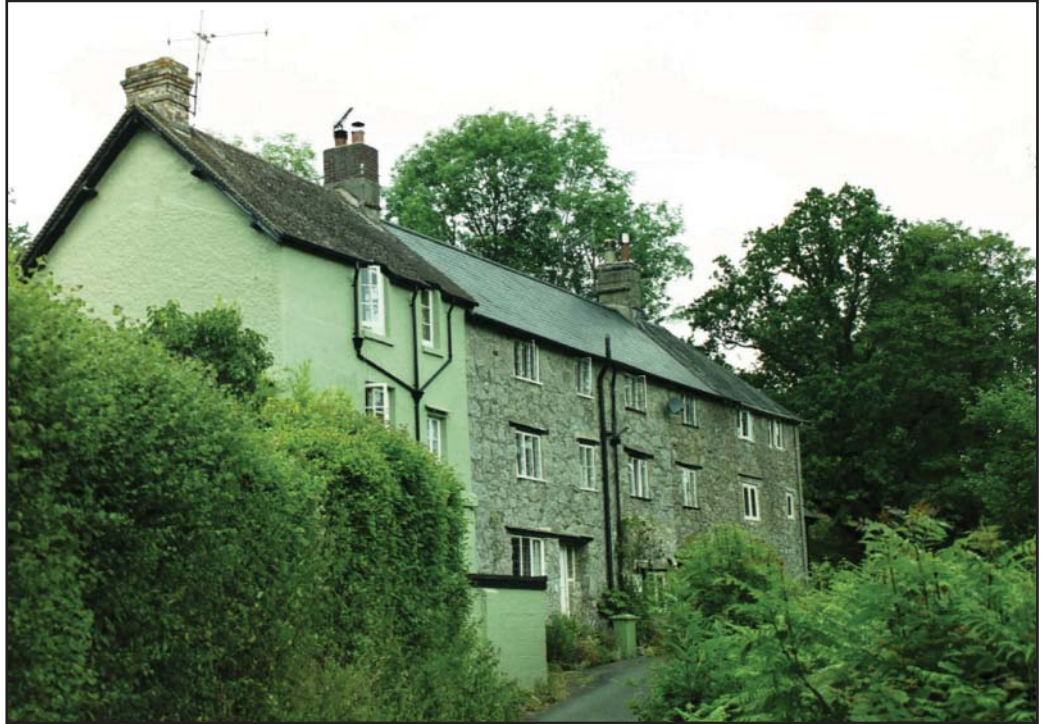
Figure 13 1, 2 and 3 Rock Cottages

These are the three cottages in the photograph with exposed granite walls. Built in the late 18th century, their characteristics are similar to the Old Vestry in that they are a blend of both the vernacular and later types. Their 3-storey height and split-level design are not typical of rural cottages, neither the uncluttered slate roof and fairly regular fenestration, so maybe a different use for the buildings was originally planned. Whatever the case, the cottages today are certainly a prominent and somewhat dominant feature in this part of the Conservation Area when approached from the Mill further down the valley.

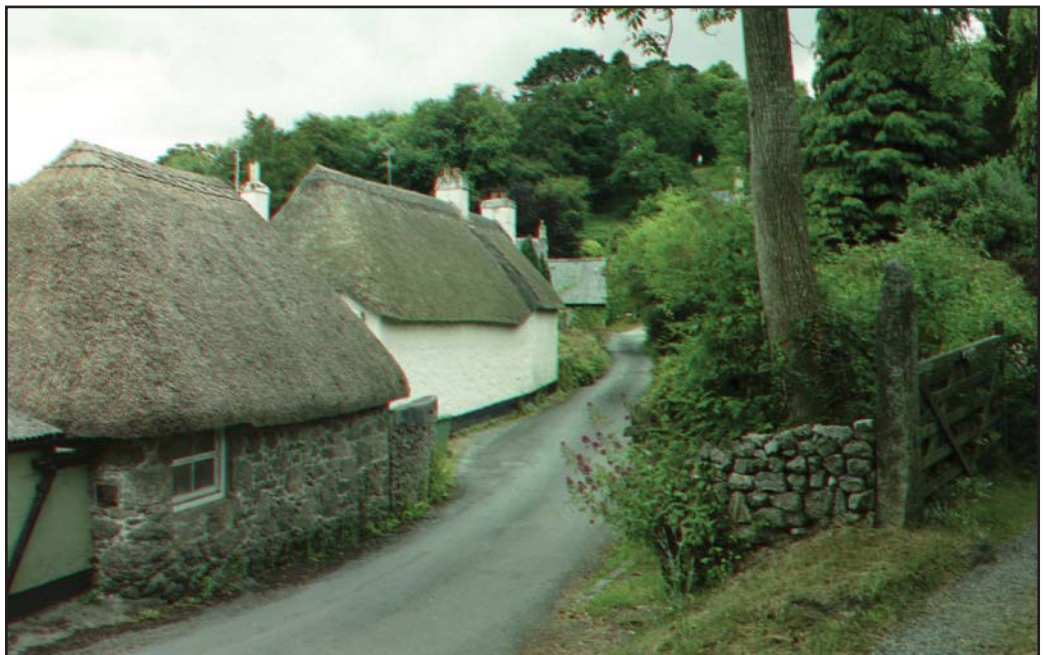
Figure 14 Lynnfield

Built on the roadside, the vernacular characteristics of this extended 18th century cottage (and those of the small outbuilding close by) dominate the scene. Their low proportions, thatched roofs, and the painted walls of Lynnfield itself, are in complete contrast, however, with the later villas that actually prevail in this part of the Conservation Area (south of the centre), but being mostly secluded in their large landscaped gardens, they tend not to have a prominence along the highway that serves them.

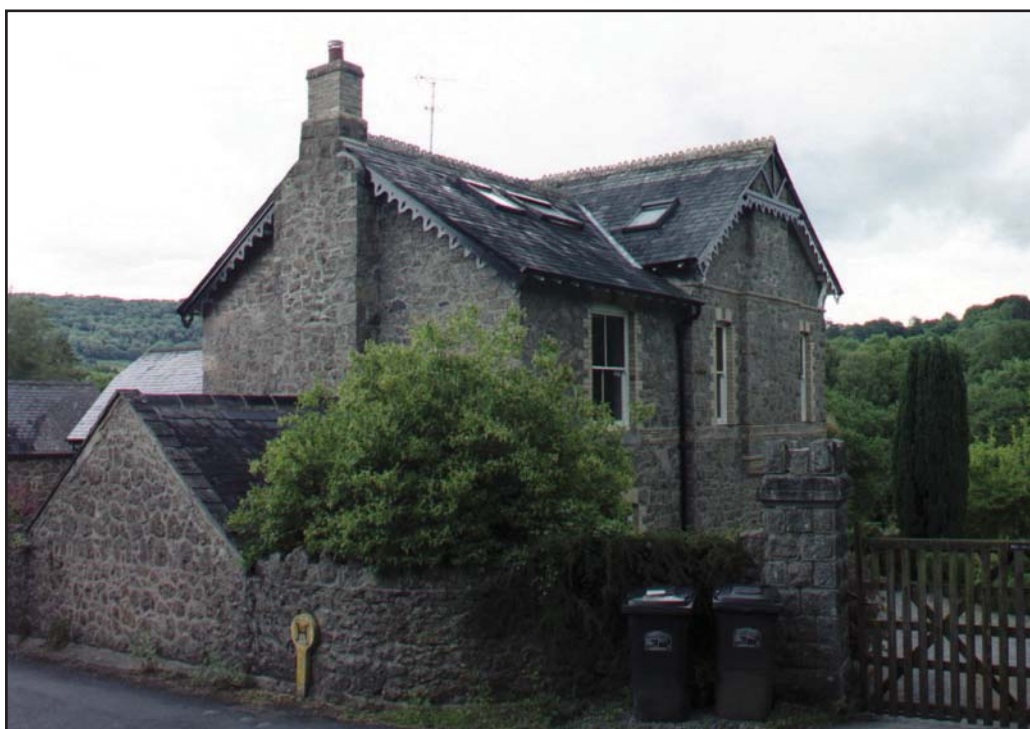
Figure 15 Rockdale

The only late 19th century villa in the area south of the centre that is close to the highway, and as with Lynnfield, it turns its back to face east to take advantage of the view. It has all the characteristics typical of its type, including slate roof, decorative ridge tiles, exposed granite walls, yellow brick dressings to window and door openings and decorative bargeboards. In addition, to complete the decorative effect, it has string courses at first floor sill and eaves levels made up of specially modelled yellow bricks. The large rooflights, however, clutter the roof slopes and spoil an otherwise authentic composition.

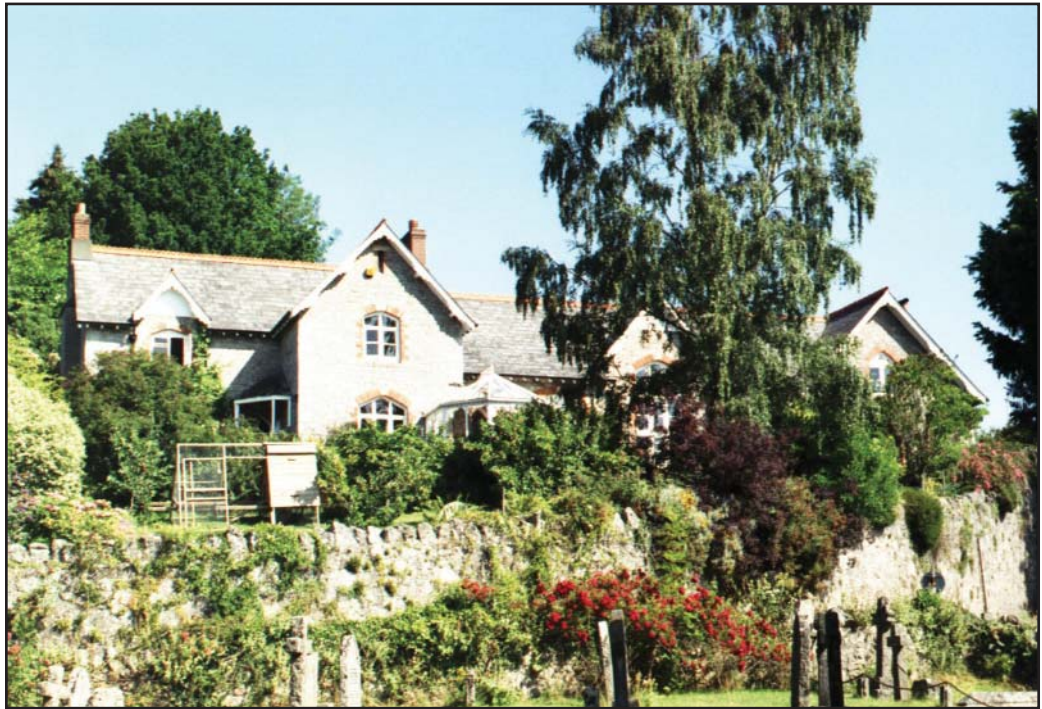
Figure 16 *The Old Schoolhouse*

Although masked by its maturing gardens, the scale of this building, and its prominent location above the church and next to the main route into the village, mean it still catches the eye. Fortunately, therefore, its conversion to a dwelling was well executed so that the essential characteristics of its age (1876) weren't eroded or spoilt – including its grey-blue slates and decorative ridge tiles; its gabled roof form with exposed rafter ends and decorative bargeboards; its exposed masonry walls with brick dressings, and its painted timber windows. As the roof is so dominant, the absence of modern rooflights is a positive asset.

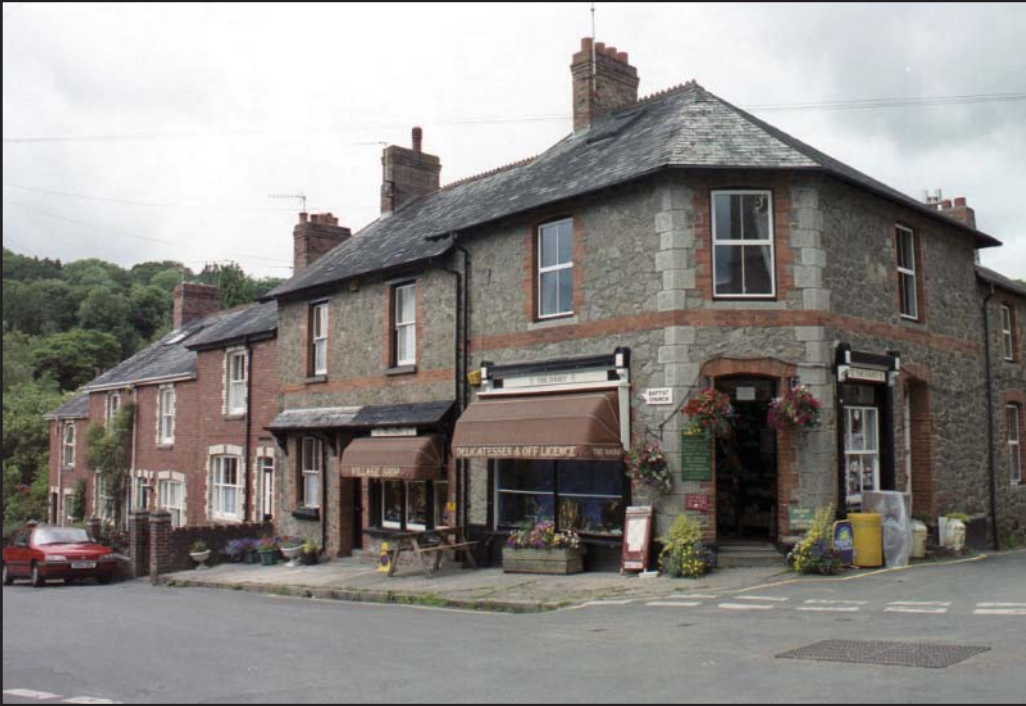
Figure 17 *The Dairy and next door cottage*

This pair made a handsome addition to the village scene with facings of granite and finely executed quoins at the angles. The shop fronts and extended porch across the neighbouring frontage add interest to the street scene but are spoilt by the addition of two cumbersome-looking modern blinds. (The shopfront to the post office opposite is equally attractive and has a more sympathetic, traditional style of blind). The replacement of some of the original timber sashes with upvc types is regrettable in this very prominent location. Had Melrose Terrace been likewise faced in stone, the effect would have been much more in keeping with the characteristics of the village scene.

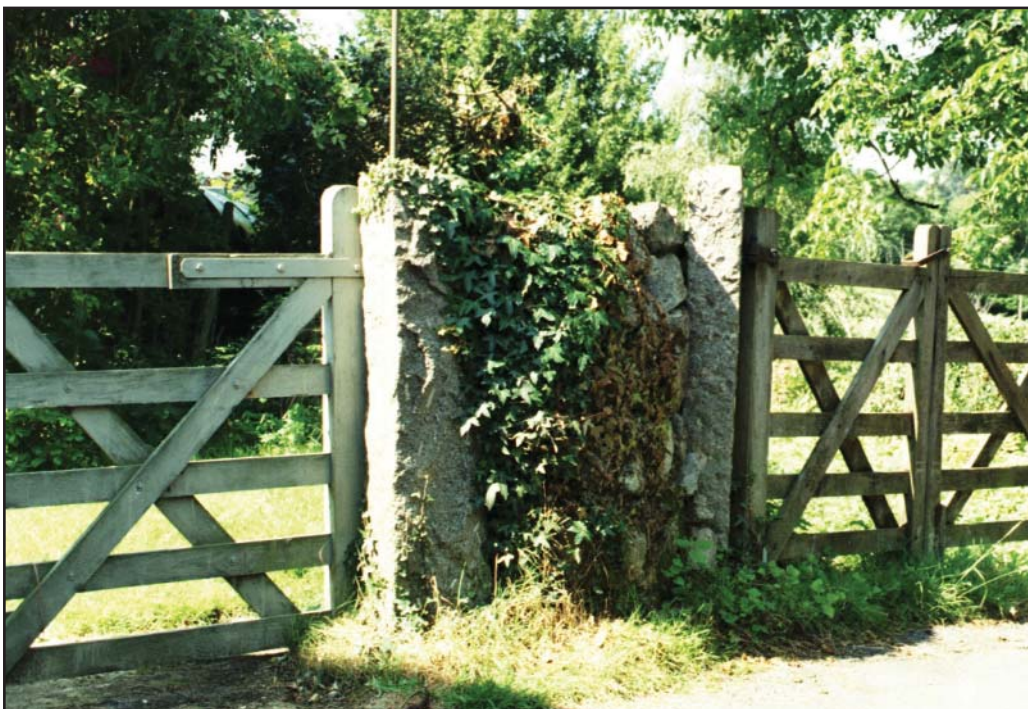
Figure 20 One each of two pairs of granite gateposts near Lower Wreyland

While granite is used in the construction of every sort of building, from modest out-house to magnificent church, and brings with it a tremendous sense of visual cohesion to the village scene, this impact is made all the more telling due the material's extensive use in boundary walls, road and railway bridges, kerbstones, steps, gate-posts, monuments, crosses and troughs – and less obviously, perhaps, in the lining and bridging of the leats, which are themselves an essential part of the village's historical, visual and audible character.

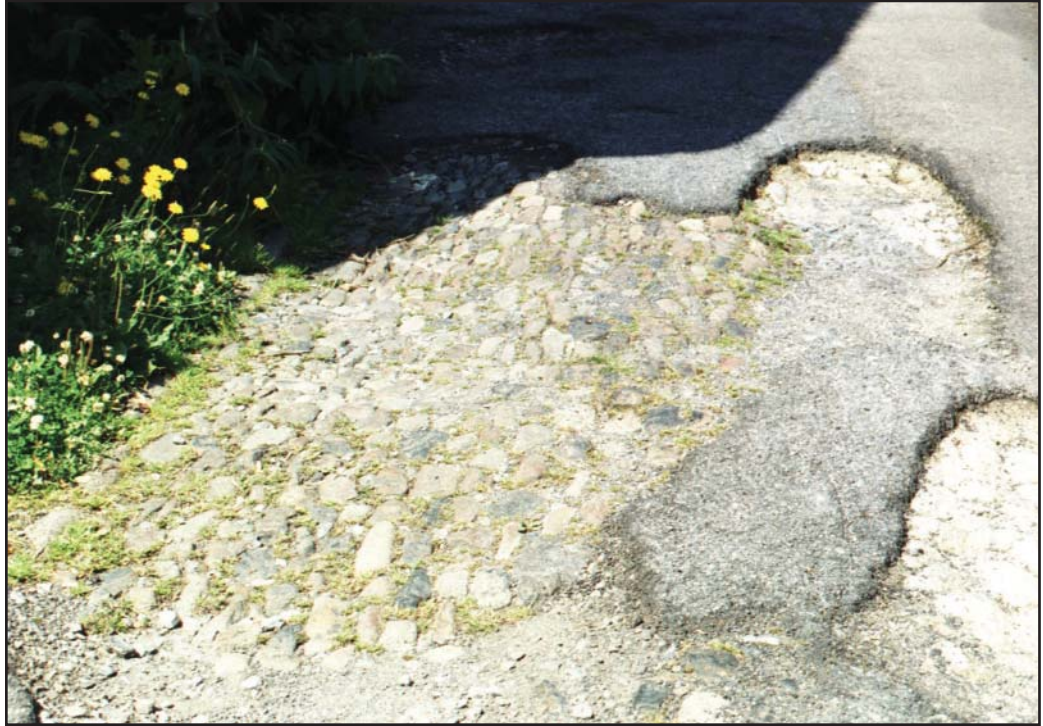
Figure 22 A section of cobbled surface that was formerly covered in tarmac, on the lane to the cricket ground adjacent to the Cleave

No doubt cobbled surfaces also contributed towards the sense of cohesion, but these have been all but lost beneath layers of tarmac or concrete. Remnants come to light when these 'top coats' begin to perish [Figure 22 page 28], but all too often they are simply buried again. The most complete and easily seen examples are in the private forecourt of the Cleave and the private yard of Middle Wreyland [Figure 21 left]

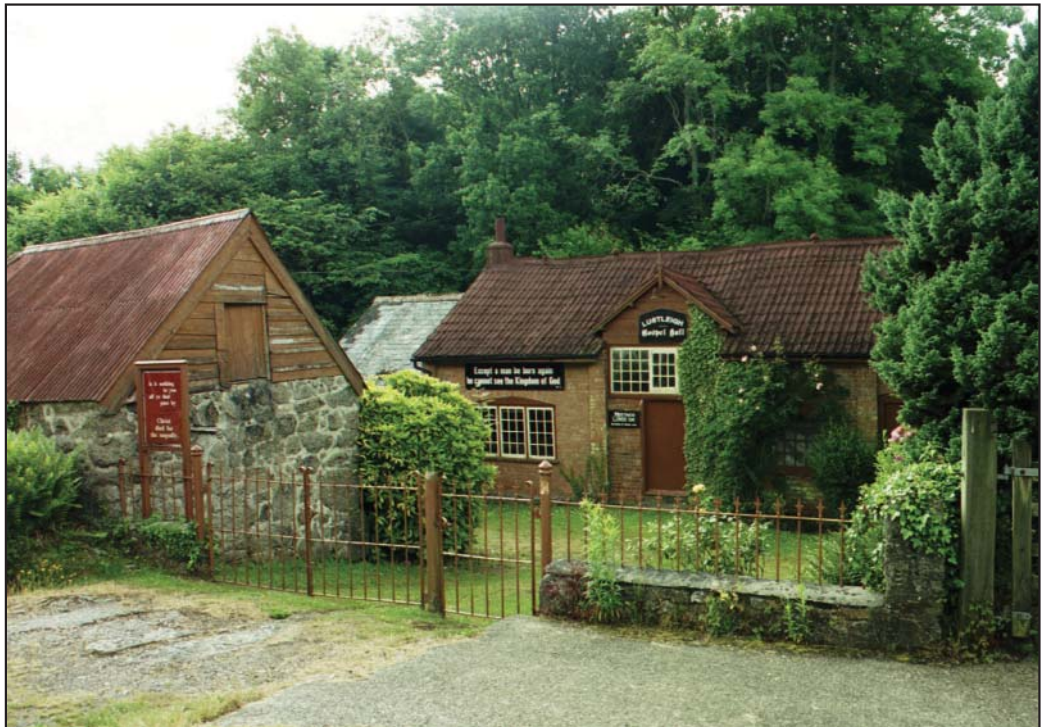
Figure 23 The Ironwork Railings in front of the Gospel Hall

Ironwork railings are relatively uncommon within the Conservation Area, even though Lustleigh had its own manufacturer – a W. Osborne, whose name embellishes a cast iron gatepost at the entrance to Woodlands (NW of the centre, on the unmetalled lane past the Rectory). They do, however, survive alongside the Wray beneath the railway bridge, on three of the four garden walls fronting Melrose Terrace, and along the frontage

of the Gospel Hall, setting it off as a key building beneath the village green [Figure 23 page 28].

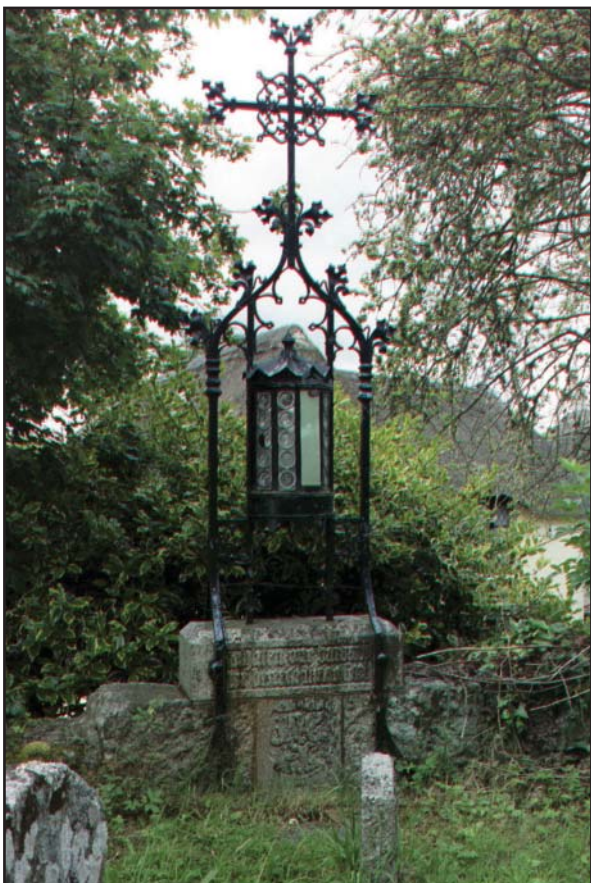
Figure 24 The Lantern on the churchyard wall

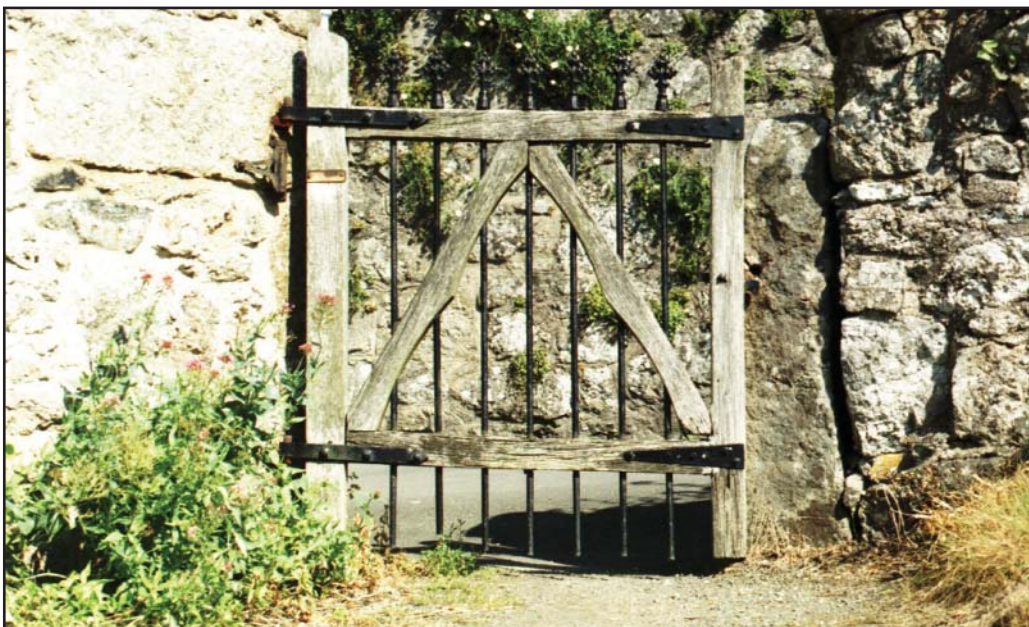
Figure 25 One of the elegant churchyard wall gates about 6m from the Lychgate.

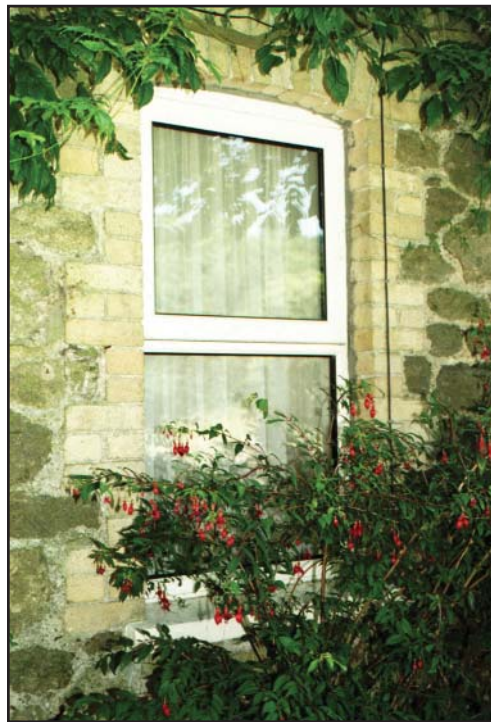
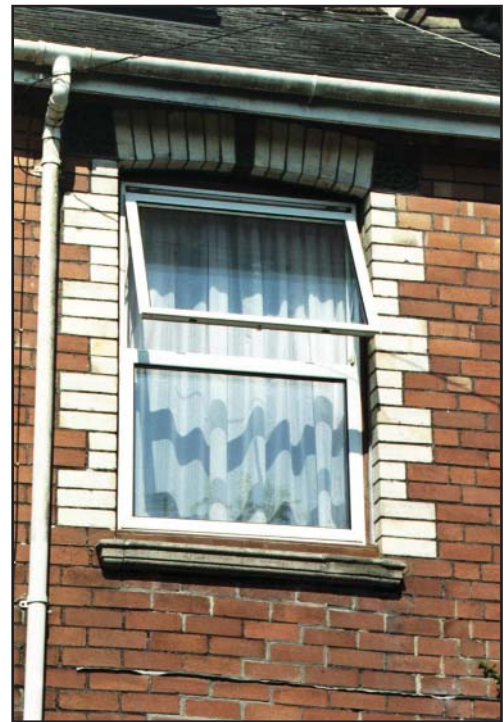
Figures 30 and 31 Inappropriate upvc windows have replaced traditional, painted timber, vertical-sliding sashes.

The least agreeable developments, however, are those affecting the historic buildings themselves and involve changes that erode or damage their authentic character – and therefore that of the Conservation Area as a whole. The replacement of timber windows and doors with inappropriate upvc types is particularly damaging [Figures 30 and 31 below], and likewise the replacement of natural slate roofs or decorative ridge tiles with modern alternatives. The introduction of incongruous features such as eye-brow dormers in thatched roofs, or the addition of inappropriate structures (such as garden sheds or conservatories or flat-roofed extensions) in exposed locations, can be equally harmful.
