Manaton

Conservation Area Character Appraisal

Dartmoor National Park Authority January 2011

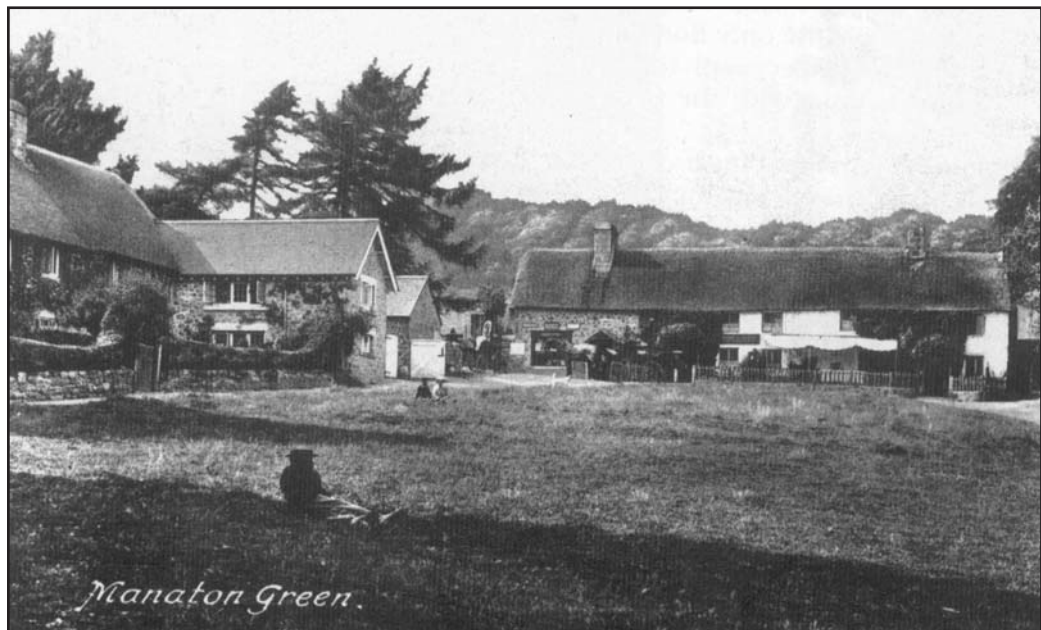
Figure 1 Taken in the early 1900s when a post office occupied the left end of Half Moon

Also now a residence is Half Moon, a name possibly originating from the time it was used as an inn, from the late 19th century to about the middle of the 20th when a post office occupied its west end as well [Figure 1 page 6]. Some time before the middle of the 19th century the original farmhouse had been divided and extended at both ends to create the pair of cottages shown on the tithe map.

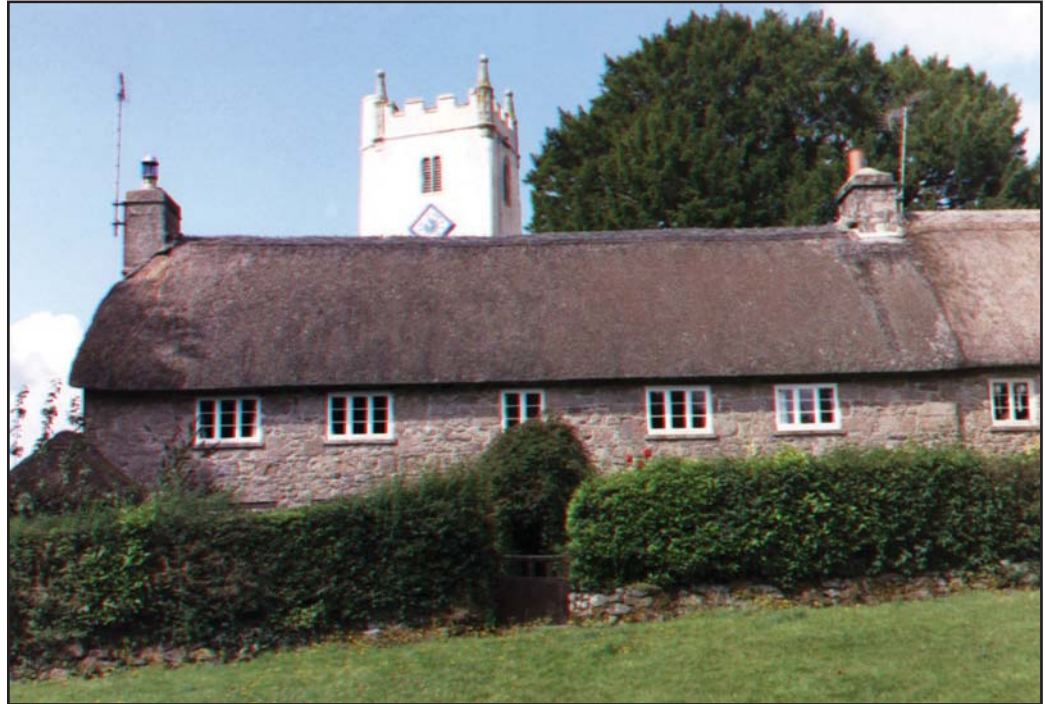
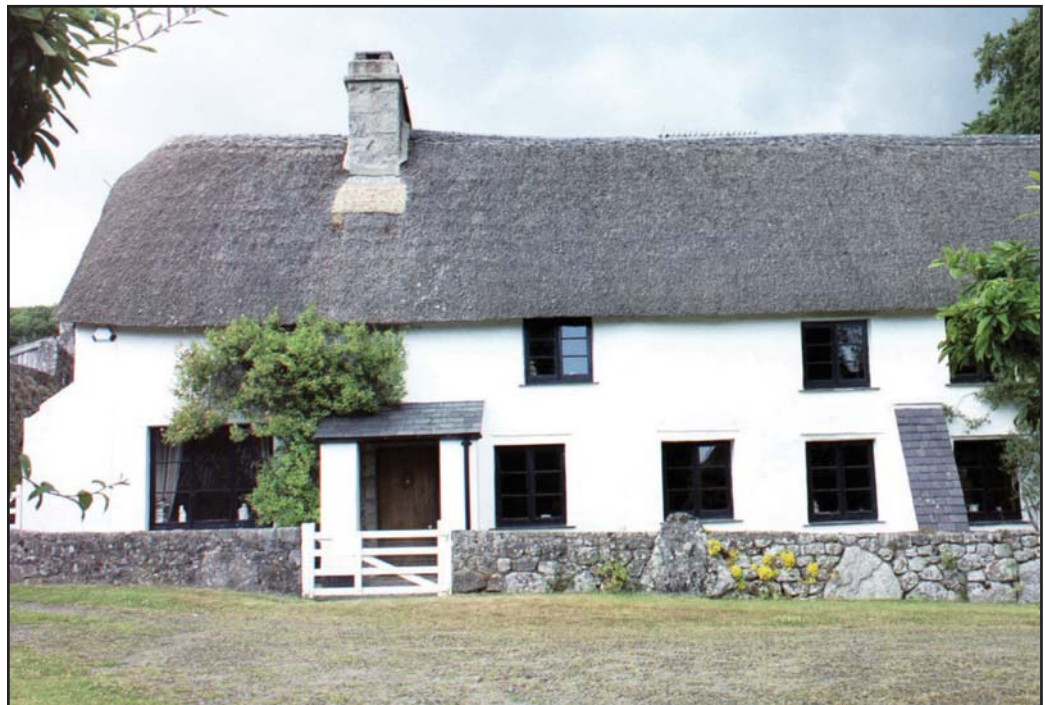
Figures 2 and 3. The long, low proportions, flush casement windows and thatched roofs of Church Cottage (top) and Half Moon (above) are typical of their medieval age, but one has its granite walling exposed and the other has it clad in (painted) render.

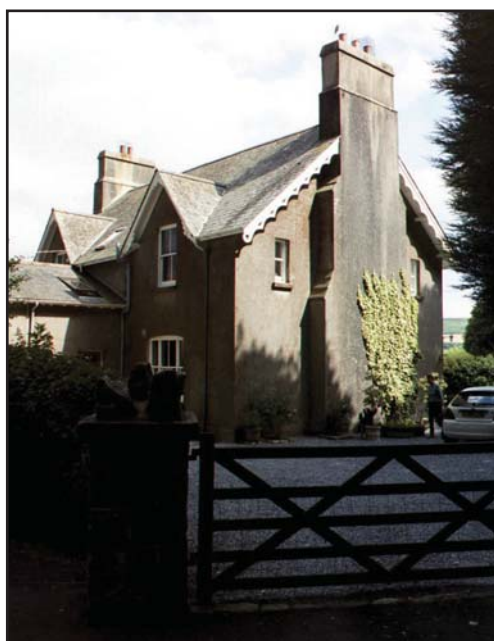
Figures 5 The side and rear elevations of Town Barton farmhouse

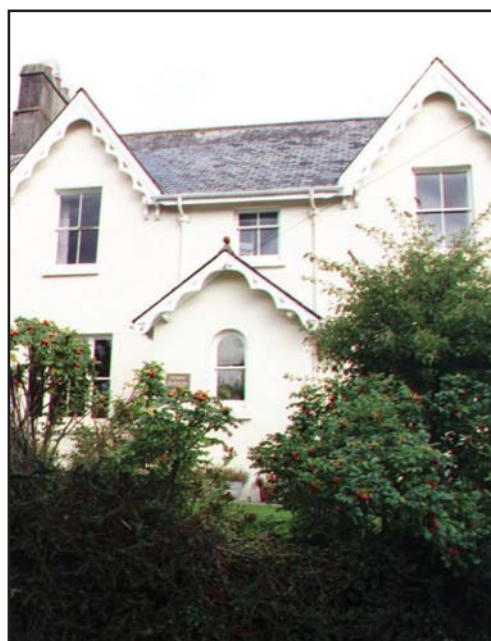
Figure 6 The front of Town Barton farmhouse with its enclosed porch

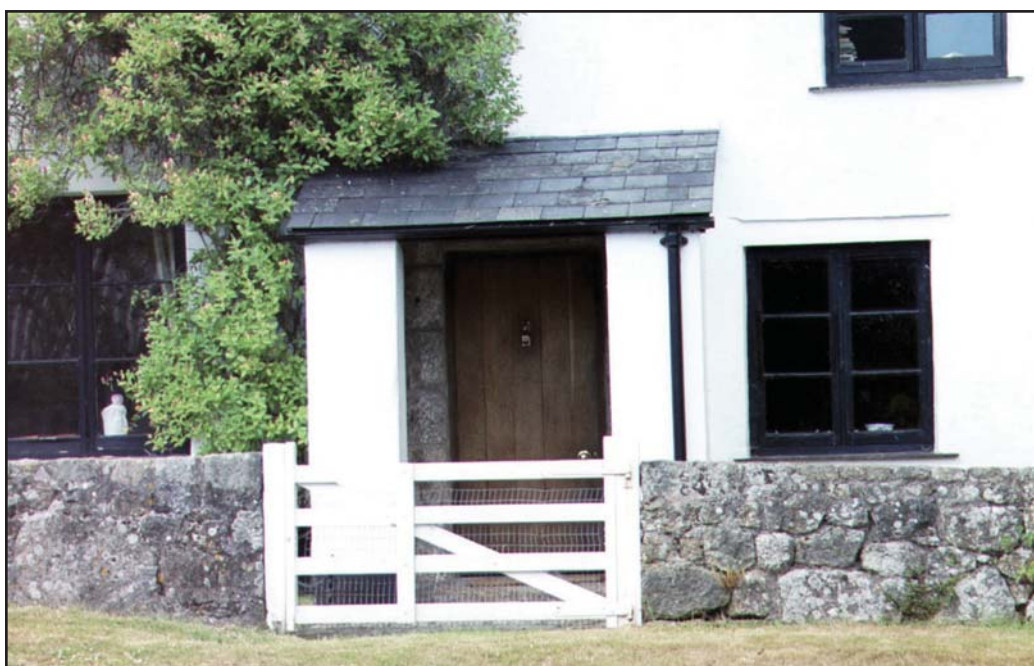
Figure 7 The open porch at Half Moon

characterised by brick dressings to the door and window openings – a practice later adopted by Lord Hambleden throughout his estate [Figure 4 page 15]. With the gothic styled school building close by [Figure 13 page 21], this corner of the hamlet is decidedly Victorian; its appearance characterised by slate roofs, a multitude of gables and the decorative bargeboards, enclosed porch and timber sash windows (with their typical 2 over 2 pattern) of the farmhouse [Figures 5 and 6 below]. In contrast, at the northern end of the green, and across the way at Cross Park, a vernacular appearance prevails that is characterised mainly by roofs of thatch, multi-paned or leaded casement windows and the open lean-to porches of Half Moon [Figure 7 below].

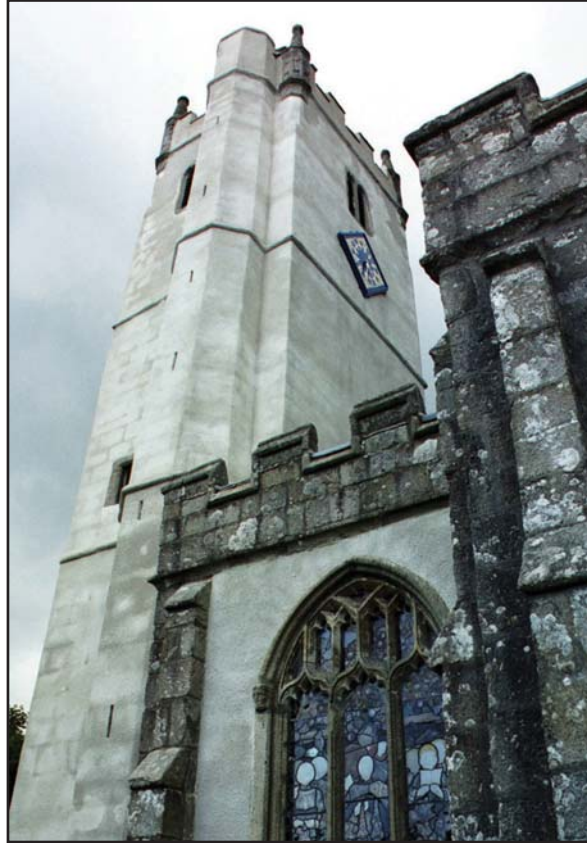
Figure 8 Church of St Winifred

Church of St Winifred: grade I

Built during the 15th century in the perpendicular style, it was partially rebuilt after a lightning strike in 1779 and much restored during repairs carried out in 1859 and 1924. Perhaps the most obvious change to its original appearance occurred in the 1930s when the tower and the west end of the south wall were rendered (on account of the severe damp they suffered). Some might consider the resultant mix of exposed granite and render harmful, but it nevertheless reflects the mix that is characteristic of the hamlet as a whole.

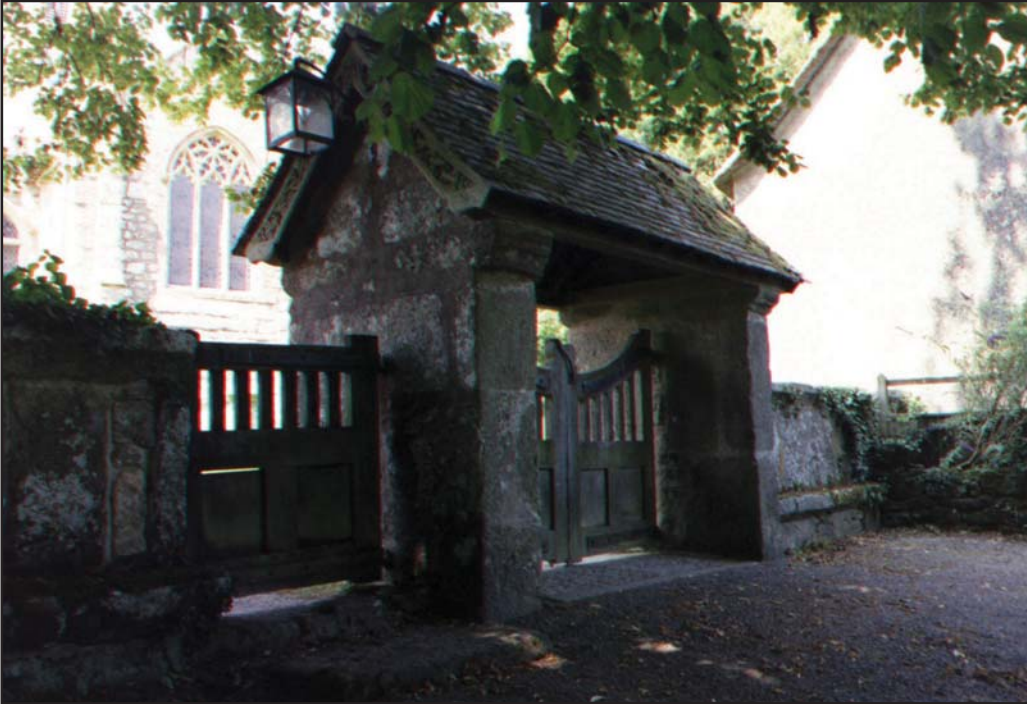
Figure 9 The Lych gate

Lych gate and Flanking Walls: grade II

This is a quality structure in a very prominent position at the entrance to the churchyard. Its dressed granite walls which are corbelled to support the roof, and the bargeboards in each of the gables, are particularly attractive features – as are the cornices to the copings and benches which run the length of the granite walls that flank it.

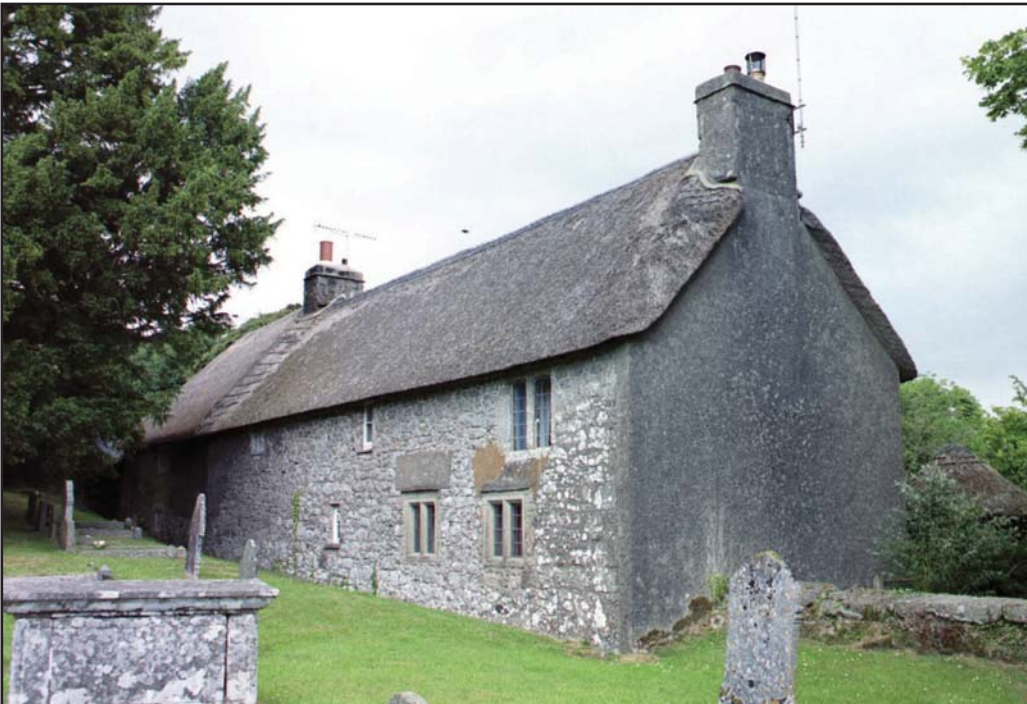
Figure 10 Rear elevation of Church Cottage

Church Cottage: grade II

A building with 16th century origins, although the only obvious external feature of this age is the stone mullioned window on the rear elevation, to the right at first floor. This side of the cottage is probably closer to its original appearance than the front – whose windows are all 20th century and set in openings that were mostly enlarged in the 18th. It is nevertheless a most characterful granite building whose long, low proportions are typical of its age.

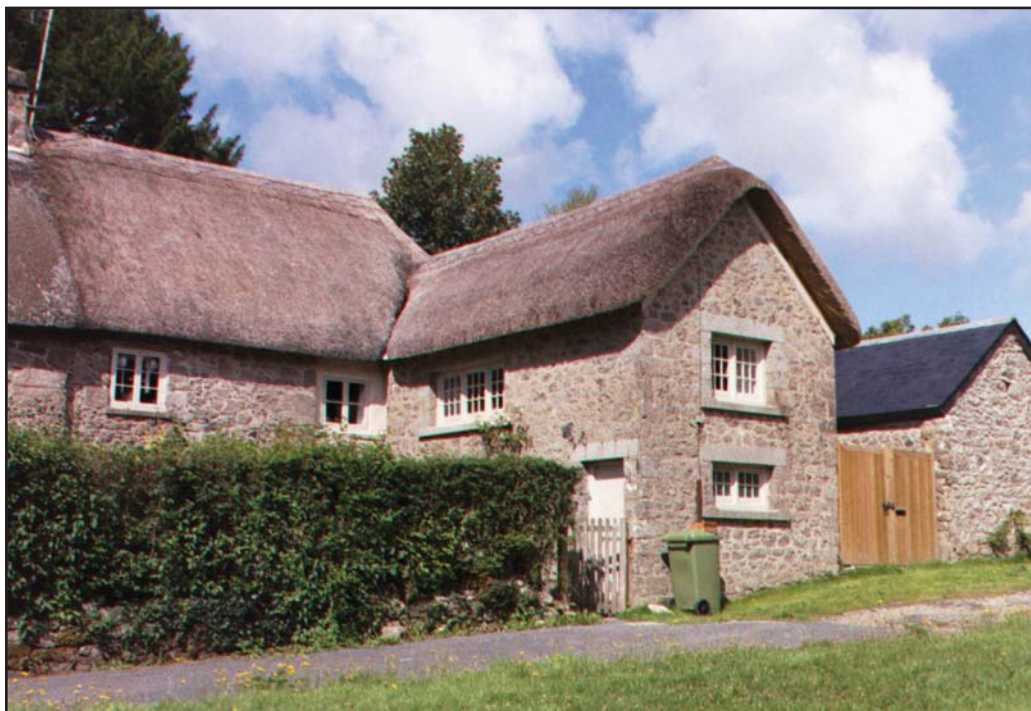
Figure 11 Ivy Cottage

Ivy Cottage: grade II

While appearing to be of similar age to Church Cottage – and even a continuation of it – Ivy Cottage probably originated as an unheated room or store that was attached to its north end. A front wing was added just before 1900. Its granite walls and thatched roof are most appropriate, the latter being a recent replacement of the original slate with its flush ridge properly below that of the main roof.

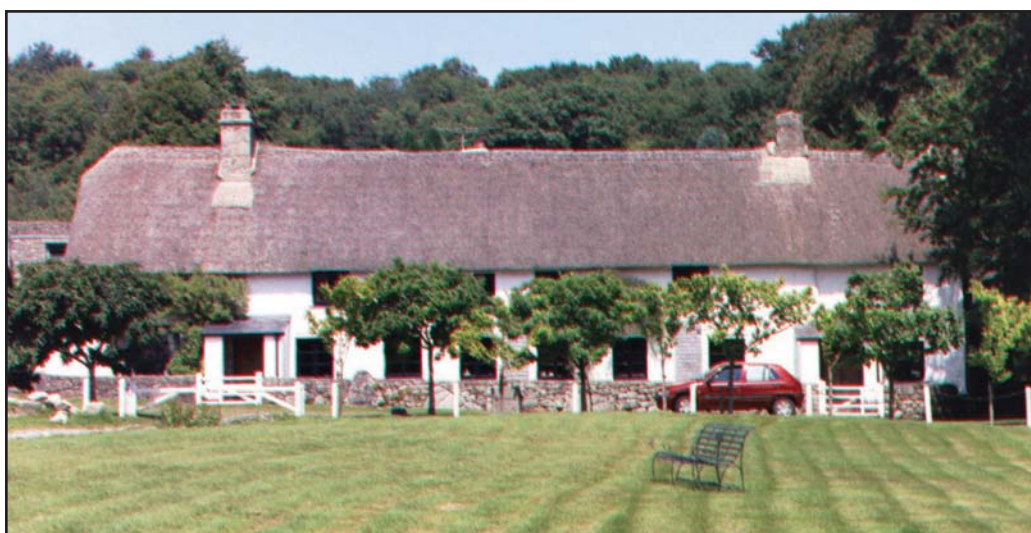
Figure 12 Half Moon House

Half Moon House: grade II

Originating as a farmhouse in the 16th century, it was extended each end in the 18th across the end of the green. In a visual sense, therefore, it is probably the most significant building on the green, closing views north and sealing it off from the wooded slopes that rise behind it.

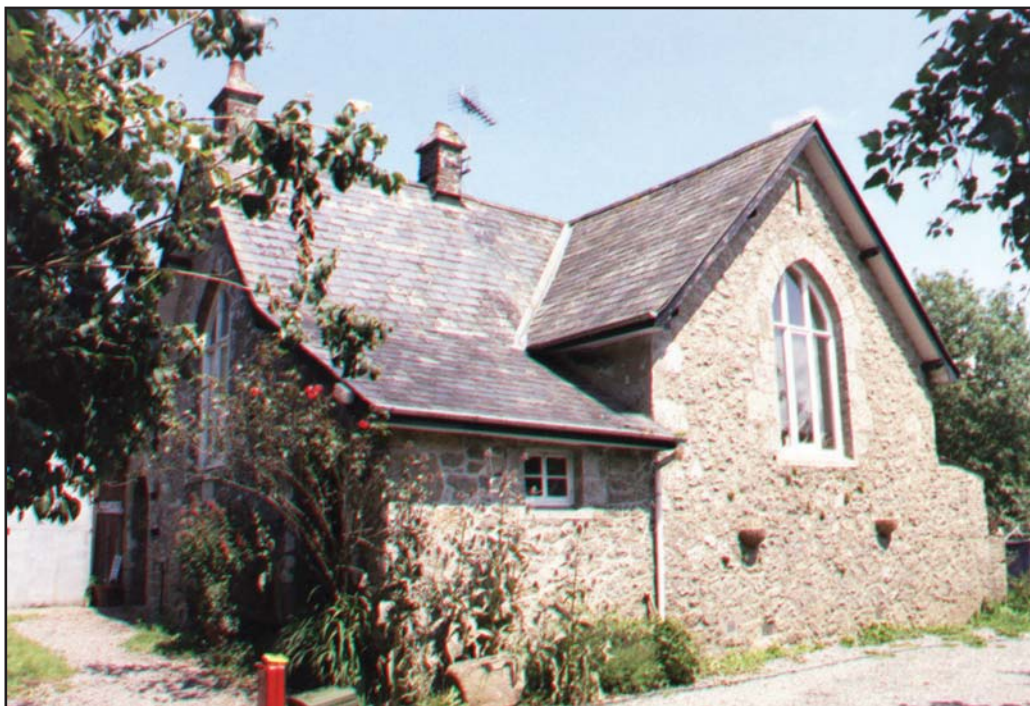
Figure 13 Church House School

Church House School: grade II

A tablet on the west front proclaims the building to be 'Manaton National School erected AD 1859'. Although converted to a residence after the school closed in 1947, its Gothic style, is well preserved.

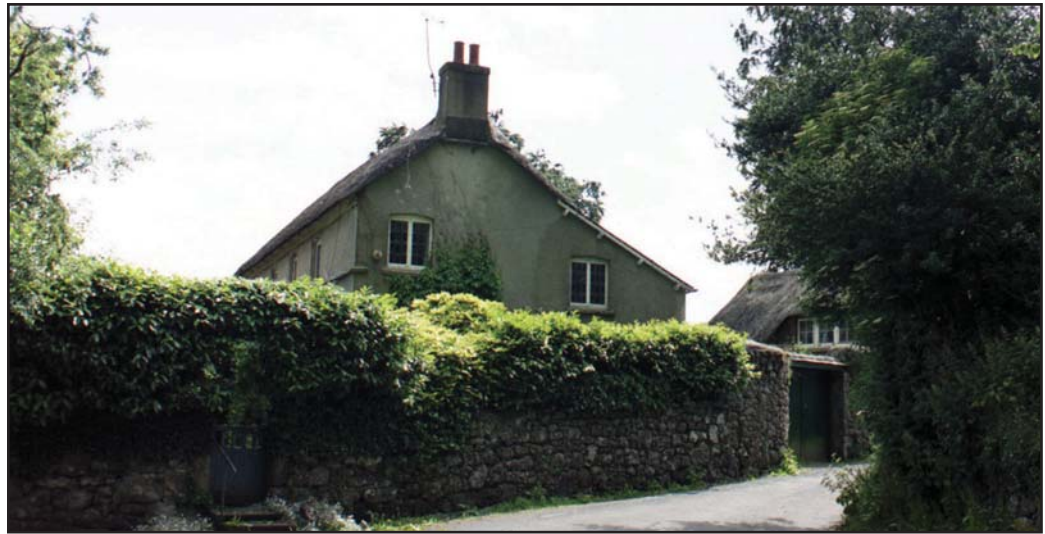
Figure 14 Cross Park Cottage

Cross Park Cottage (not listed)

Built in the 18th century with leaded casements and a thatched roof, this small farmhouse has a distinctly picturesque style that is certainly enhanced by its render not being painted. The thatched, granite barn adjacent, and the high granite walls that shelter its yard, contribute positively towards the farmstead's interest and character.

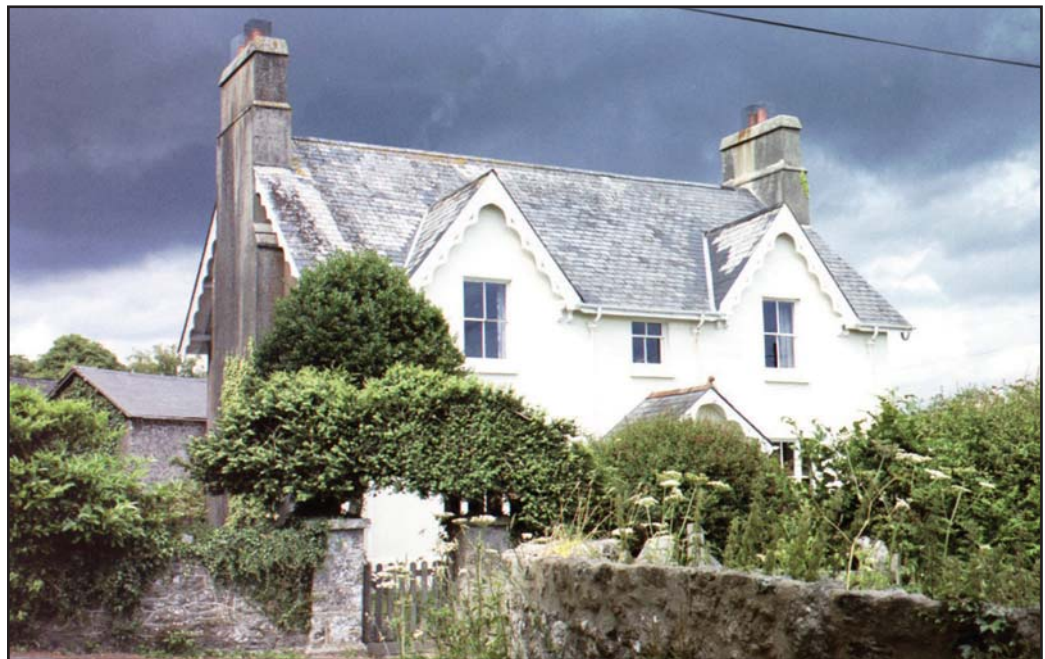
Figure 15 Town Barton Farmhouse

Town Barton Farmhouse (not listed)

Built in the mid 19th century with tall sash windows and a slated roof, this farmhouse has a fairly formal appearance. However, its low eaves and the decorated gables of its half-dormers and porch purposefully create a cottagery character that is most suited to its rural setting.

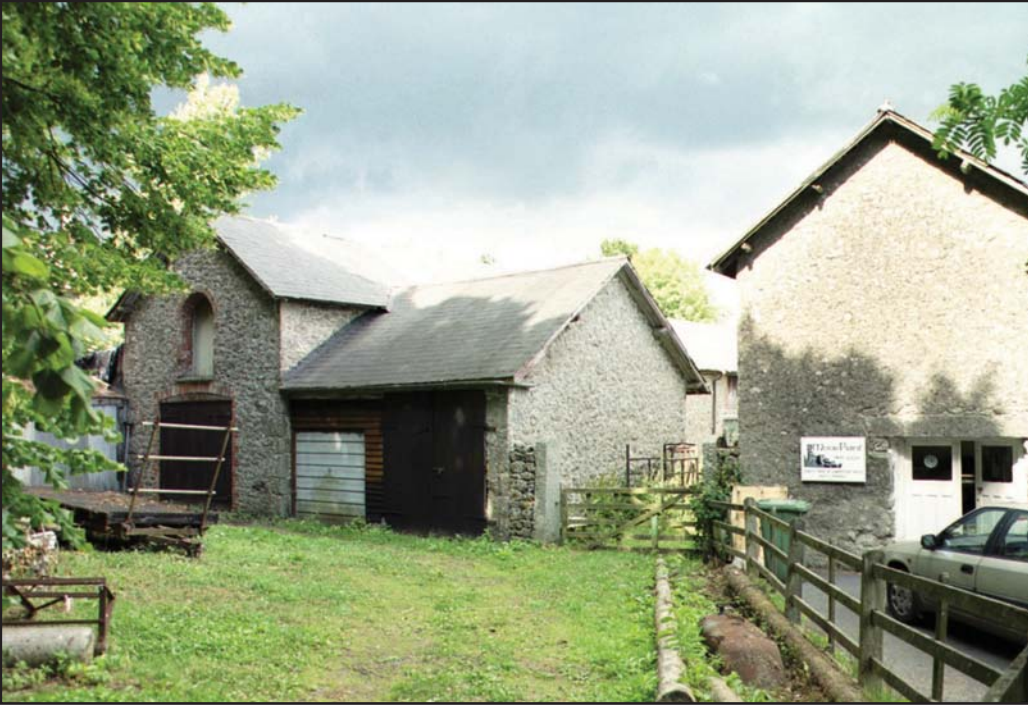
Figure 16 Town Barton farmbuildings

Town Barton Farmbuildings (not listed)

Built in stages during the second half of the 19th century to replace a medieval farmstead, the range has the notable characteristic of brick dressings to the wall openings. The range survives today as a complete example of a model period farmstead, and for this it possesses considerable interest.

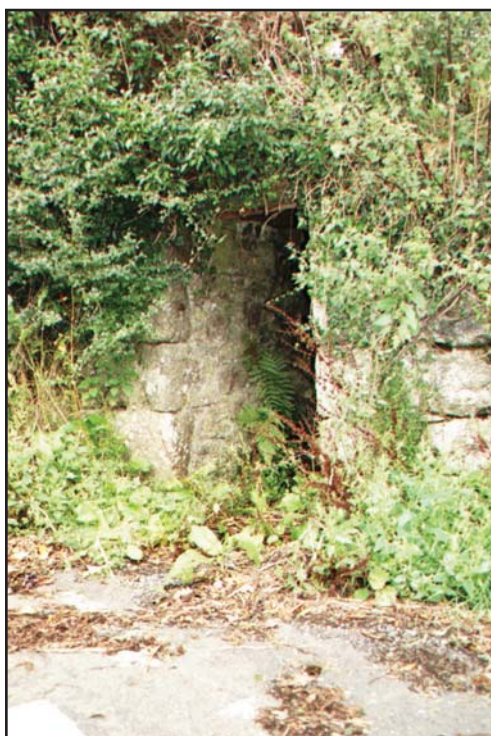
Figure 17 The Well built of granite

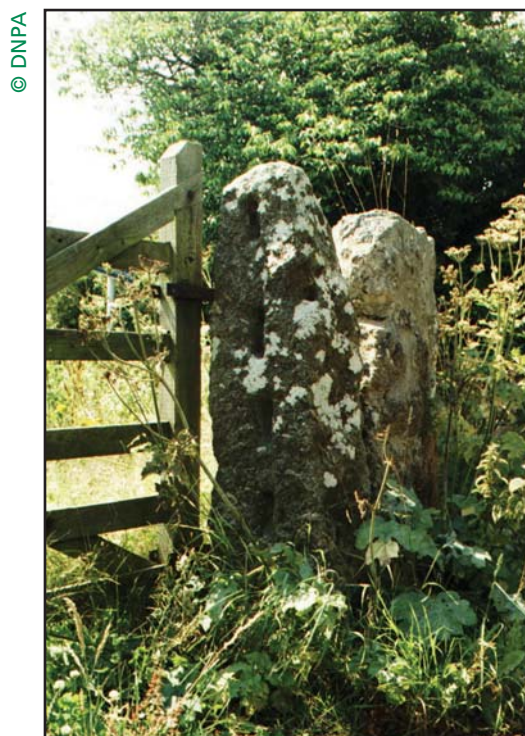
Figure 18 A slotted granite gatepost

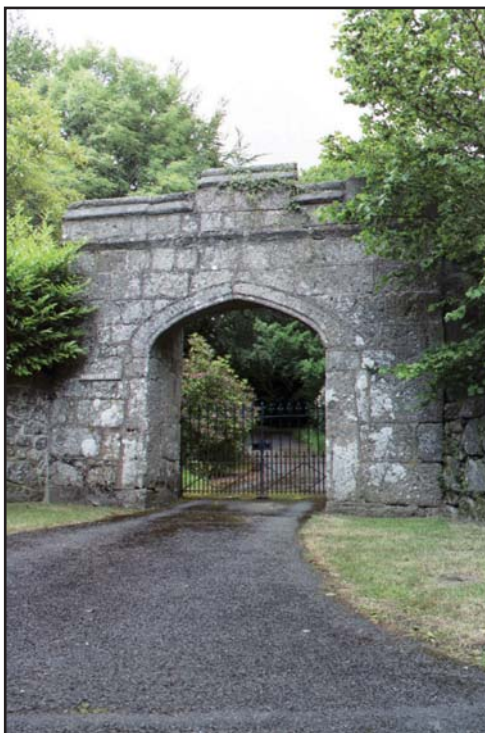
Figure 20 The granite gateway nearby

Rather less rustic are the carved copings and seats of the walls flanking the lych gate, but of an altogether higher status are the medieval granite gateways on and near the northeast of the green at the pedestrian and vehicular entrances to the former Rectory. The 5-piece arch at the former is actually a re-used doorway from a building of 15th or 16th century date – which could possibly have been the Old Parsonage that was demolished nearby [Figure 19 page 25]. The large gateway nearby was constructed in the 19th century using material salvaged from a former gatehouse or forecourt arch that was probably 16th century and clearly served a high status house [Figure 20 page 25].

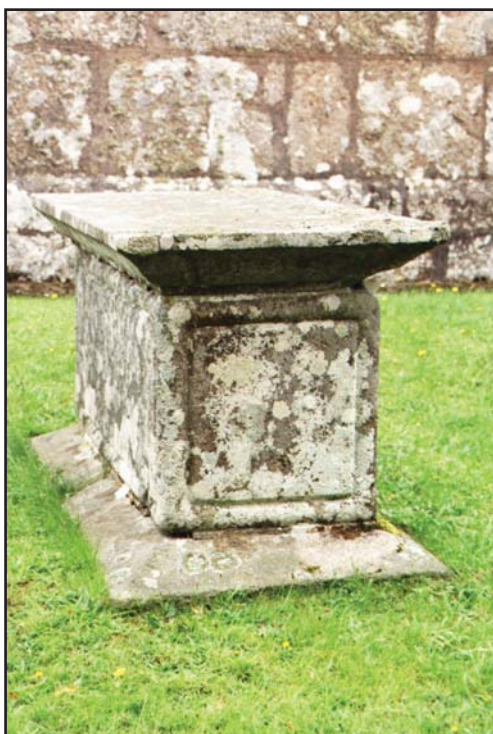
Figure 21 Chest Tomb in churchyard

There are other granite structures adding character and interest to the Area, several of which are close together in the churchyard. A listed chest tomb with some fine architectural qualities is one of them, dating from about 1700 [Figure 21 page 25]. Another is a granite cross (also listed) which is thought to be medieval, and was re-erected in the southwest corner early in the 20th century [Figure 22 page 25]. Not least in significance, is the war memorial, in an appropriately prominent position just inside the lych gate.

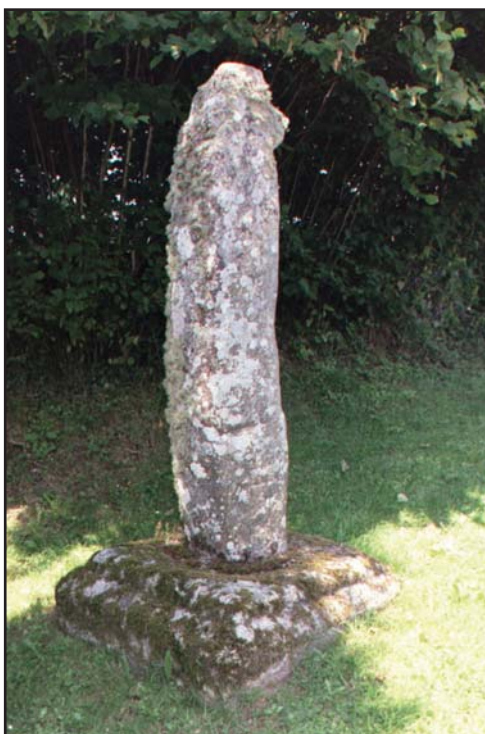
Figure 22 Ancient Cross in churchyard

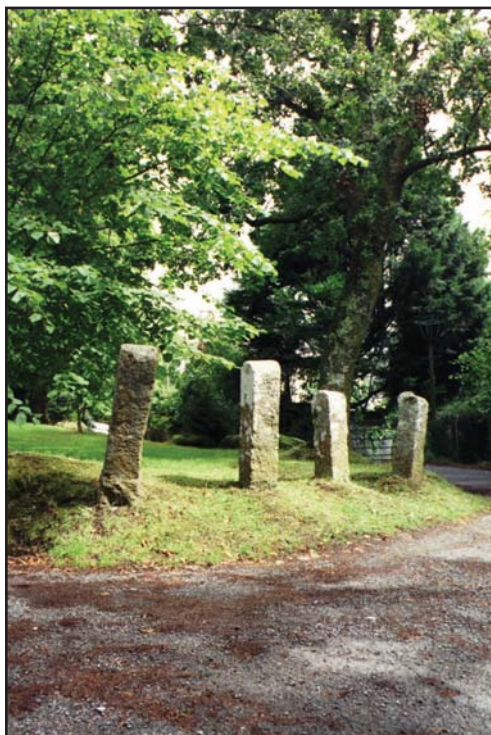
Figure 23 Granite bollards on green

Alongside the green, granite posts act as bollards to deter vehicular access and roadside parking [Figure 23 page 26], and on the green itself a granite slab has been laid to commemorate the new millennium. A noteworthy granite feature near the crossroads is the large structure built to house the traditional, cast-iron letterbox [Figure 24 page 26].

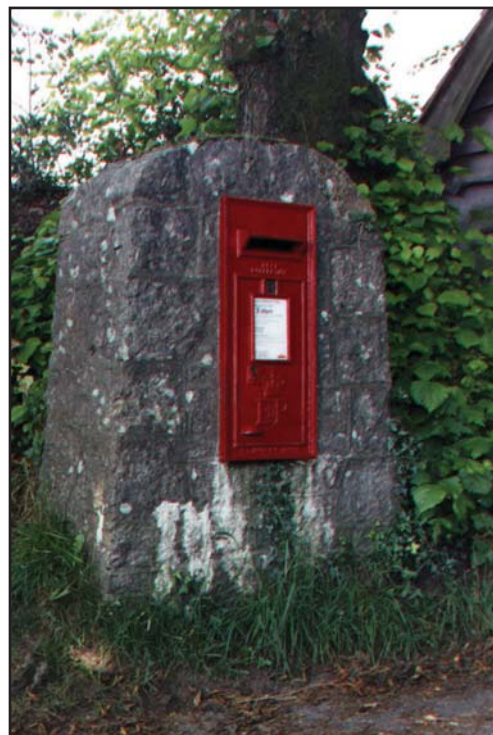
Figure 24 Letter box in its granite housing

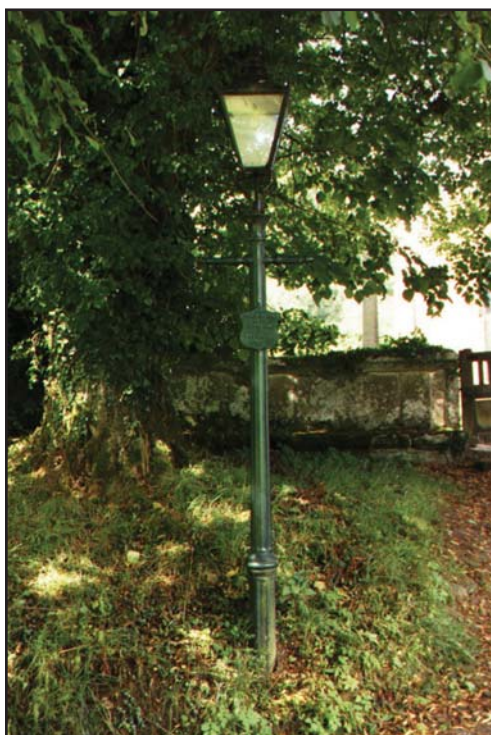
Figure 25 Lamp standard by lychgate

Examples of ironwork are of interest as well, including the lamp standards introduced in 1911 next to the gated entrance to the former school and in front of the lych gate [Figure 25 below], and the seat on the green whose elegant form has graced the area since 1897. Ironwork railings also survive to mark the roadside boundary outside Town Barton [Figure 26 below], while over at Cross Park there is a simple rail on the entrance steps to the garden.

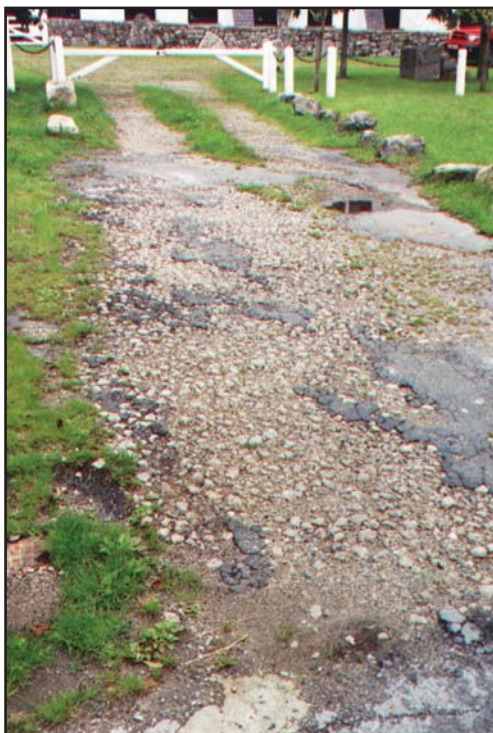
Figure 27 Exposed area of cobbles

Other than at the very end of the lane to Half Moon where a small area of cobbling is being re-exposed [Figure 27 above], tarmac covers the lanes beside the green. Most significantly, however, kerbstones have not been introduced where grass and tarmac meet, thus preserving the essential rural character of the scene. The small boulders along the edge in front of Church and Ivy Cottages appear inconspicuous now they are embedded in the soil [Figure 28 above]. However, the white painted timber posts at the head of the green are less successful in their integration, as their character and appearance is quite suburban.

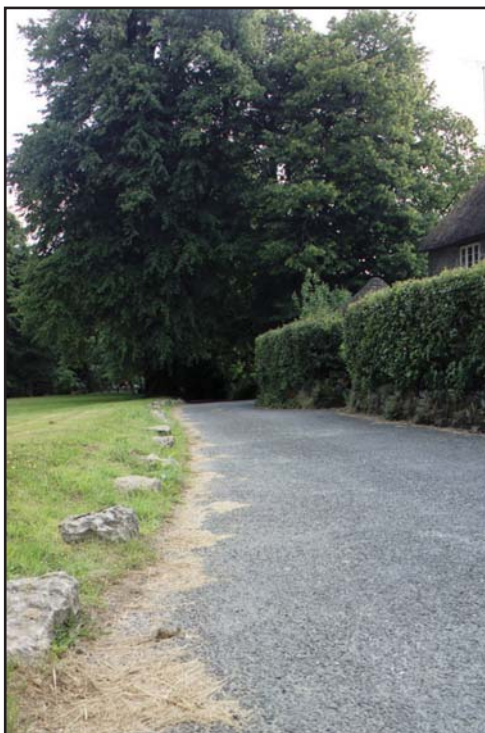
Figure 28 Small boulders protecting the edge of the green

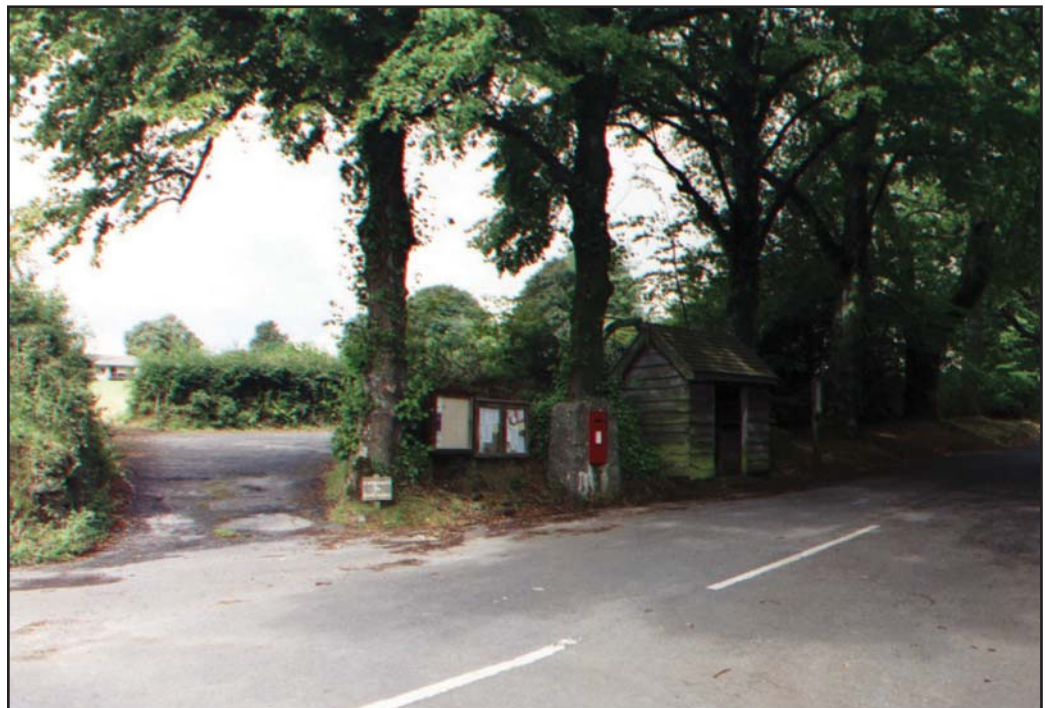
Figure 33 The Car Park and Bus Shelter near the crossroads

Elsewhere in the Conservation Area, in and adjacent to the sports ground, various community facilities have been provided including a traditionally styled pavilion on the far side of the sports field; a not unattractive timber bus shelter just off the crossroads, and behind it a well concealed and suitably surfaced car park [Figure 33 below]. None of them have a harmful effect, although it is fortunate that the nondescript garage sited in the car park is hidden from general view.
