Crockernwell

Conservation Area Character Appraisal

Dartmoor National Park Authority January 2011

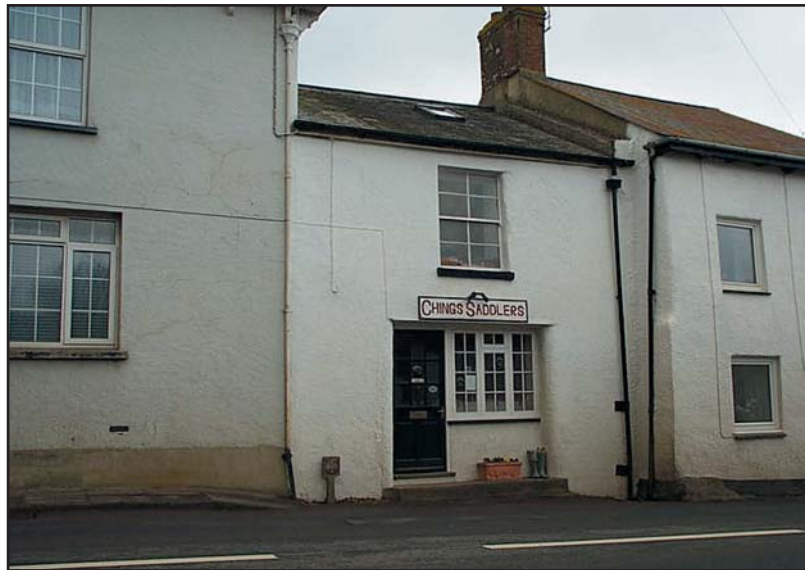
Fig 1 Chings Saddlers

Physical evidence tends to indicate that Crockernwell never really thrived as an agricultural settlement, although there are wealthy farms nearby. The reasons for this are not entirely clear. White's Directory of 1850 records only one tenant farmer, but there was an interesting range of other trades operating in Crockernwell. As well as the two inns and a Post Office/shop, there were coopers, blacksmiths, saddlers, butchers, masons carpenters, wheelwrights and boot/shoemakers. This all supports the impression of a village offering services to travellers and the local rural population. Several properties have larger windows that may have once been shop windows - although those at Chings Saddlers were inserted in place of garage doors.

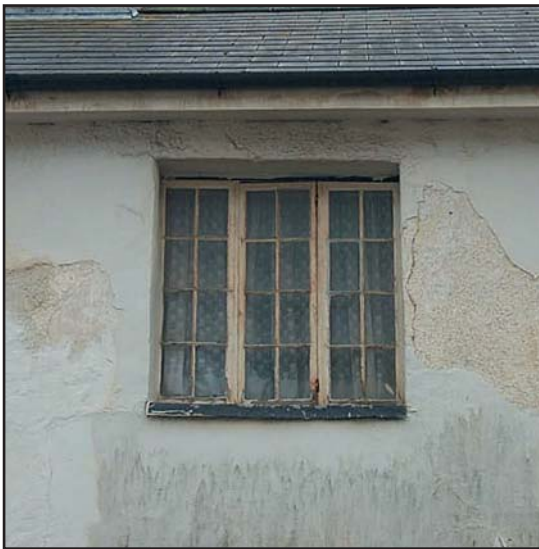
Buildings of the 16th – 18th centuries have casement windows of various ages; the earlier openings are smaller than those that have been enlarged during later modifications. Later homes, mostly of the 19th century, are deeper and taller but still built on the street frontage, albeit behind a pavement on the main road. They tend to have vertical sliding sashes that reflect their age. A significant proportion of properties have had windows replaced in styles that fail to complement their historic character, some in modern materials like PVCu.

Fig 2 An early 19th century casement window

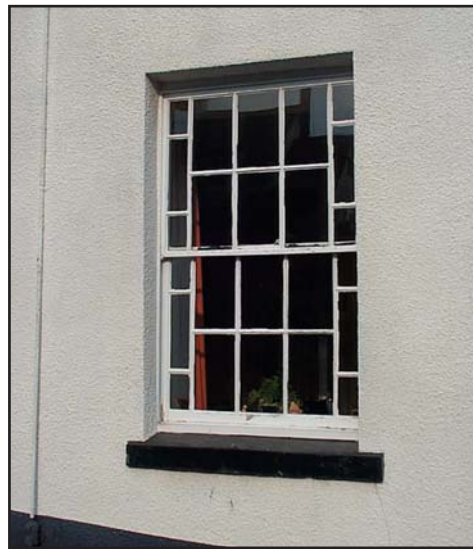
Fig 3 Decorative sash window at Court House

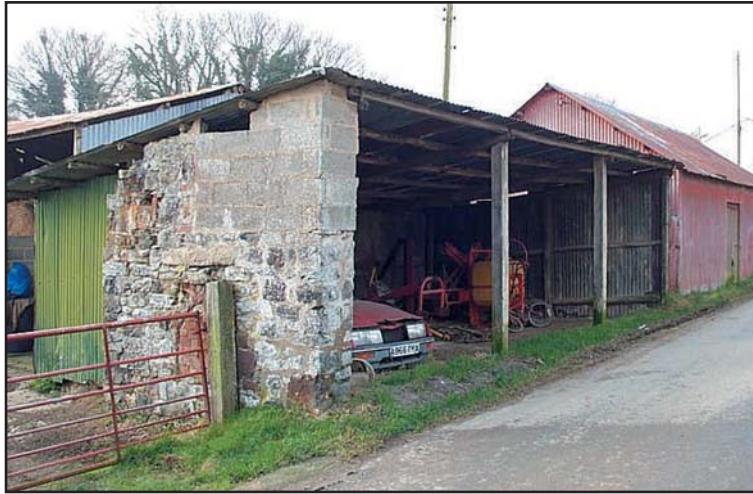
Corrugated iron is common, especially on agricultural and ancillary buildings, but also notably on the large gable of Stonelands.

Fig 4 Corrugated iron is a traditional material

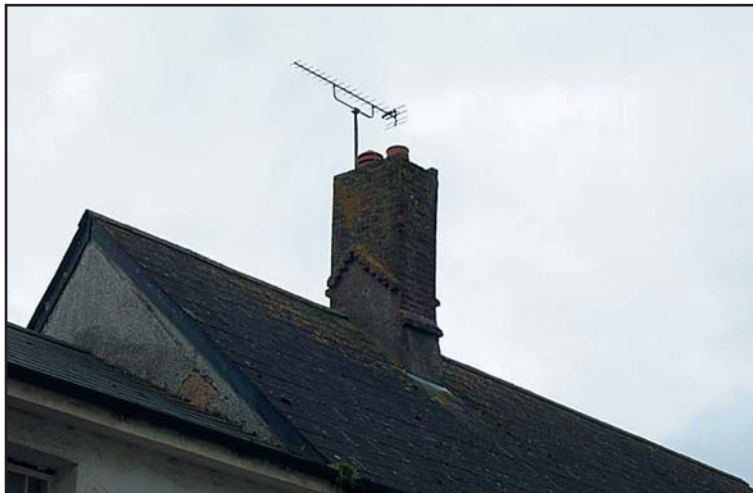
Chimneys contribute a great deal to the character of the village. Most have brick stacks, with the notable and outstanding exception of Pilgrim Cottage that has its original granite shaft. An interesting and unusual feature of Crockernwell is the number of stacks that have drips constructed in brick. This is a distinctive local character feature that also indicates the level of formerly thatched roofs.

Fig 5 Chimney with brick drip course showing the height of the former thatched roof at The Old Post Office

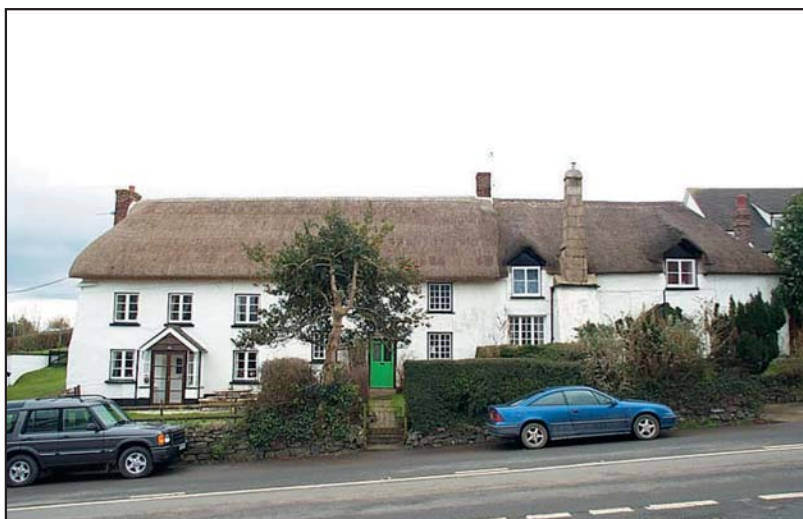
Fig 6 Lilac, Holly and Primrose Cottages

Lilac, Holly and Pilgrim Cottages: Grade II*

Originally a farmhouse built in the 16th century to the usual three room cross passage plan. Partly re-modelled in the 17th century and extended in the 18th or 19th centuries. Converted to cottages and substantially altered in the 20th century. An eye-catching range at the western end of the village.

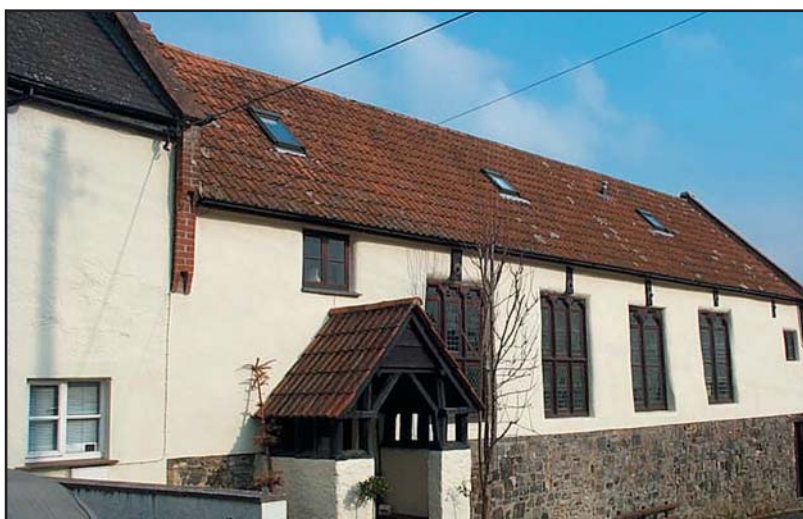
Fig 7 Holy Trinity Chapel

Holy Trinity Chapel: Grade II

This is an important and unusual building at the heart of the Conservation Area. Quite anonymous from the main road but the ecclesiastical windows are a feature of the back lane.

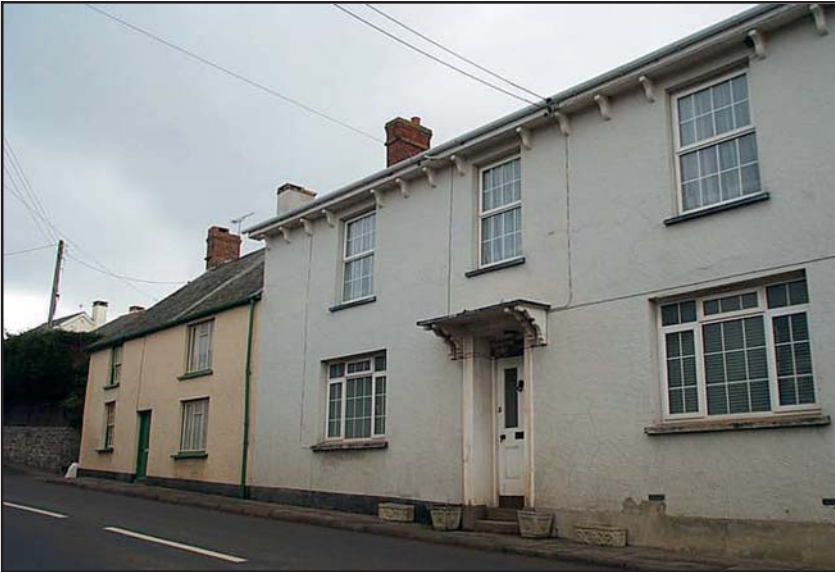
Fig 8 The former Golden Lion Inn

Golden Lion House: Unlisted

This large 19th century property, with the lower (and earlier) range to the west and its extensive outbuildings, was The Golden Lion inn. It appears to have been purpose-built when the Exeter to Okehampton road was improved – possibly before the grander Royal Hotel. The completeness of this group is rare and is an essential element in the special historic character of Crockernwell and it is located within one of the toft plots.

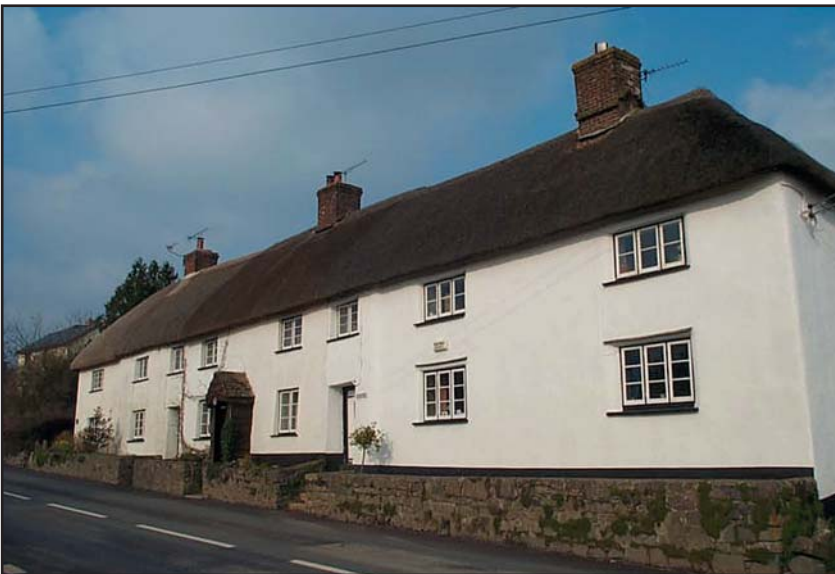
Fig 9 Fulford Cottages

Fulford Cottages: Grade II

Although they have been altered this remains a row full of character in a prominent location on the eastern edge of the settlement.

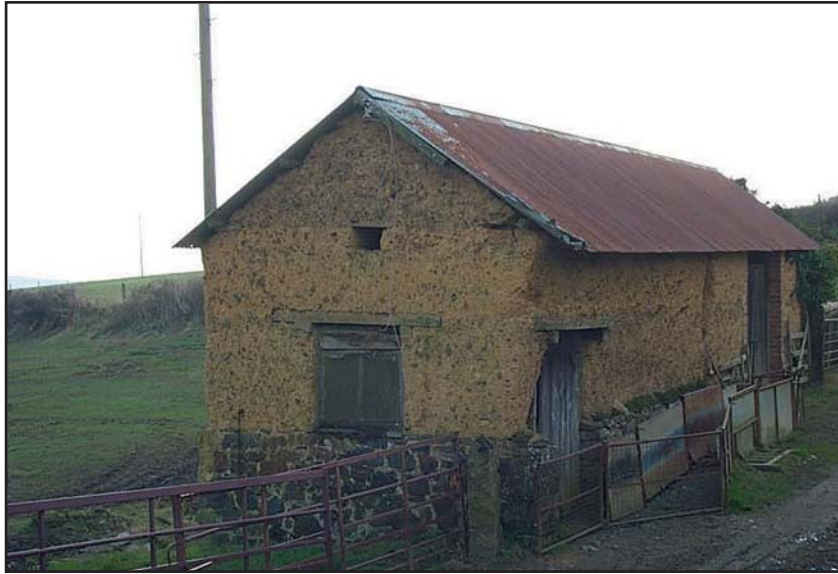
Fig 10 Cob barn

Cob barn at Budbrook: Unlisted

A narrow and strongly linear 19th century stone and cob barn with later adaptations, prominent in views of Crockernwell from the east. One of a pair of barns of about the same age – the other immediately to the west now collapsed. Another stone barn north of this has partially collapsed and further loss of this historic group would be a significant loss to the character of the Conservation Area.

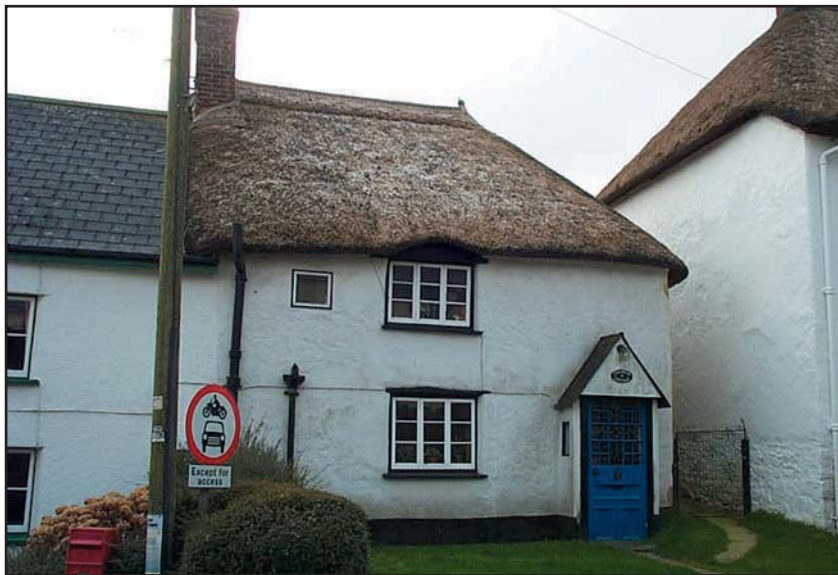
Fig 11 Oak Beam Cottage

Oak Beam Cottage: Grade II

Although the fenestration has been re-ordered this cottage encapsulates the historic character of cottages in the old centre. The survival of thatch here shows how much impact the introduction of slate and tile has had.

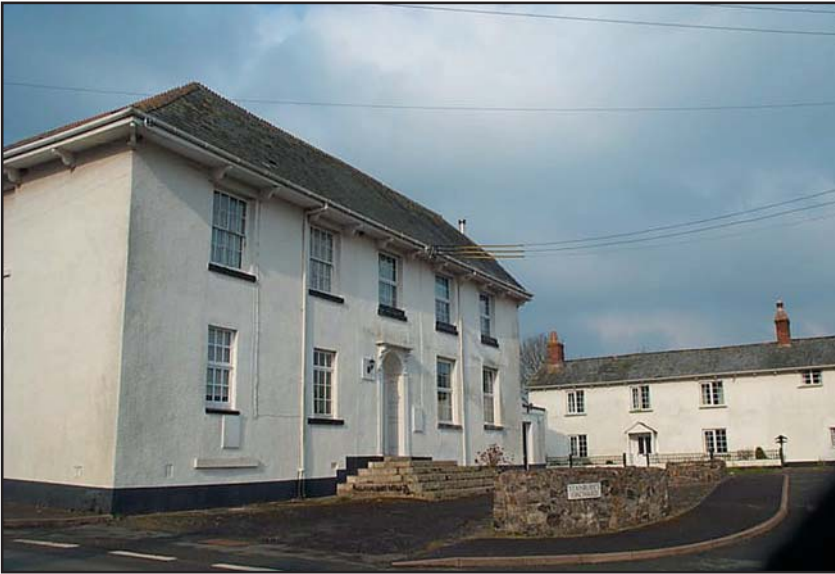
Fig 12 The former Royal Hotel

Court House (formerly The Royal Hotel): Unlisted

Built end on to the main road, this substantial 19th century coaching house and its associated buildings retain an impressive presence. The surviving historic sashes give an impression of the status the owners sought to convey. Alterations to the building and its setting have rather diminished its historic character.

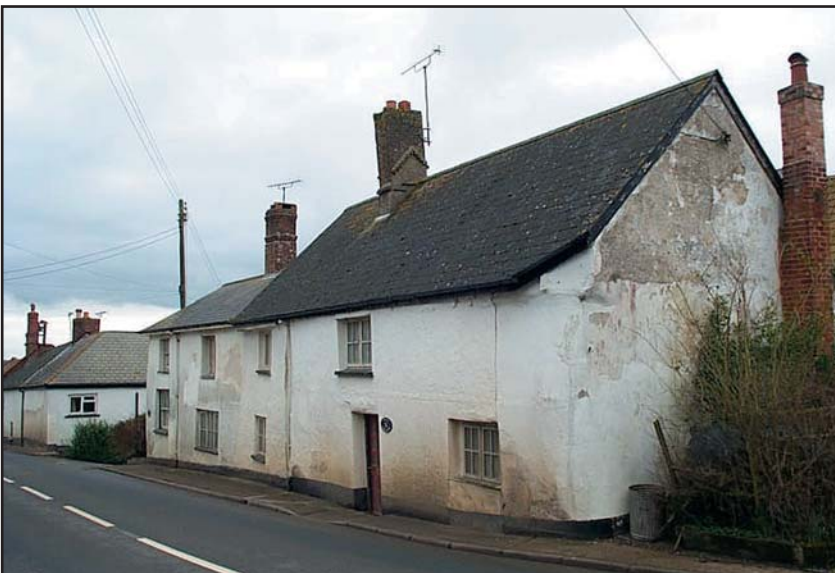
Fig 13 The Cottage and Old Post Office

The Old Post Office and The Cottage: Unlisted

The prominent location of the formerly thatched historic dwelling, once the Post Office, makes it a focal point for those passing through. The Cottage has an interestingly curved south elevation which is an attractive character feature on the back lane.

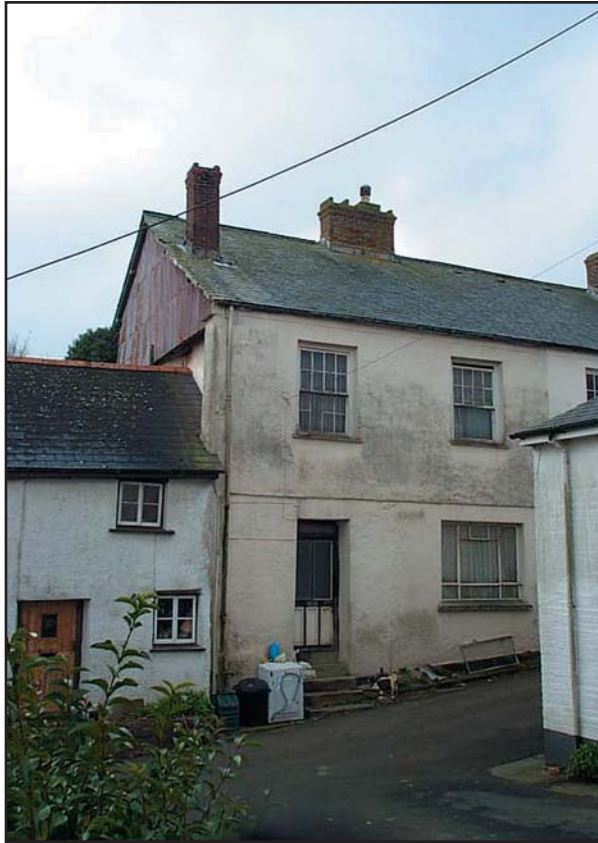
Fig 14 Stonelands

Stonelands: Unlisted

The sudden change in depth of plan and ceiling heights, compared to the old cottages either side, gives this 19th century building a colossal presence. An eye-catching and characteristic building because of the context into which it was inserted.

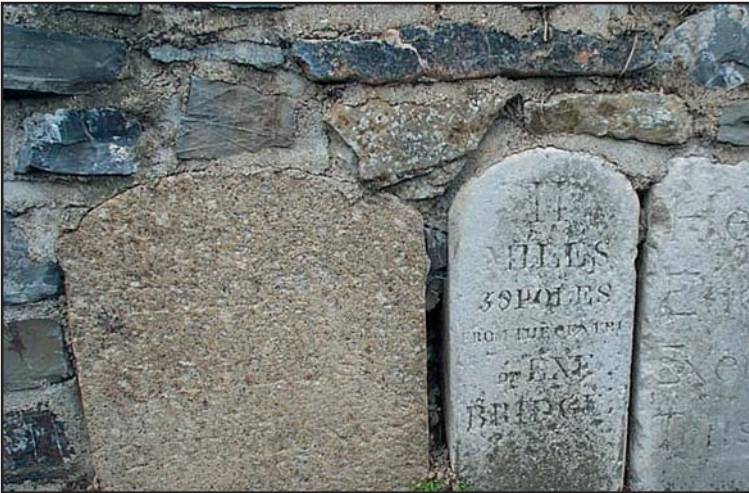
At the back of the stretch of raised pavement outside the Stanbury's Orchard development is a collection of three historic milestones built into a modern stone wall. These reflect the importance of the main road over the centuries (the one on the right was probably brought here from Cheriton Cross as it reads "here ends Exeter trust").

Fig 15 Historic milestones

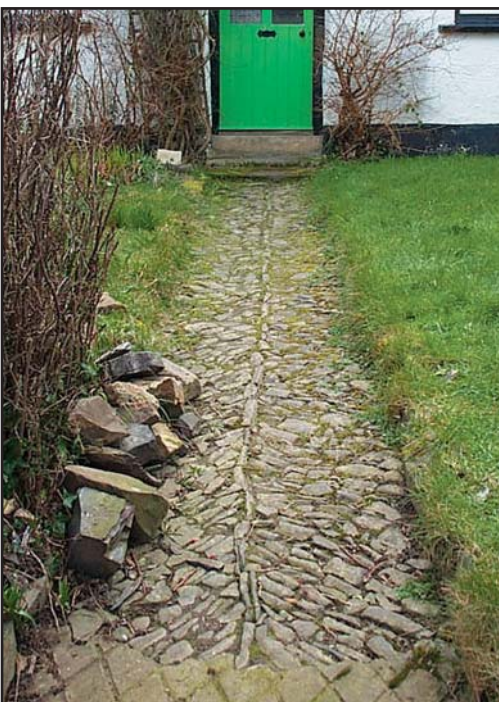
There is little sign of historic surfacing with the notable exceptions of the path to Holly Cottage and the entrance to Holy Trinity Chapel. There is a gully that runs down the north side of the back lane that offers the sound of trickling water but is mostly formed of concrete.

Fig 16 Cobbled path at Holly Cottage

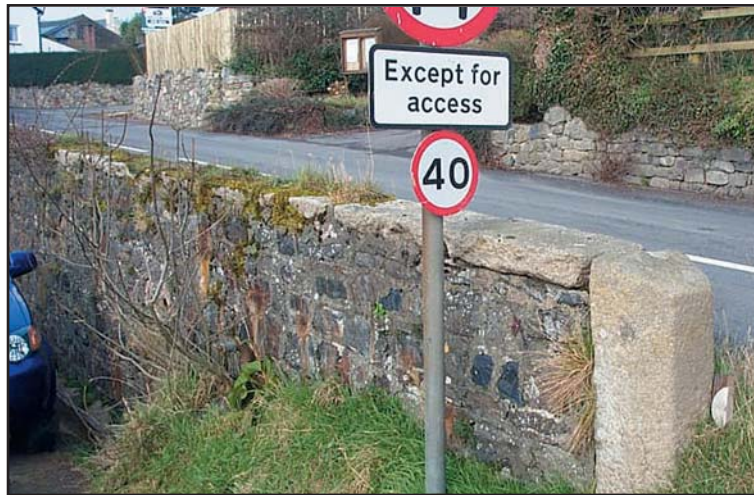
The retaining wall supporting the new road east of Holy Trinity Chapel is well built in rubble stone with a granite post at the end and nice granite coping [Fig 17 page 22]. There is an overgrown set of steps nearby that could be maintained as a positive feature [Fig 18 page 22].

Fig 17 Retaining wall with granite post

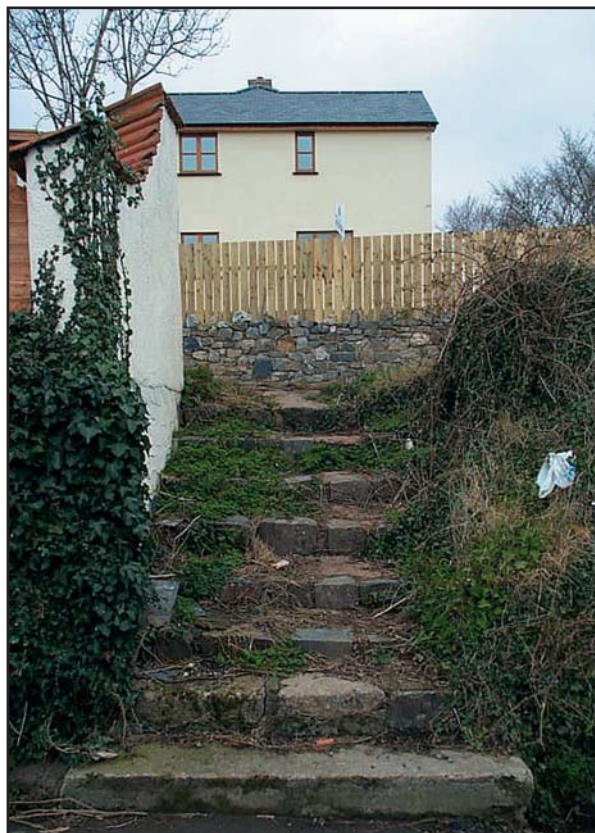
Fig 18 Stone steps linking the back lane with the new road

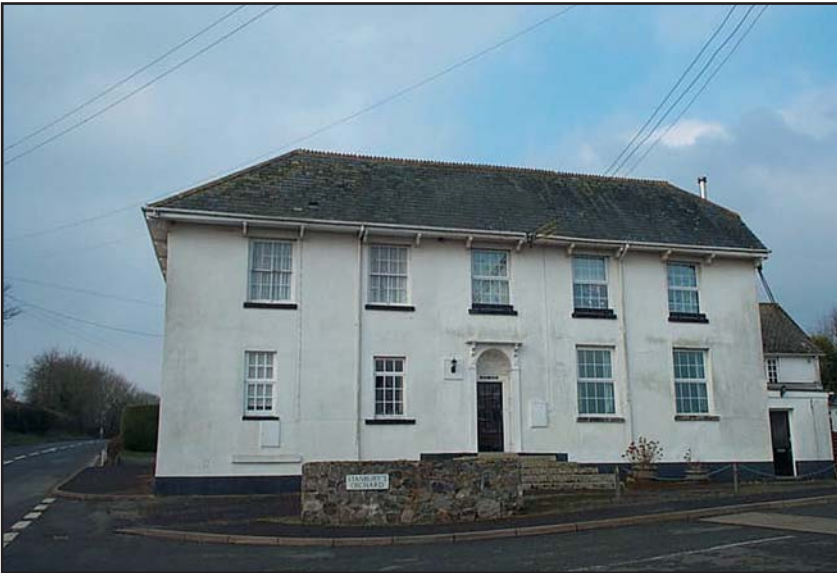
The creation of the Stanbury's Orchard development has fundamentally changed what must have been the forecourt to this substantial inn. It remains a significant space but now lacks definition and the stone planters fail to provide focus or interest [Fig 20 page 26].

Fig 20 The forecourt of the former Royal Hotel

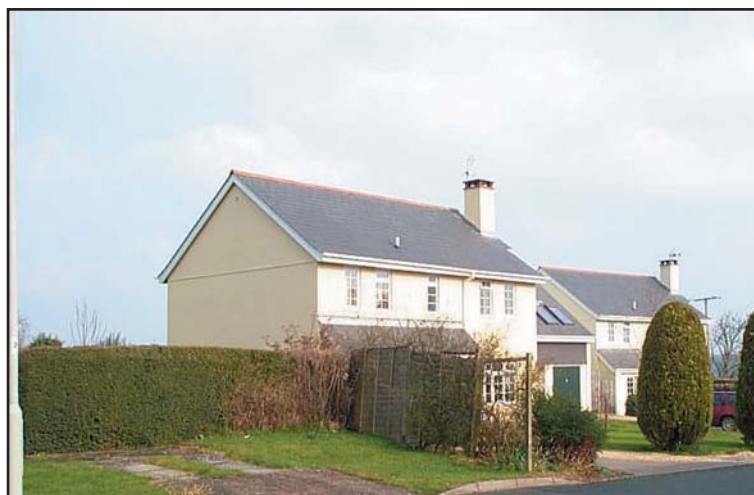
Fig 27 Stadbury's Orchard

There are two significant modern developments within the Conservation Area – Stanbury's Orchard and Saddler's Close. Both are cul-de-sac developments within toft boundaries on the north of the main road. They have reduced the clarity of the historic plan and the form of development, (detached houses not relating to the street), and fail to respect the historic character of Crockernwell. The designs are nearly all of a standard housebuilder type and the materials lack character in places, especially concrete roof tiles and PVCu windows.
