Throwleigh

Conservation Area Character Appraisal

Dartmoor National Park Authority January 2011

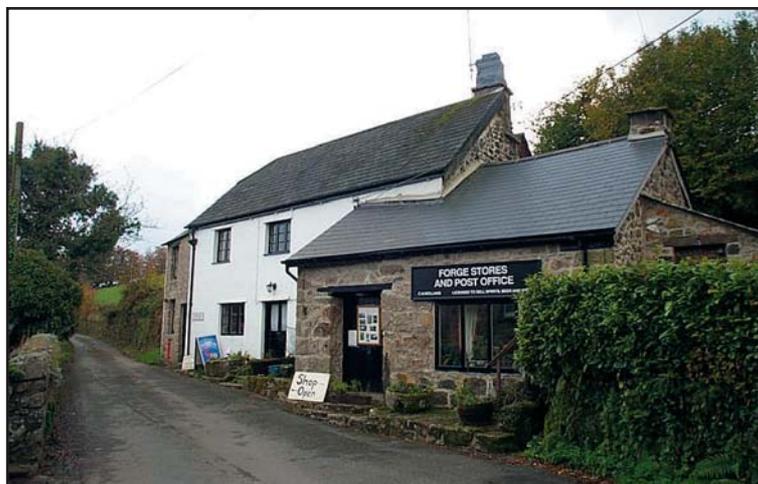
Fig 2: Forge Cottage is one of few rendered buildings in the Conservation Area

One of the characteristic features of Throwleigh is the number of buildings with exposed stonework, even on modern buildings. Granite is ubiquitous and only on the Barton, Wayside and the house at the Smithy is it covered by render [Fig 2 page 12].

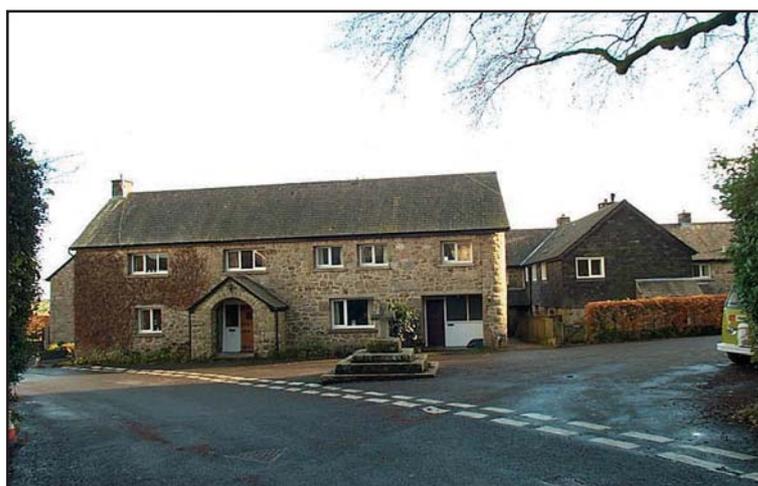
Fig 3 : Slate is a recent introduction to Throwleigh

Historically thatch would have been used on all buildings bar the church and it remains the typical roof covering with simple plain wrapover ridges. As in much of Devon many farm buildings had their thatch replaced with corrugated iron in the later 19th or 20th centuries. There has been a trend in Throwleigh for slate to be introduced when redundant barns are converted to residential use and on new dwellings. This has had a quite fundamental impact on the historic character of the village [Fig 3 page 12]. The cladding of walls with slate is not characteristic of Throwleigh (in its sheltered location) so that its introduction tends to appear out of keeping with its authentic appearance.

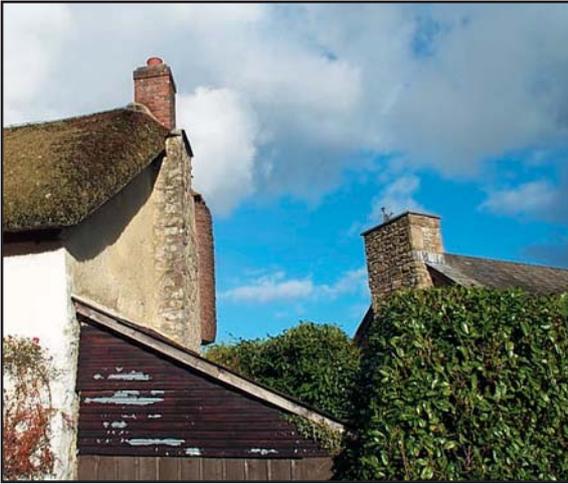
Fig 4 : Chimney stacks old and new

Whilst the majority of houses and cottages have a linear plan and face the street, their locations and the spaces between mean that gables are a strong feature in many views. As axial chimney stacks are the norm this makes them more prominent. Some chimney shafts have been re-built in brick or rendered blockwork and those on newer dwellings generally lack the character of older stacks [Fig 4 page 13]. Dormers are not a local tradition.

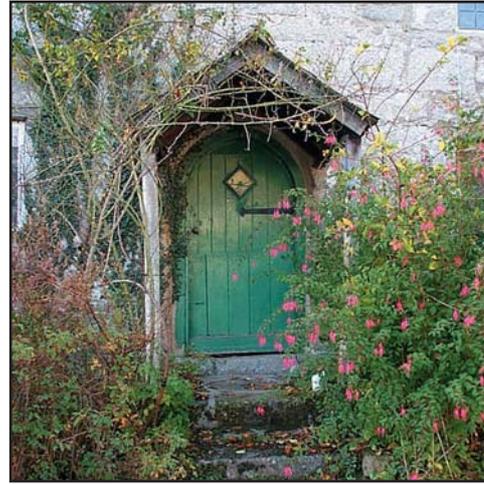
Fig 5 : Beneath the entrance canopy at Church House is an arched granite 16th century door frame.

Entrance canopies are found on several thatched properties [Fig 5 page 13] and porches have become something of a local feature on new-build and barn conversions [Fig 3 page 12].

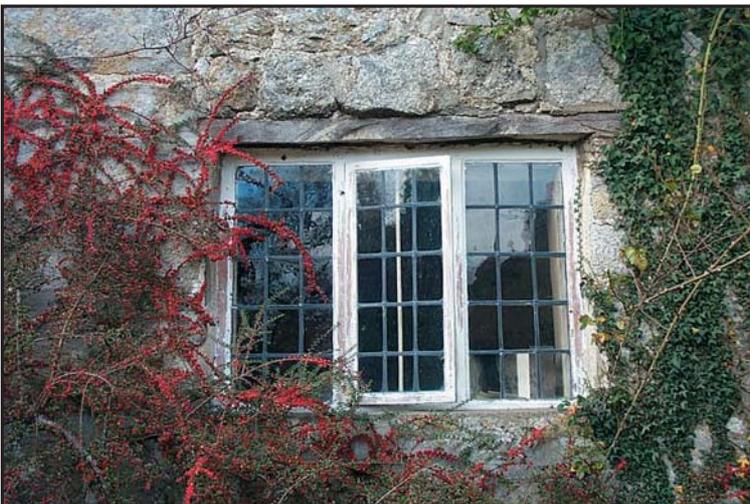
Fig 6 : Leaded casement windows at Church House

Timber casement windows are found on most buildings, with the notable exception of The Rectory which has fine Georgian sliding sashes. The leaded lights in the Church House are a reminder of what windows in the village were like in the more distant past [Fig 6 page 13], although some are replacements.

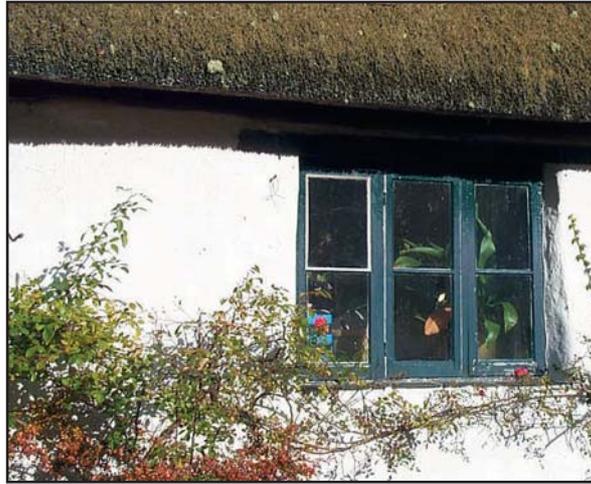
Fig 7 : Victorian casement windows at Wayside

Wayside has Victorian casements that retain the proportion of the openings and the vertical emphasis of the individual lights [Fig 7 page 14]. Unfortunately some newer and converted buildings have introduced modern materials and designs which tend to look out of keeping in an historic setting.

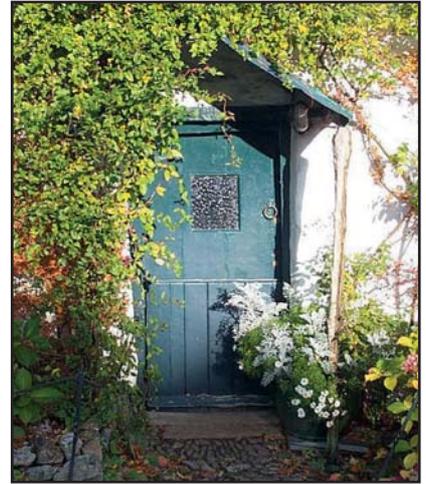
Fig 8 : The old plank door at Wayside

Plank doors are most usual – the historic 3-plank front door at Wayside epitomises this character and the separate half door is a functional feature that has been copied at the Church House [Fig 8 page 14]. Solid and part-glazed panelled doors are also found.

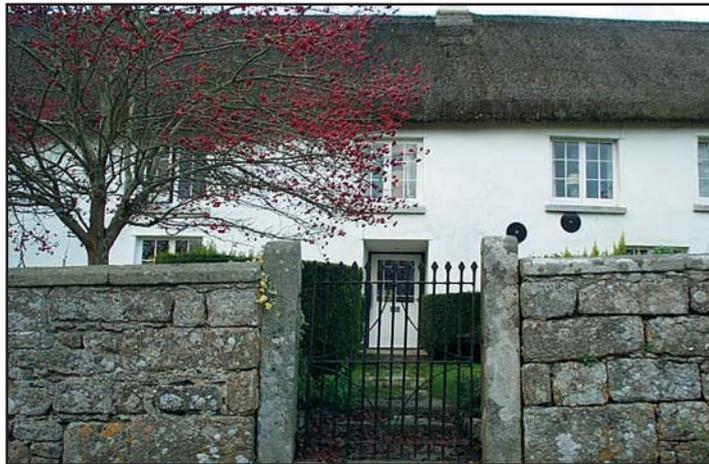
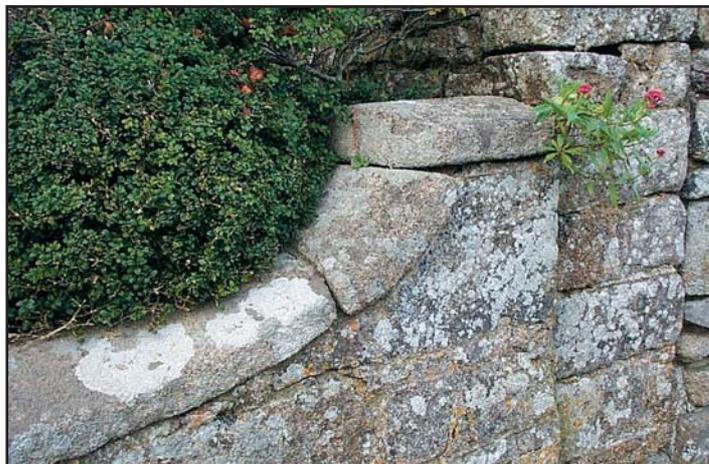
Fig 9 : The garden wall at Throwleigh Barton shows great care and considerable wealth in the quality of its construction

Those homes built tight to the street frontage often have planted verges – an attractive and traditional treatment. Gardens are mostly set behind stone walls and the Barton is an example of exceptional quality [Figs 9 and 10 page 14].

Fig 10 : Detail of garden wall at Throwleigh Barton

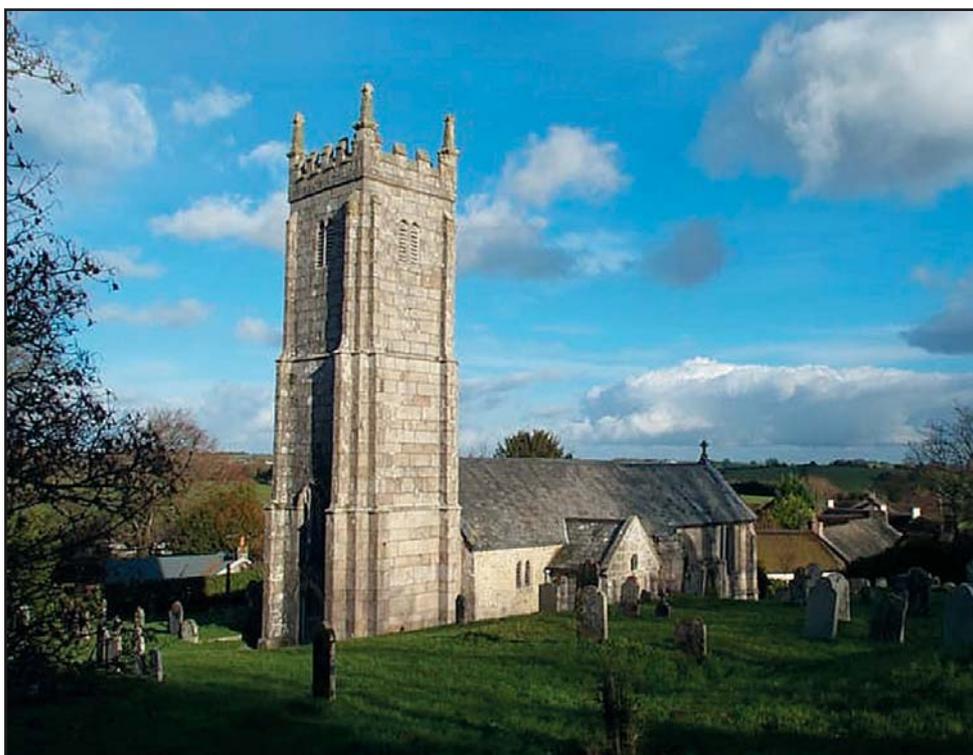
Fig 11 : The Church of St Mary the Virgin

Church of St Mary the Virgin: Grade I

Standing in its elevated location this fine church dominates the village. Mostly built in the 15th century but with earlier rubble stone fabric evident, it exhibits fine granite ashlar work and an elegant perpendicular tower. Much of the roof structure and many windows date from the 15th century but the north aisle was built in the 16th century.

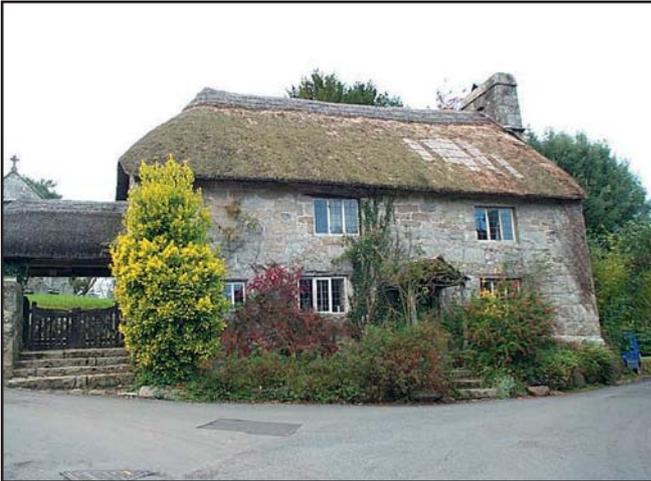
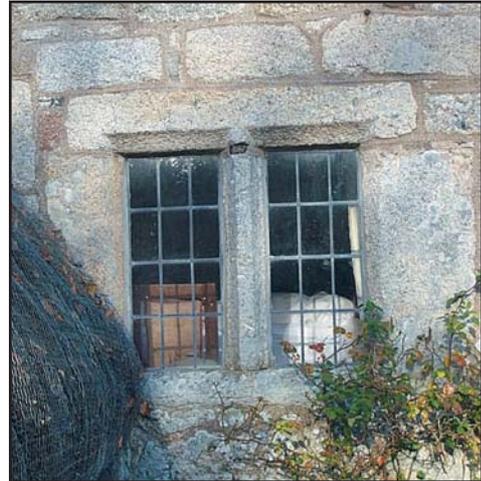
Fig 12 : Church House

Fig 13 : Granite window at Church House

Church House: Grade II*

Nestled beneath the churchyard is the 16th century church house. Built in granite ashlar it has interesting granite mullion windows in the south elevation – these are a feature next to the lych gate at the entrance to the churchyard [Fig 13 page 17].

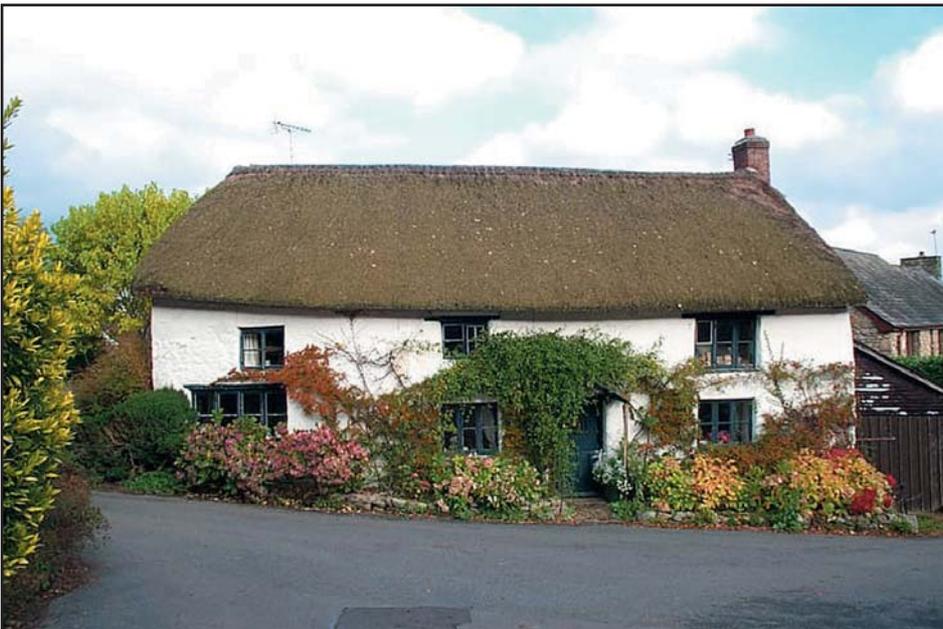
Fig 14 : Wayside

Wayside: Grade II

A typical 3-room cross passage house in the Devon vernacular tradition. Built of granite rubble with a rendered finish, probably 16th or early 17th century.

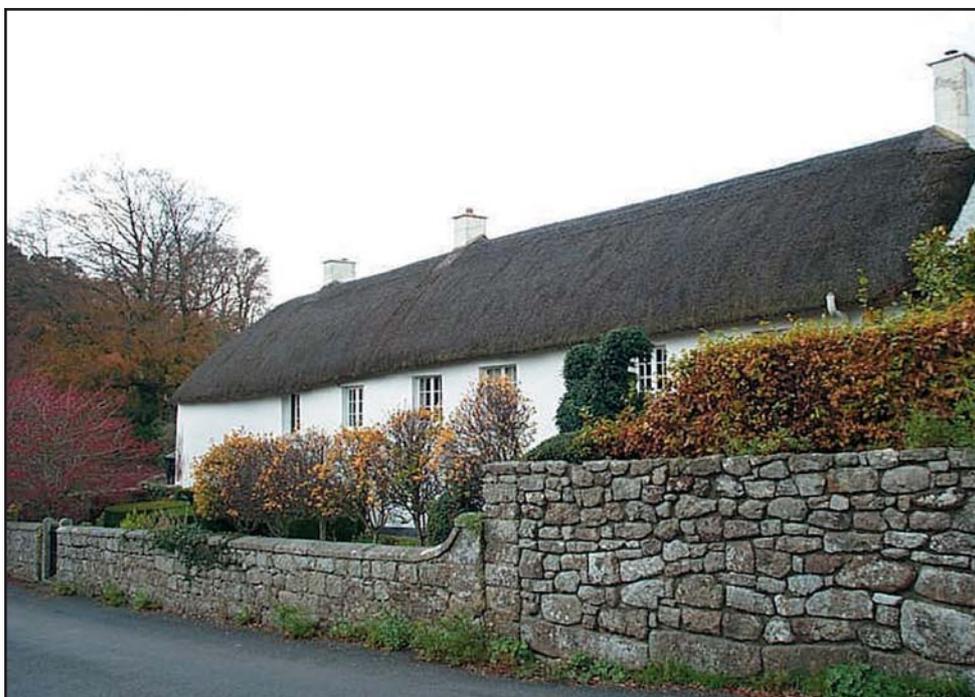
Fig 16 : Throwleigh Barton

A rare and substantial example of a 16th century house which occupies an important location at the eastern edge of the village. For centuries it was the focus of farming activity in Throwleigh.

The courtyard at Throwleigh Barton is the only extensive survival of historic surfacing, with granite slabs at the entrance giving way to irregular setts further in [Fig 26 page 23]. Wayside has a little cobbling at its entrance [Fig 8 page 14].

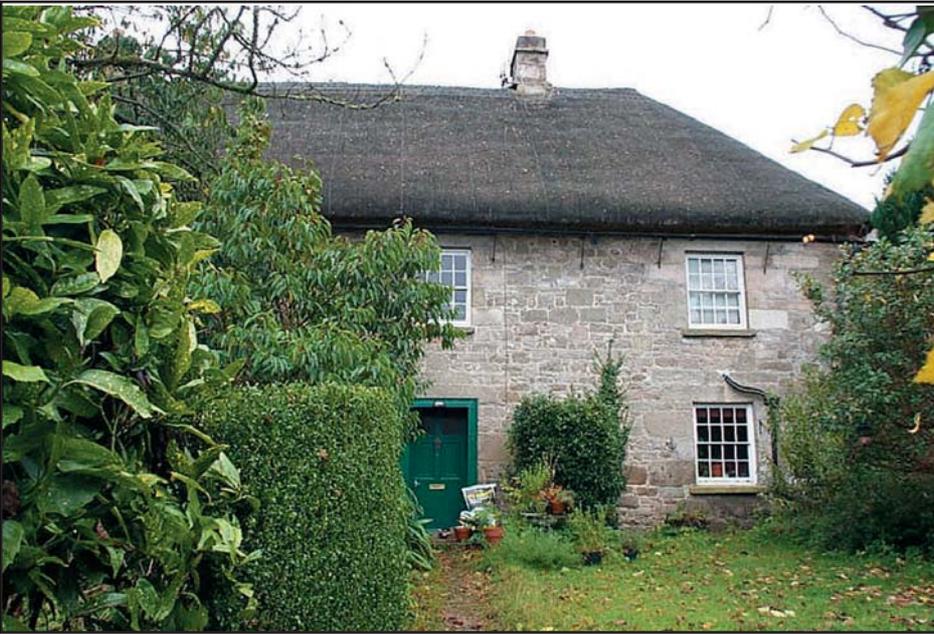
Fig 21 : The Old Rectory

A good example of a polite and substantial house of the early 19th century with a traditional thatched roof. Unusually for its time it has no 'picturesque' features, at least not on the principal elevation.

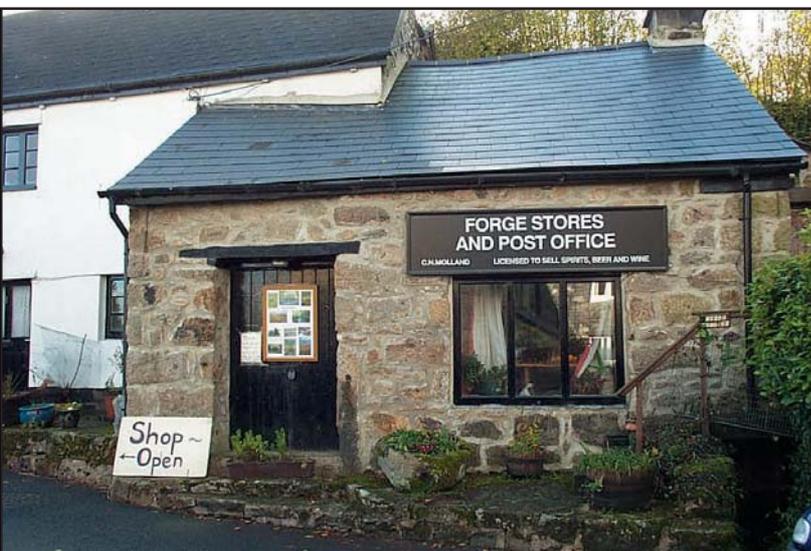
Fig 17 : Forge Stores and Post Office

An important functional building and home that retains historic features, including an 18th / early 19th century window in the return elevation of the forge building itself. Now the village stores and Post Office it is the hub of the local community as well as being a key building.

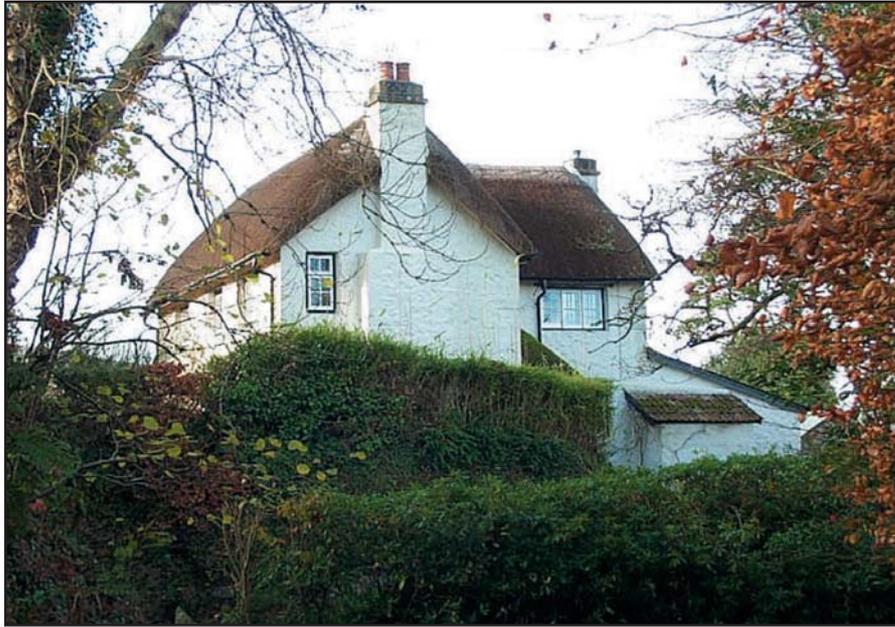
Fig 18: Church View

Woodacott appears on the 1905 OS map [Map 4 page 9], presumably Church View was built shortly afterwards. These houses are fine examples of vernacular revival in the Arts and Crafts tradition. To the casual observer they appear centuries old, but there are enough clues in the construction and fenestration to reveal their true age.

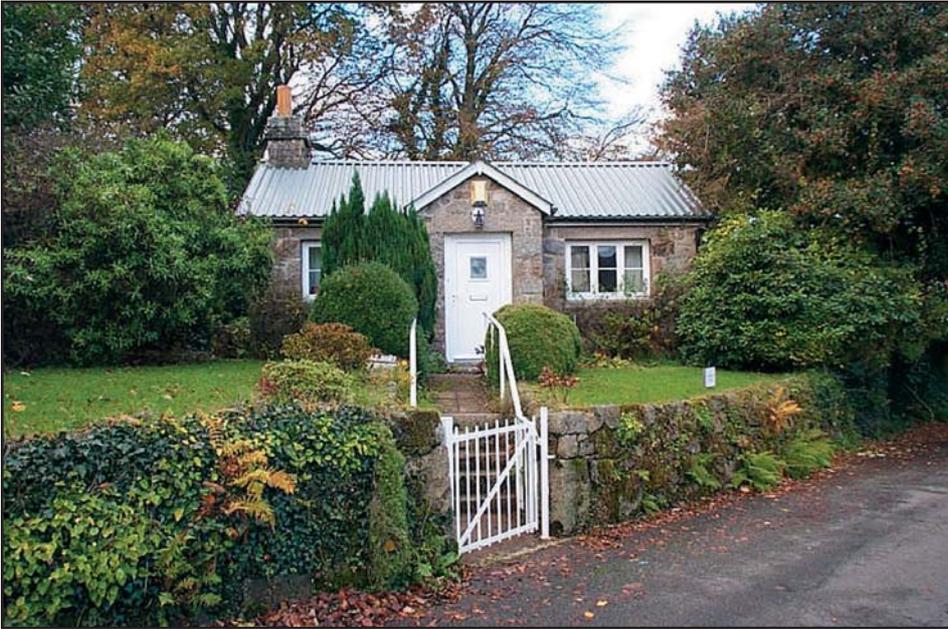
Fig 20: *Little Phantasy*

A quirky little home and another contribution to the character of Throwleigh from Rev. Lowe. The original slate roof has been replaced with modern industrial metal sheeting.

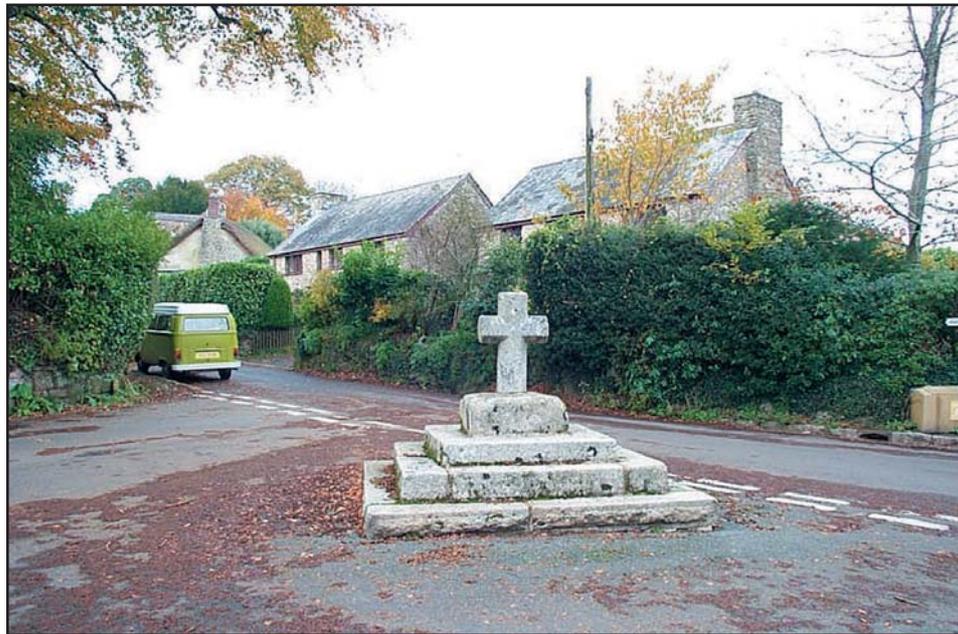
Fig 24 : The Village Cross

The village cross lies at the main convergence of lanes [Fig 24 page 22]. The list description states it was erected in 1897 to commemorate the 60th year of the reign of Queen Victoria. This seems, however, to be a restoration and enhancement date as the OS map of 1886 [Map 3 page 8] features a 'Stone Cross (Remains of)' in this locality. Perhaps the restoration was instigated by Rev. Lowe as one of his first projects.

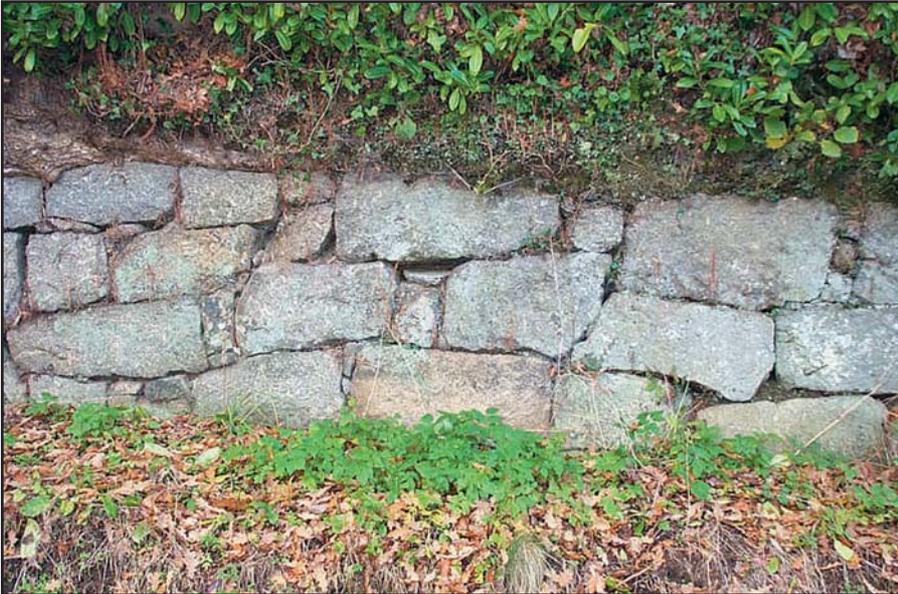
Fig 25 : Granite block wall retaining the churchyard

Roadside walls constructed in assorted styles of granite rubble are a very strong unifying feature of Throwleigh - the huge blocks in the retaining walls near the church are especially impressive [Fig 25 page 23]. Many walls are supplemented by hedges which include a lot of laurel as well as other plants including privet and beech.

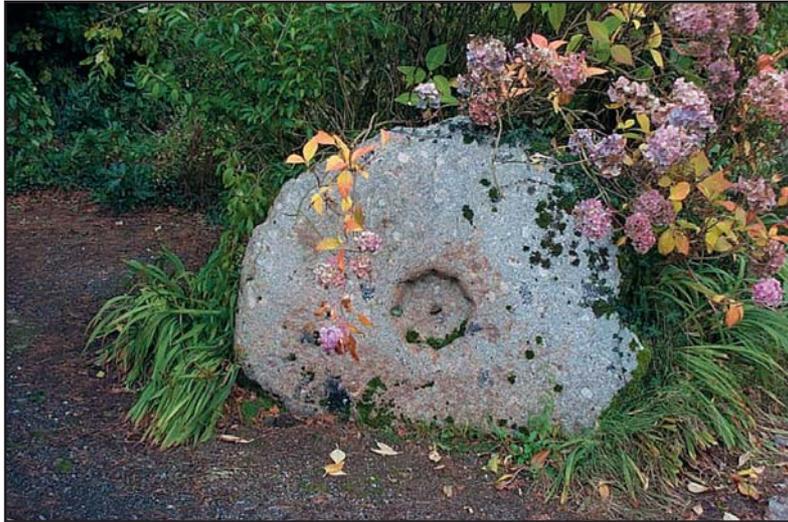
Fig 27 : The wheelwright's stone

The circular stone near the village pond is a feature; formerly used by a wheelwright and not a miller [Fig 27 page 24].

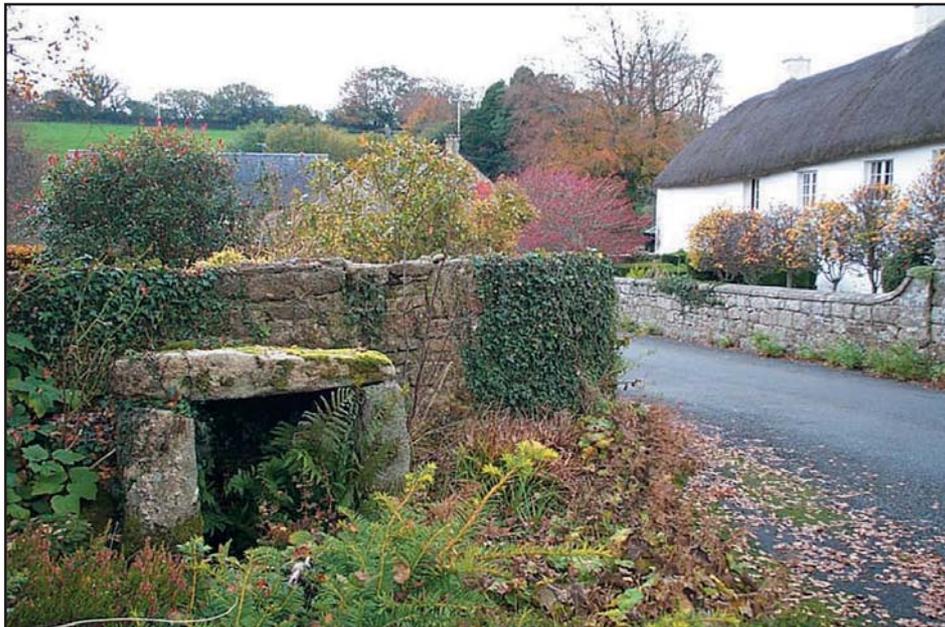
Fig 28 : The butterwell

Opposite the Barton is a very attractive butterwell [Fig 28 page 24] – a rare survival in a village context. Simply constructed from three granite slabs it retains the hinges and catch for a simple plank door.

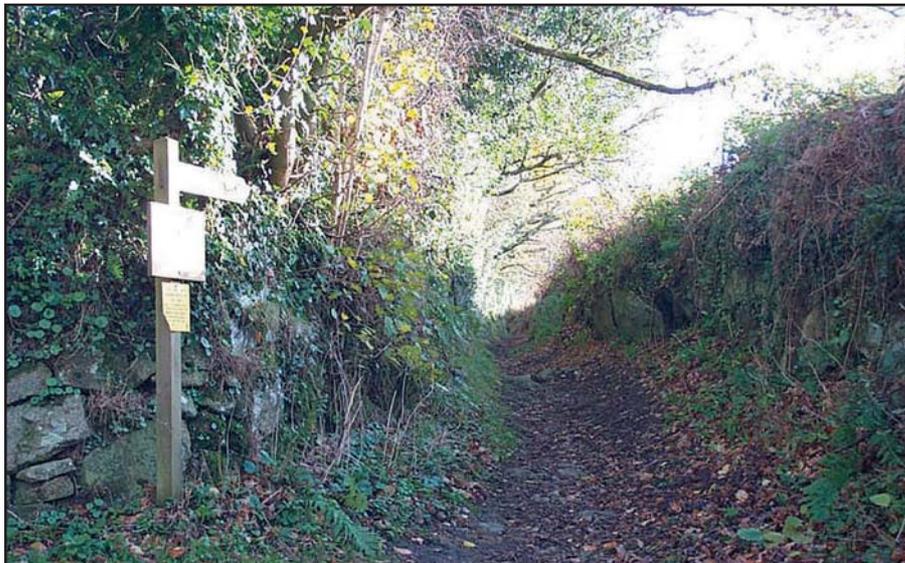
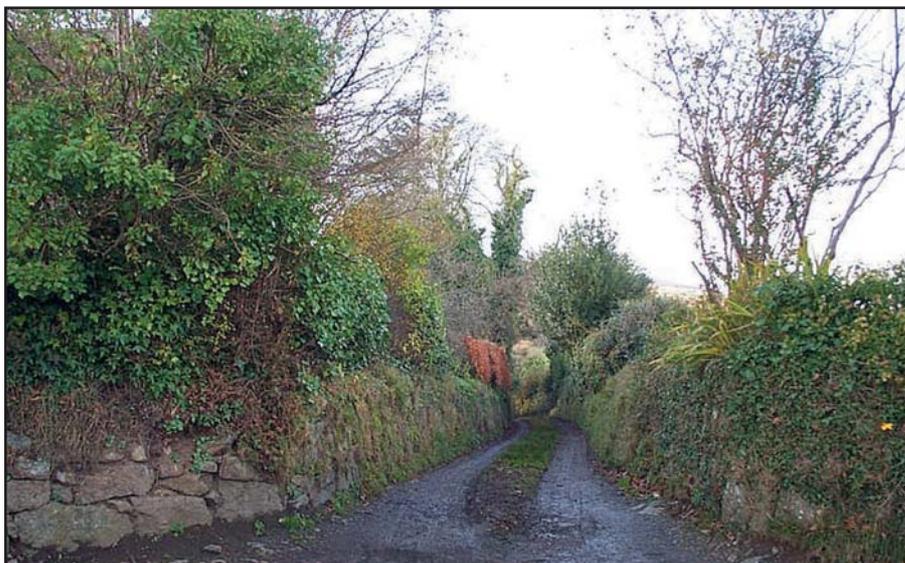
Figs 39 :The old unimproved lanes

The tracks to the south of The Hey and Woodacott represent a tangible link with the distant past when such tracks were the way to get around Dartmoor [Figs 39 and 40 page 30].

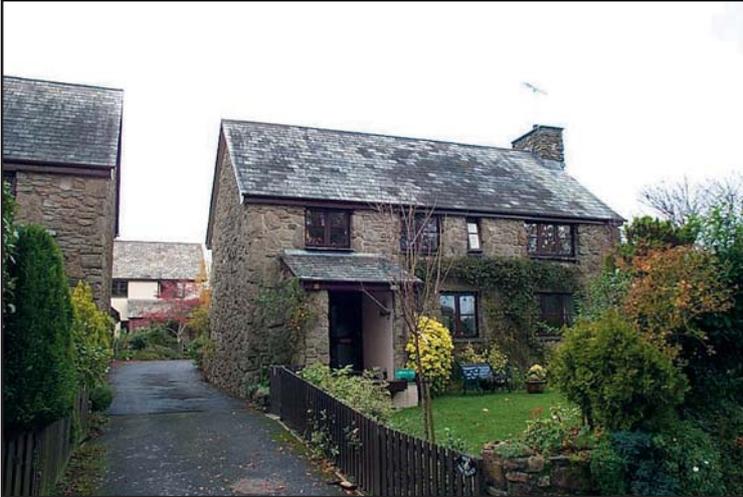
Fig 41 : Modern development in the heart of the village – The Orchard

Some barns have been so extensively altered, and even reconstructed, that their origins are no longer discernible. The most recent houses are at least mostly built of granite [Fig 41 page 32] and thereby acknowledge the characteristics of the location, though the layout of The Orchard is rather suburban in appearance. Other developments, such as Tolmen and Church Close fail to reflect the character of Throwleigh but are not prominently located.
