Walkhampton

Conservation Area Character Appraisal

Dartmoor National Park Authority June 2017

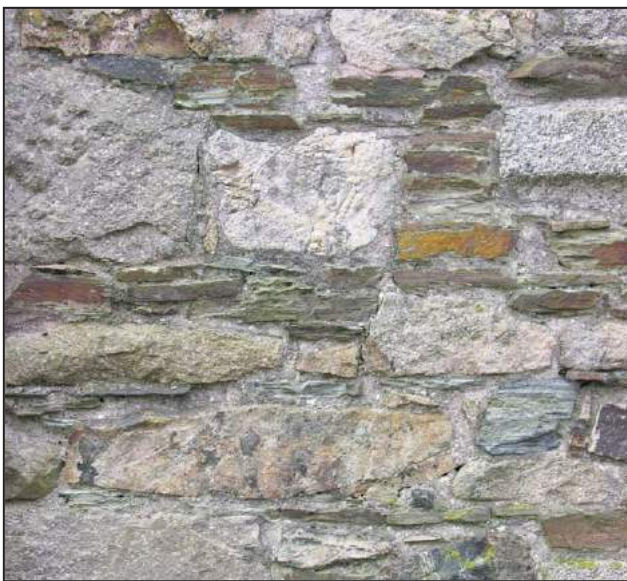
Figure 1 A variety of stone types are found in Walkhampton

The underlying geology of the area is complex, on the edge of the granite mass, there is a range of metamorphic and intrusive igneous rocks evident in the fabric of the place, as well as granite. The economic value presented by its geological heritage is evident in the historic workings for tin, copper, and granite in the parish, although none of these are evident within the village itself.

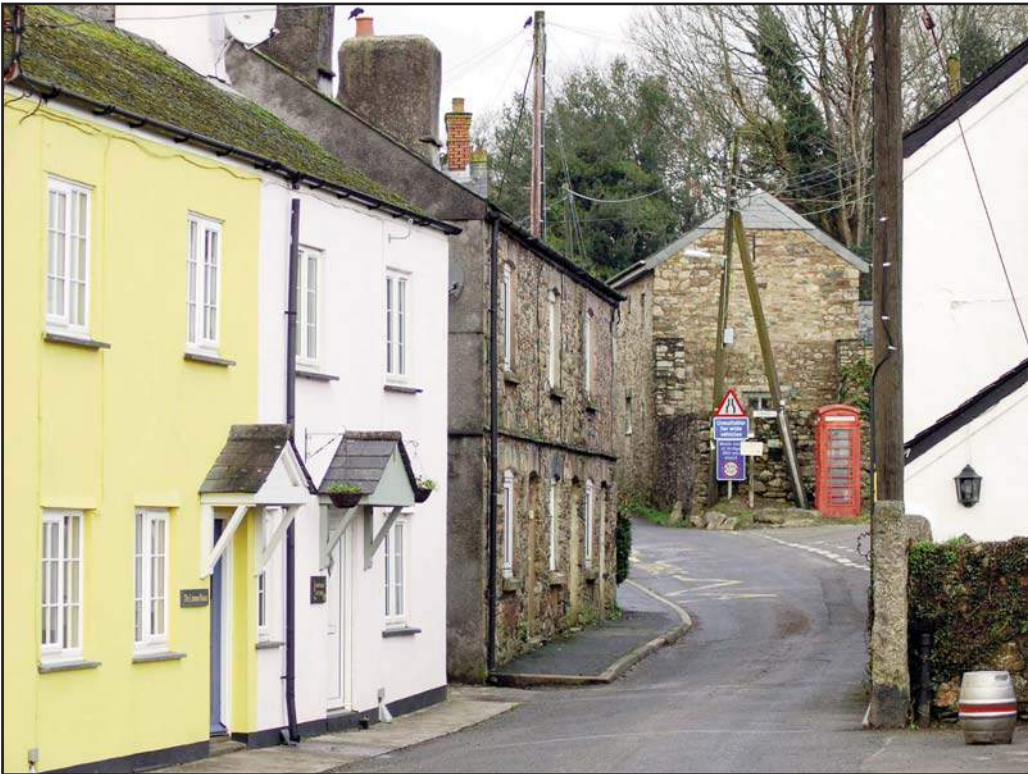
Figure 2 Rows of 19th century cottages tightly enclose the main street

The two rows of cottages north of the wheelwright's shop and opposite the inn were constructed in the early 19th century.

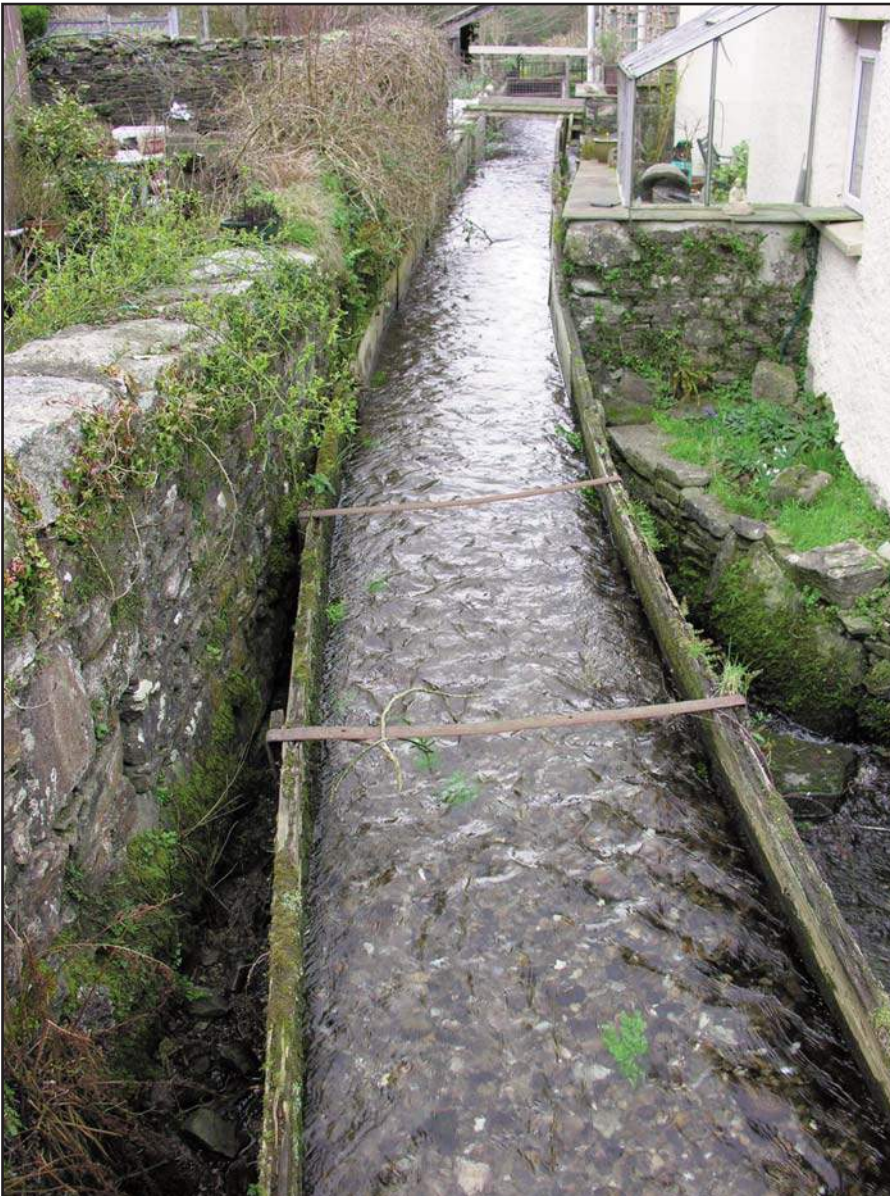
Figure 4 The launder

The crossing point of the Black Brook is the centre of the village and offers a good vantage point for the historic layout, including a view of the church. It also has the interest of the historic leat and launder carrying water to power the wheelwrights above the actual brook – an unusually compact example of the genre.

The wheelwright's shop, powered by water from the Black Brook delivered through a wooden launder to an overshot wheel, was founded in the mid-19th century by Philip Veale. In the late 19th century the building was extended by a blacksmith's shop, and in the 20th century a further addition was constructed with corrugated iron sheeting, though this has since been demolished. In a report written in 1998, the year after the business closed, mills expert Martin Watts stated, 'The Wheelwright's Shop at Walkhampton is remarkable survival of a once widespread local industry and unusual in that it retains several machine tools that were driven by water power. As a water-powered wheelwright's shop that still retains its prime mover and machinery in full working order, the site at Walkhampton can be considered unique in England'⁸. Although the setting of the former Veale & Sons works is now rather compromised by modern development, the buildings clearly demonstrate that in the 19th century the village was more than just a small agricultural settlement. The wheelwright's shop is now known, and listed, as 'Walkham Mill'.

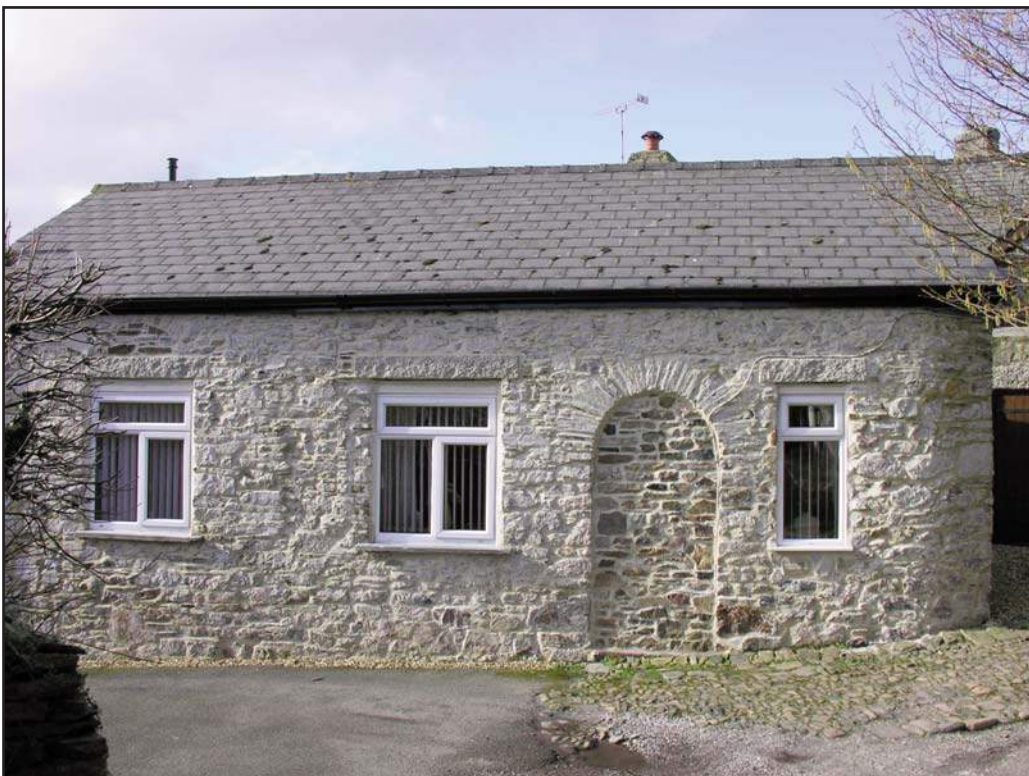
The original architectural character of Walkhampton is typical of the Devon vernacular; earlier cottages and farmhouses have a simple linear form with gabled ends, massive walls, substantial chimneys and small, usually unordered windows. This character is typified by Town Farm, Staddons, and the Church House. Lea Cottage and Veale Cottage is also a relatively early building, albeit much altered now and having the later extension that is Applegarth. Varied slate and other rubble stone construction prevails with granite used for lintels and some quoins. Render is still prevalent on domestic buildings and in the past all are likely to have been rendered and/or lime washed. A recent tendency to expose stonework and 'tidy it up' by comprehensive re-pointing is inconsistent with historic traditions.

Figure 6 Total re-pointing can strip historic character

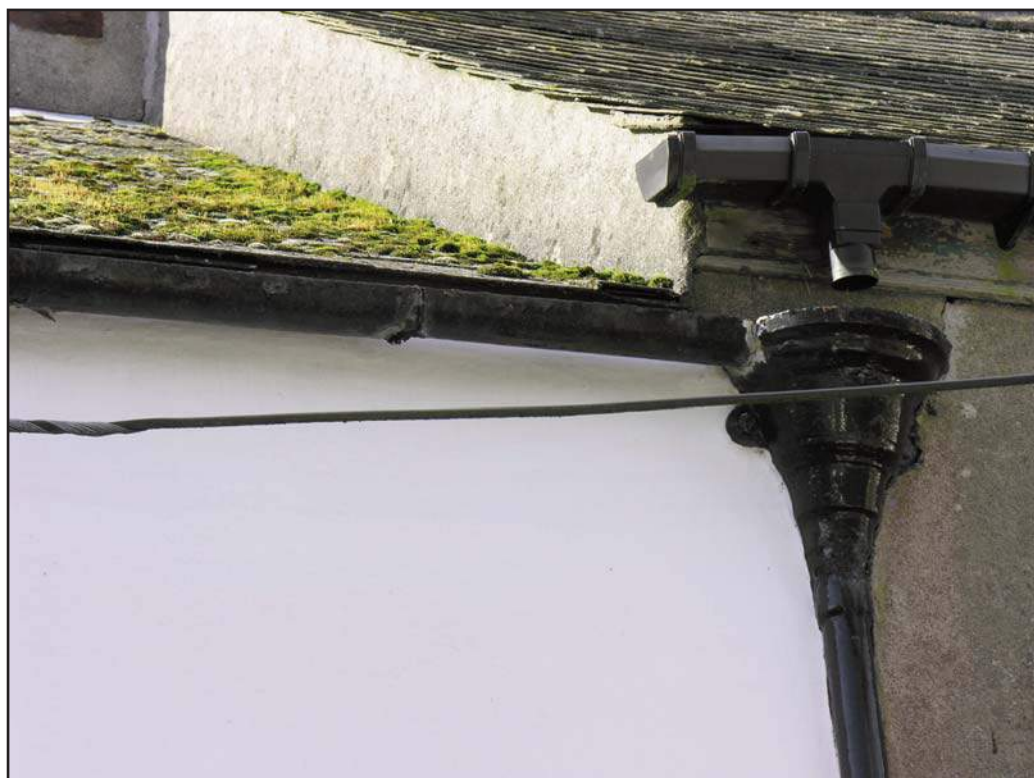
Older homes tend to have minimal overhangs at the eaves and all buildings had cast iron rainwater goods in either half round or ogee profiles, but these have mostly been replaced in plastic. Verges are also simple and either slated or rendered to the underside of the slate. Later 19th century 'pattern book' cottages tend to have more obvious overhangs and eaves dormers. Apart from these examples, some later

Figure 7 Traditional eaves and rainwater goods

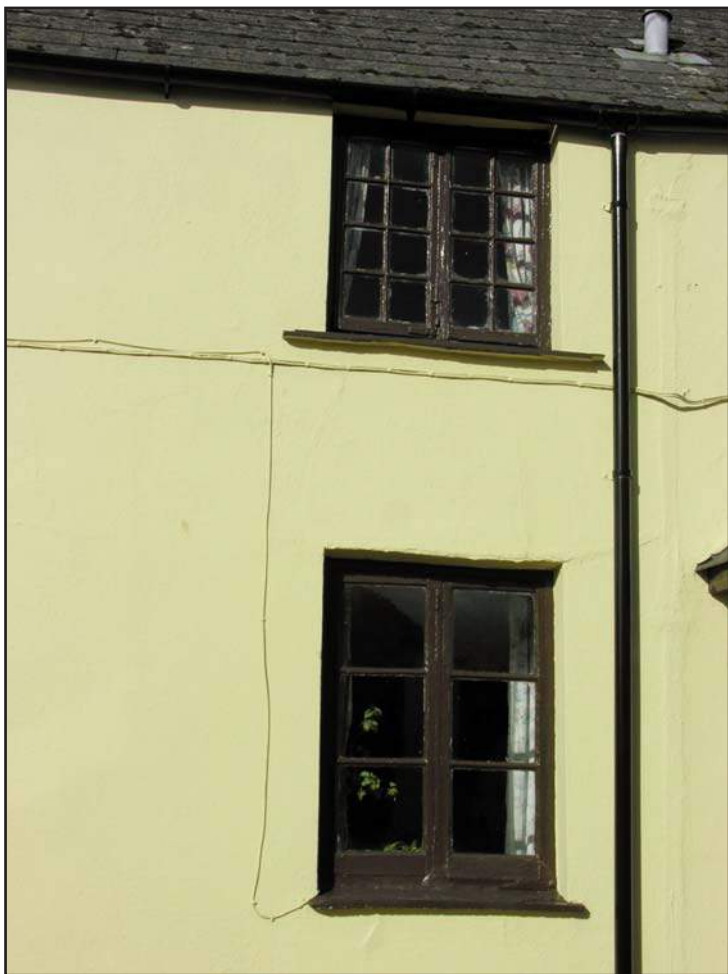
The survival of historic windows and doors is generally poor, but the few examples that remain offer a glimpse of the former historic character that prevailed. Many units have been replaced in poorly detailed uPVC, but there are also timber windows that fail to reflect the historic pattern of glazing and are finished with incongruous modern stains. Though the village shops have now closed, their shopfronts remain as evidence of their historic usage.

Figure 8 Historic Georgian and Victorian casements at Staddons

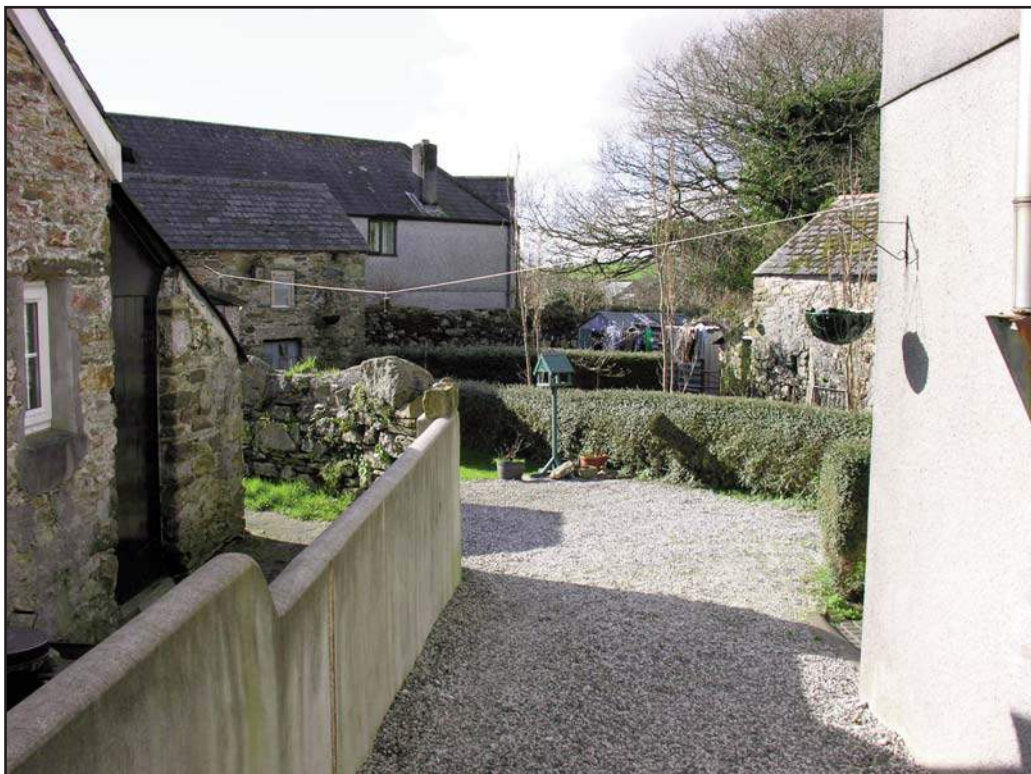
Figure 9 Traditional outbuilding

The old barns of the village also follow the vernacular tradition with rubble stone walls and slate roofs. They would also have been lime washed in most cases. The wheelwright's shop was a significant industrial complex at the heart of the village, its associated house being more visible from the street, and a range of outbuildings having been replaced by modern development.

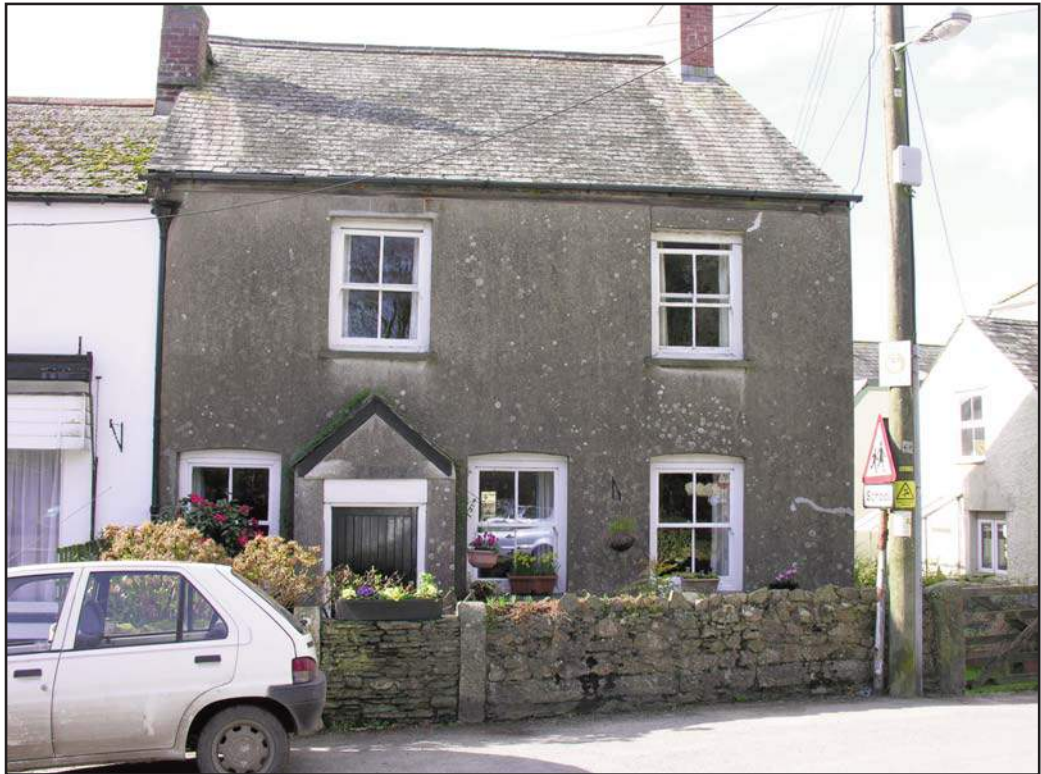
Figure 10 Brookside retains its original sash windows

From the beginning of the 19th century elevations became more ordered and symmetrical with larger sash windows more common than casements, as seen on the Walkhampton Inn and Brookside.

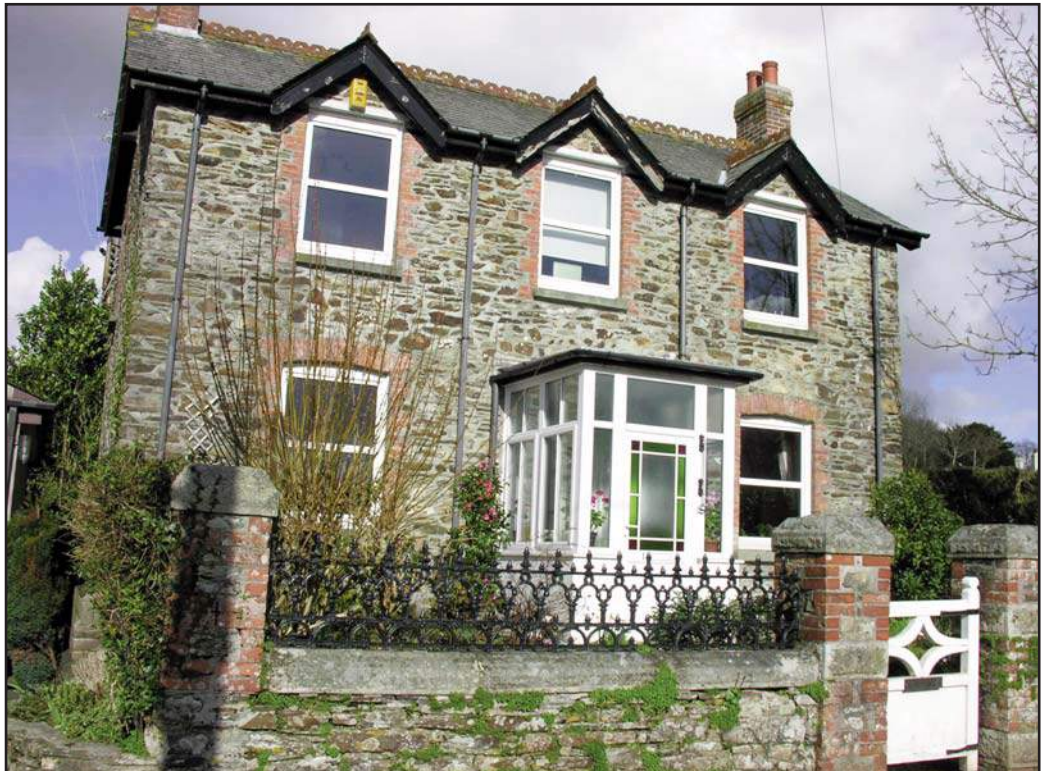
Figure 11 Whitstone is one of the late Victorian houses

In the 1890s dwellings were built to a favoured style that is faintly gothic and this probably reflects the influence of the Maristow Estate. There are four late Victorian houses that have eaves dormers to their principal elevations and are presumably based on pattern book designs. Rubble stone is still used and in the most notable example opposite Town Farm it was left exposed with dressed granite detailing combined attractively with red brick.

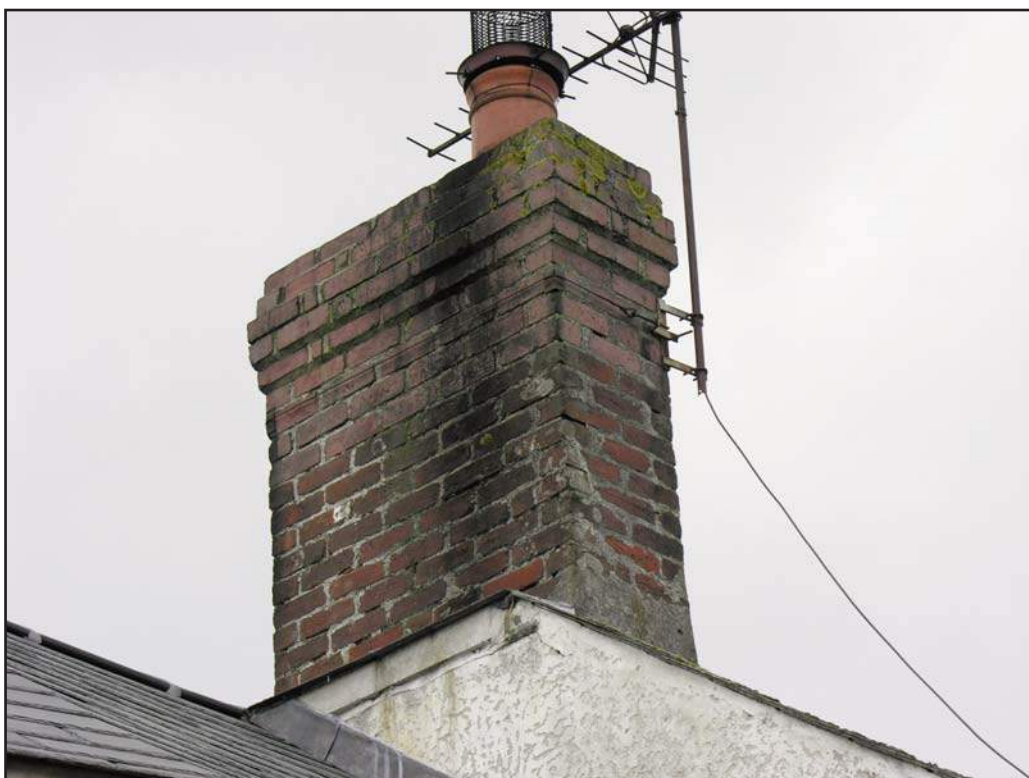
Brick is used for lintels, quoins and chimneys on later buildings as it was economical to do so after the arrival of the railway nearby - the same reason Welsh slate appears to have been used on the roofs along with decorative ridge tiles.

Figure 12 Brick stacks are part of the roofscape

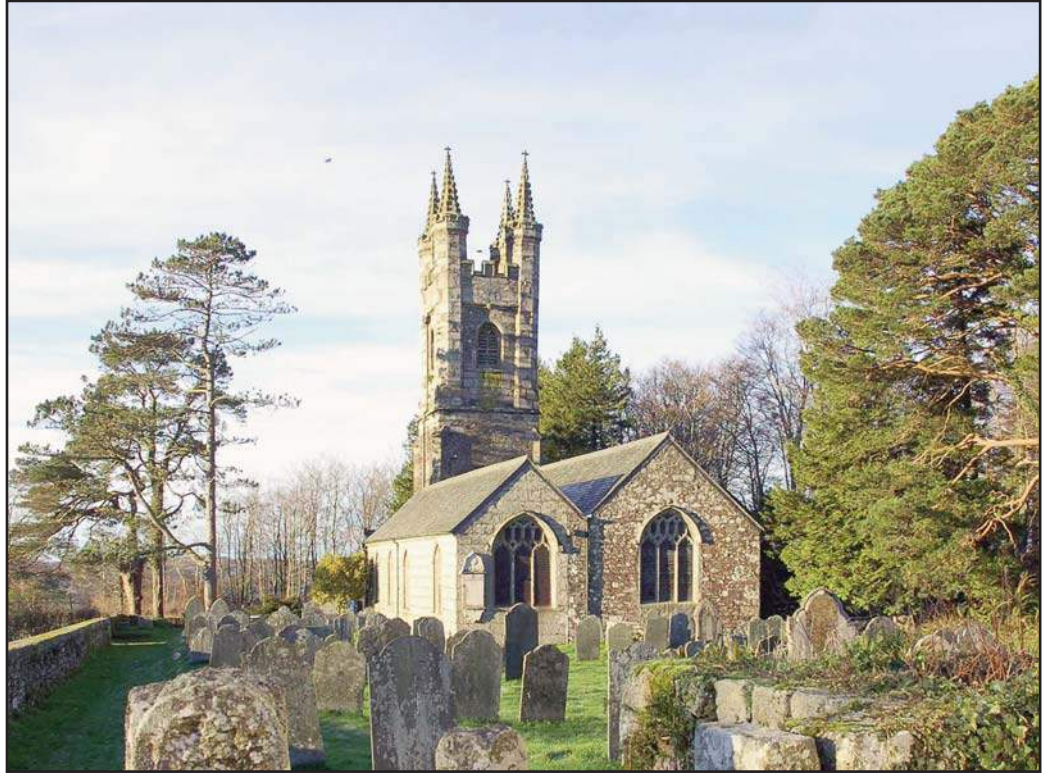
Figure 13 The church

Church of St Mary – Grade I

The 15th century parish church is strikingly located and distinctive in its character. The battlemented tower, decorated by remarkable octagonal pinnacles, is one of the finest on Dartmoor. The south aisle is a good example of massive and neat granite ashlar. Much of the inside of the church reflects the tastes of the Victorians – the church was ‘restored’ in 1860 -1, with the sanctuary tiled in memory of Lady Lopes who died in 1872. The church is visible from miles around, dominating the landscape, but curiously remains largely unseen from some of the older parts of the village. However, there is a clear view from fields below the church to the site of the ancient Manor of Knowle and this open vista is worth preserving.

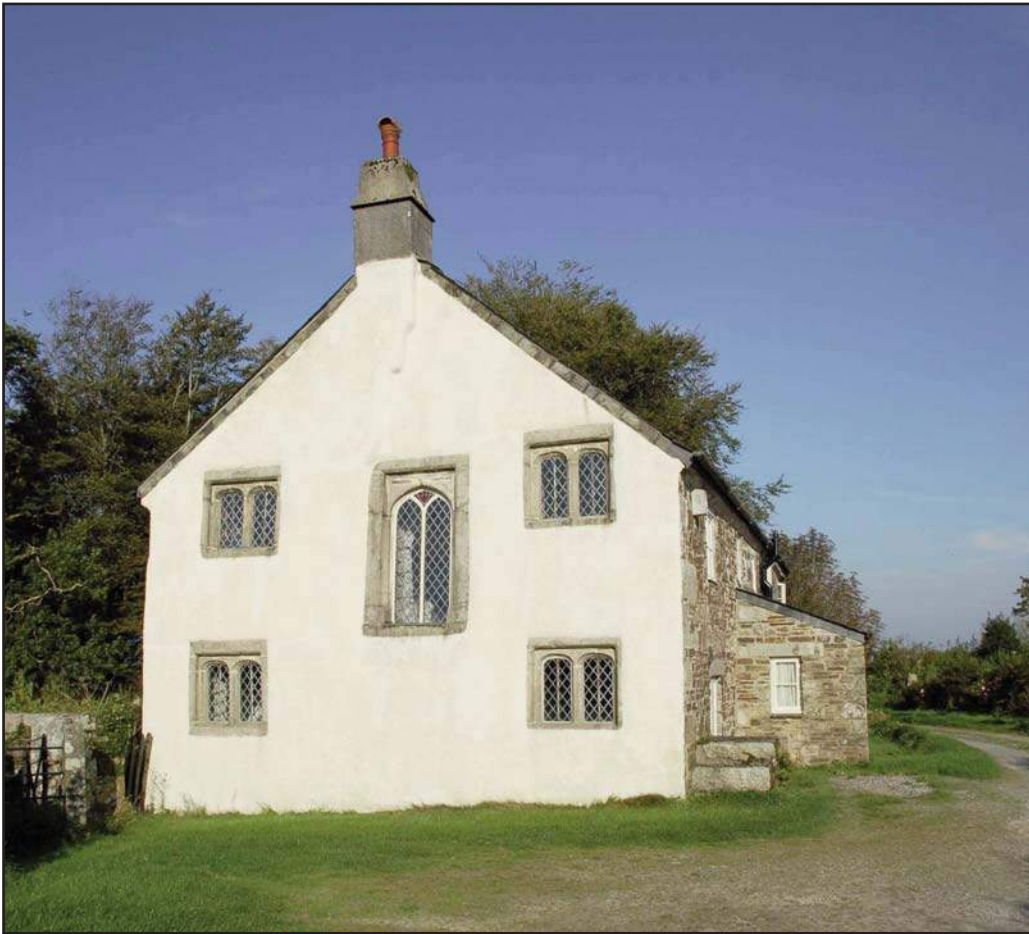
Figure 14 The Church House

The Church House – Grade II*

The list description states this to be 'one of the most complete church houses in Devon'. The 15th or early 16th century building complements the setting of the church itself and has its own particular interest, especially in the form of its granite window frames. Its picturesque appeal has long been recognised as it was recorded in an etching by Samuel Prout in 1812 (Fig.15). The building's licence as an inn was revoked in 1895 and it was converted into cottages shortly afterwards. Church House was restored in the early 1980s.

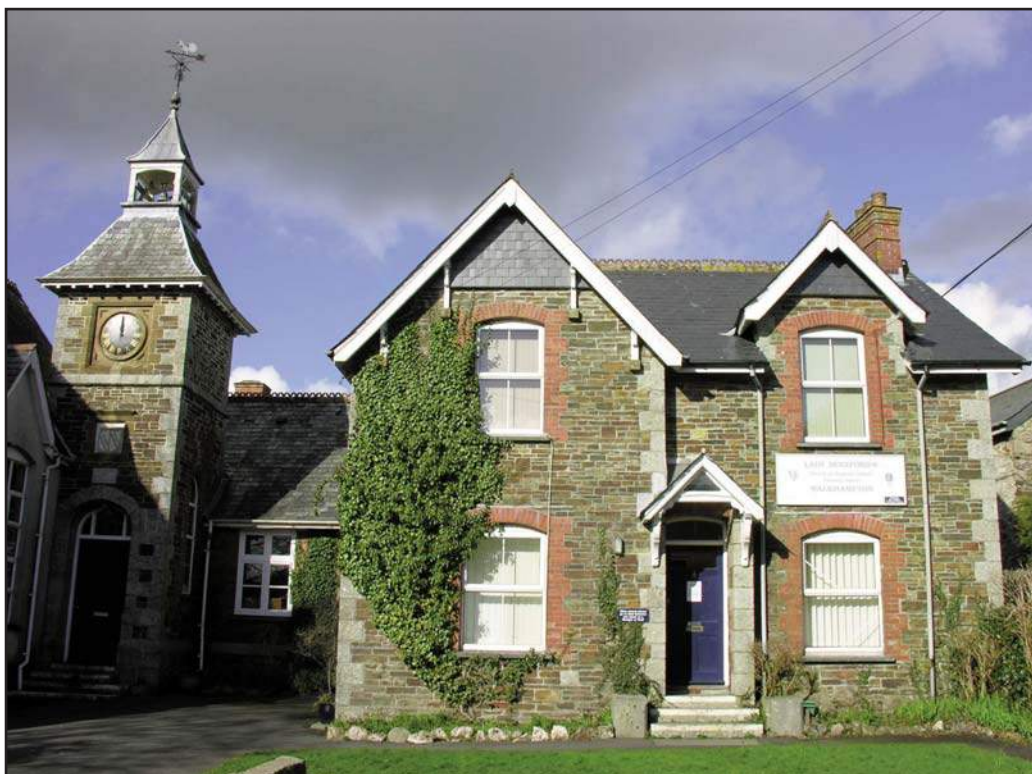
Figure 16 Lady Modyfords School

This is a key building due to its history, location, and the relative grandeur of its architecture. The bell tower, built in 1894, is visible from many vantage points around the village. The School House, of 1895, is a neat and sober example of Victorian institutional building.

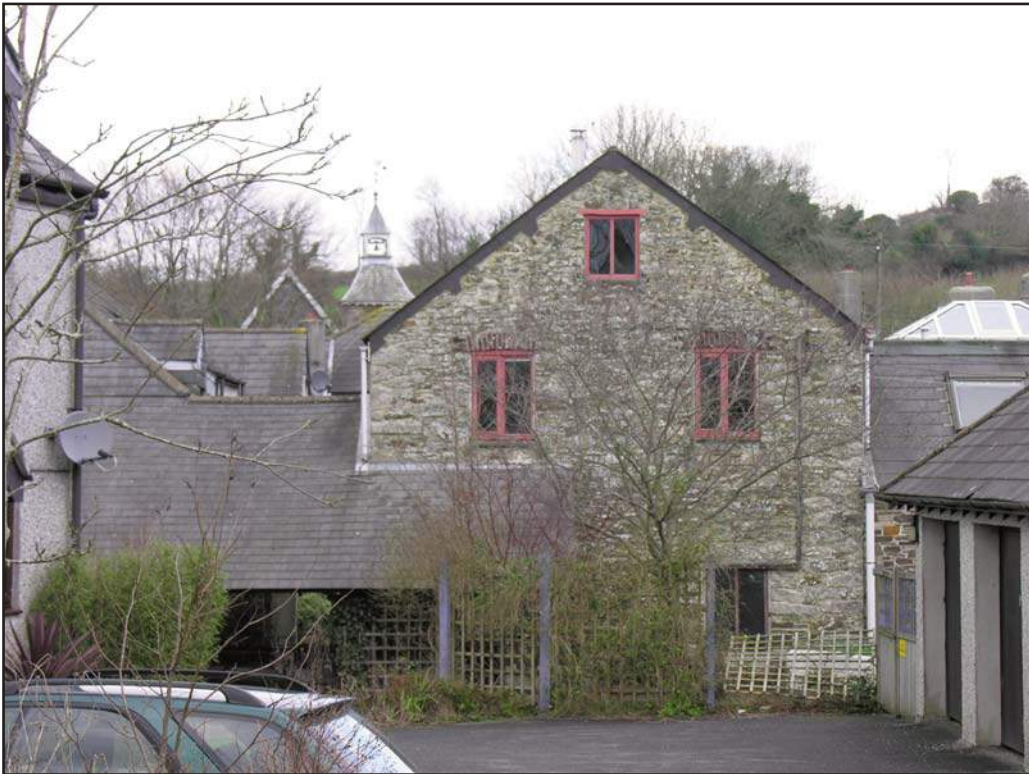
Figure 17 Veale and Sons

The Wheelwright's Shop – Grade II

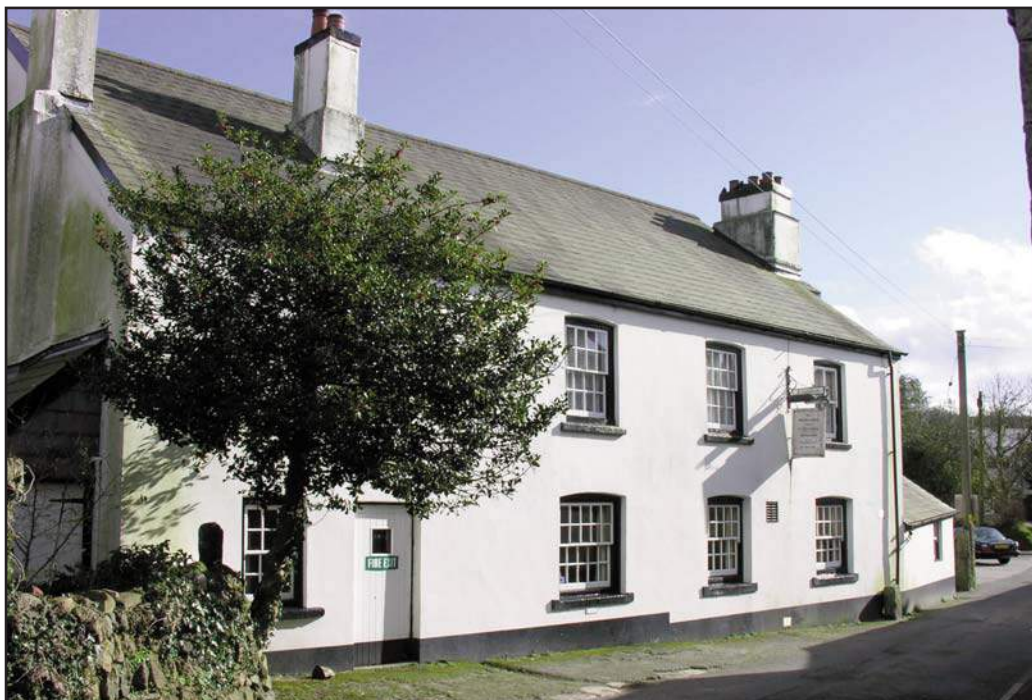
Figure 18 The Walkhampton Inn

The Walkhampton Inn – Unlisted

Whatever the date of its original construction, the inn was clearly extended and re-modelled in the 19th century and it retains much of its appearance from that time. It is a big building by the standards of Walkhampton, located right on the main north-south route through the village.

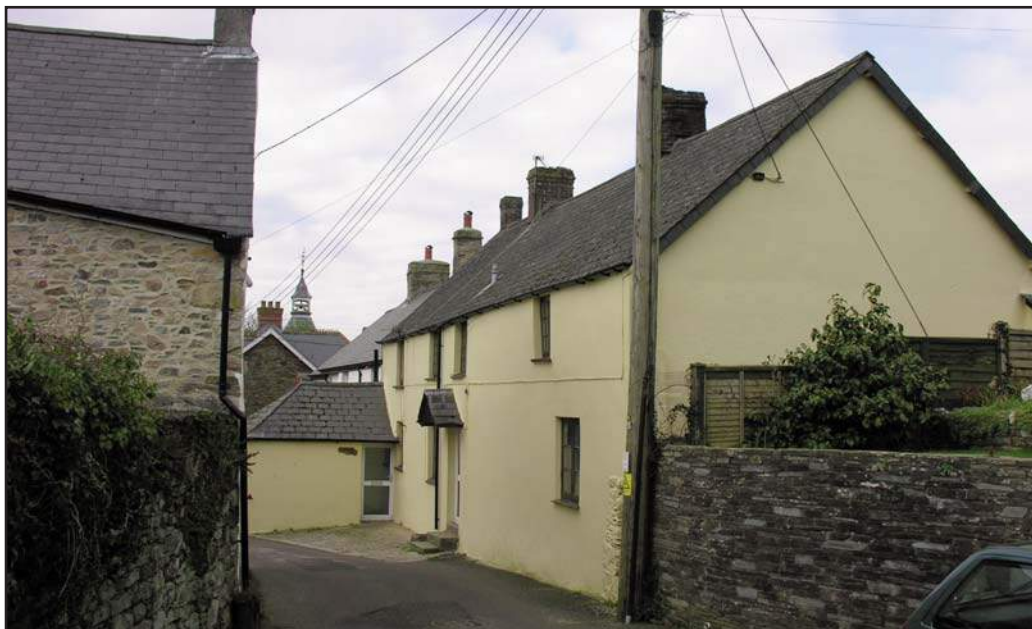
Figure 19 Staddons

Staddons House and Cottage – Grade II

Staddons is another house of the 17th century, with 19th century alterations. Its name is probably associated with a former owner. This is

now one of the more unspoilt of the more ancient houses in the village, with windows of the early and later 19th century. The artificial slate roof reduces its historic character but it is an important part of the key group at the heart of the settlement.

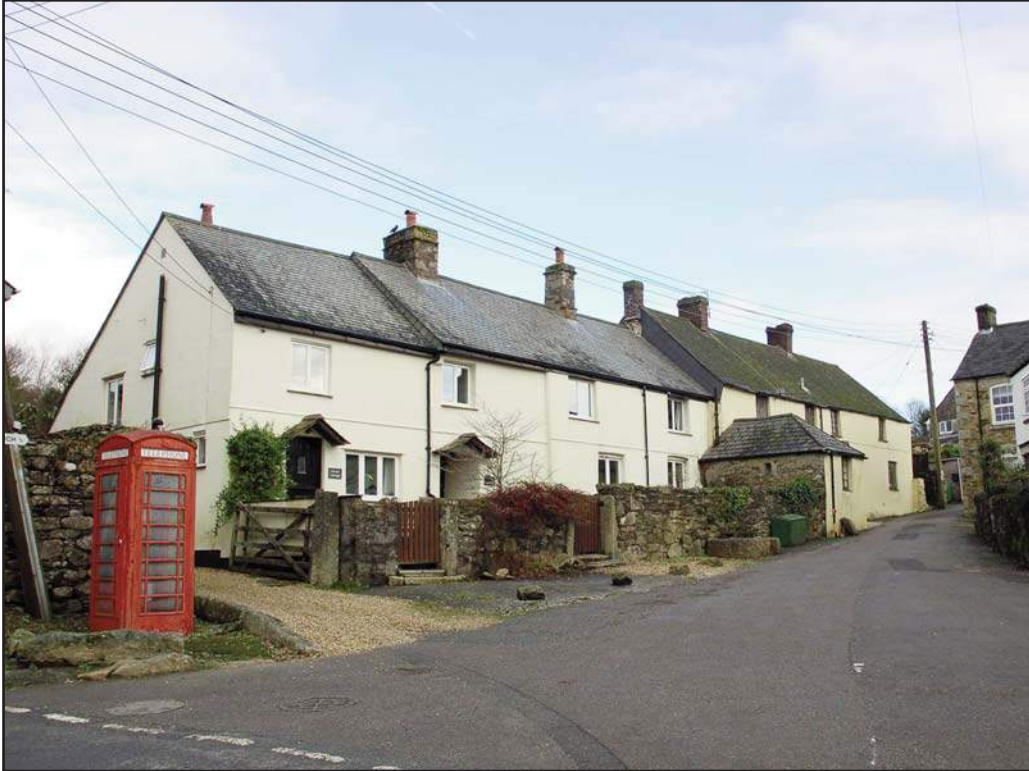
Figure 20 Town Farm

Town Farm – Grade II

Town Farm was the prime historic farmstead of Walkhampton and the buildings associated with it are a key character feature of the village. Originally a 17th century 3 room and cross passage plan, typical of many farmhouses at the time, it was adapted in the 19th century when the present farm buildings were erected. Town Farm was restored in the 1990s. The barns have been quite gently converted in terms of new openings. Town Farm forms a group with neighbouring Staddons. .

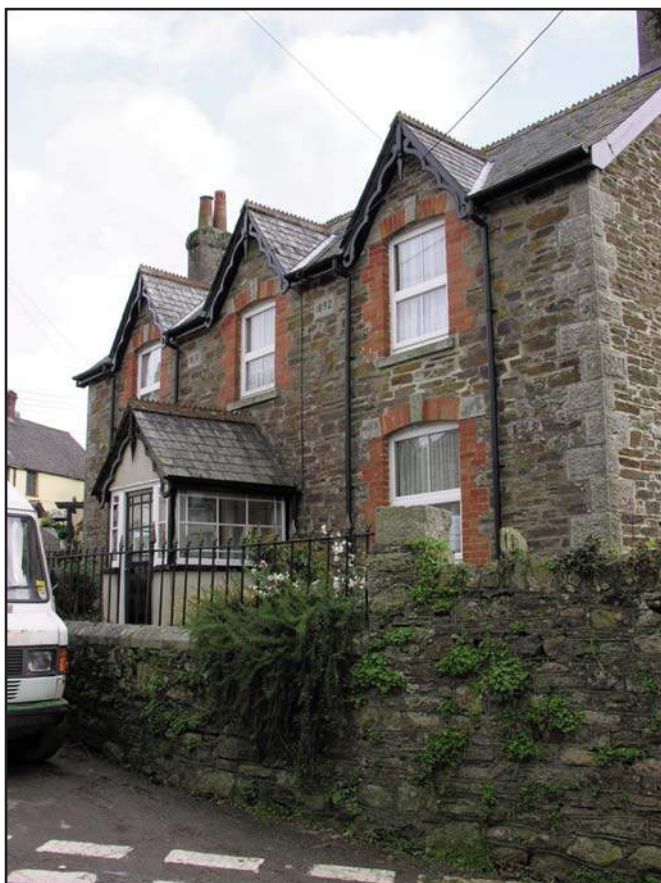
Figure 22 Late Victorian cottage

Cottage opposite Town Farm – Unlisted

This cottage dated 1892, although of a standard design, is well detailed and adds to the sense of place. The old porch is integral to the design – it is a pity the window pattern and material has been lost.

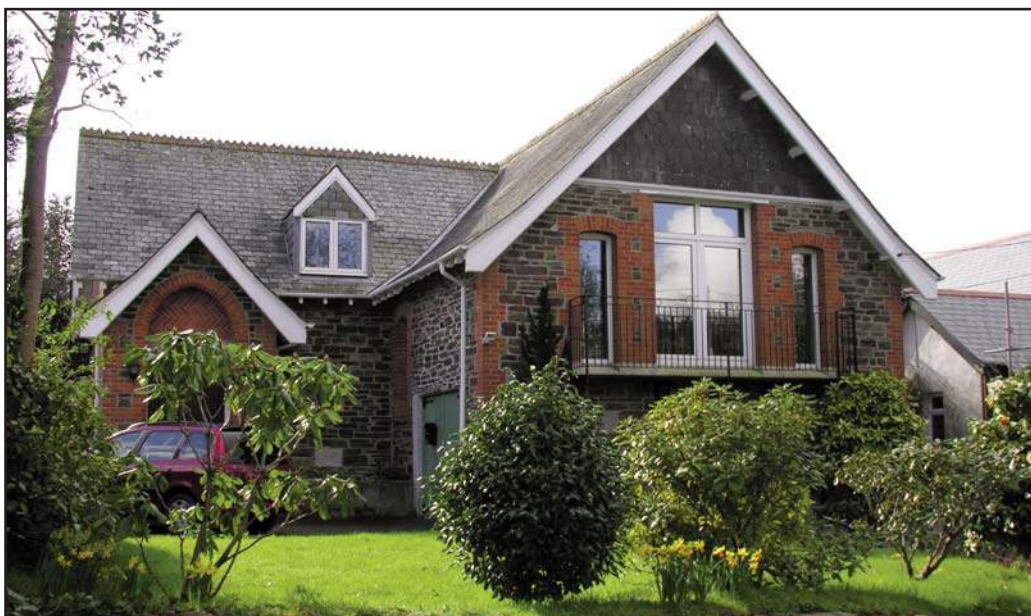
Figure 24 The second Methodist Chapel

The Old Chapel was built as a Methodist chapel in 1902 to replace the earlier, smaller chapel. In 1933 a Sunday School was built in the same style next door. Both buildings closed in 1983 and were converted to private dwellings in 1984.

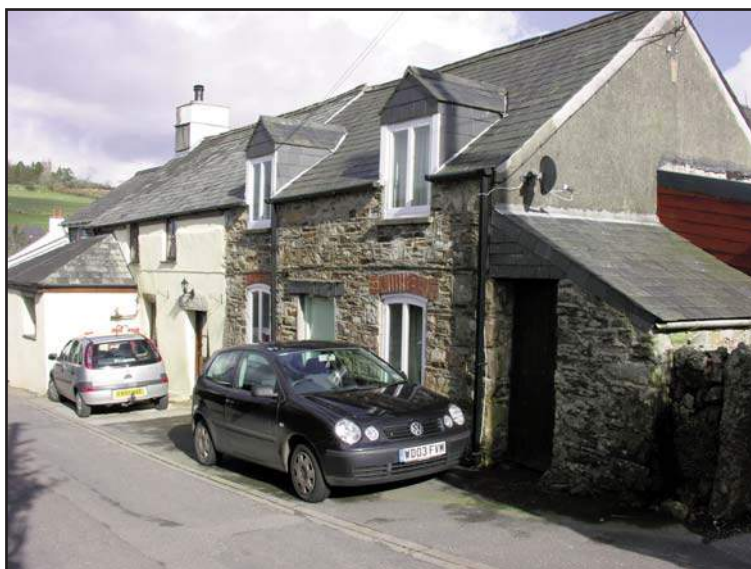
Figure 26 The Lea Cottage group

Lea Cottage and Veale Cottage – Unlisted

The massive chimney with slate drips and the evidently raised eaves are both indications that these cottages are part of a relatively early farmhouse or cottage. It is possible that Applegarth occupies part of the footprint of the original building but it was either re-constructed or heavily modified in the 19th century.

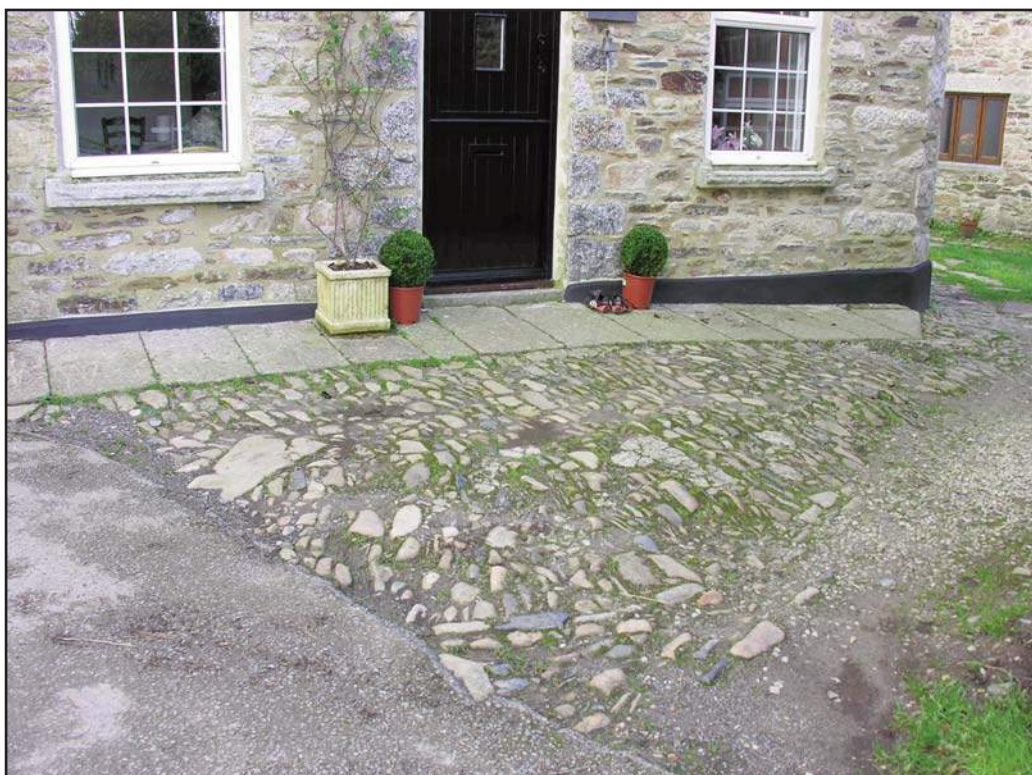
Figure 28 Rough cobbles, granite slabs and hoggin at The Cottage

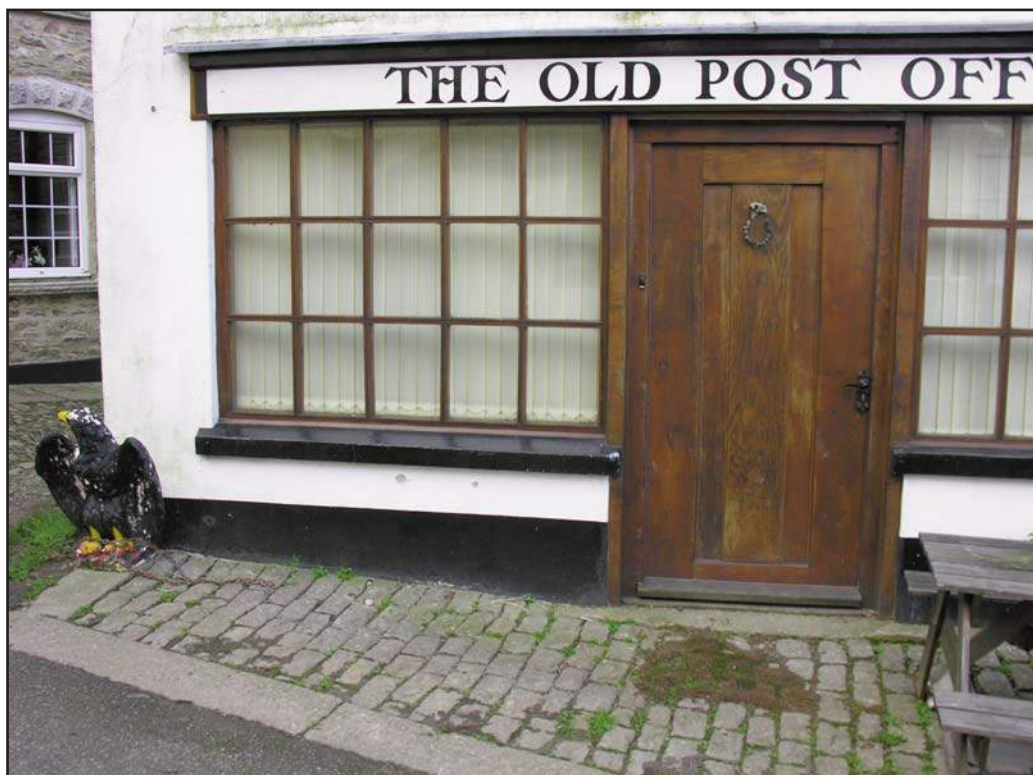
Figure 29 Granite setts at The Old Post Office

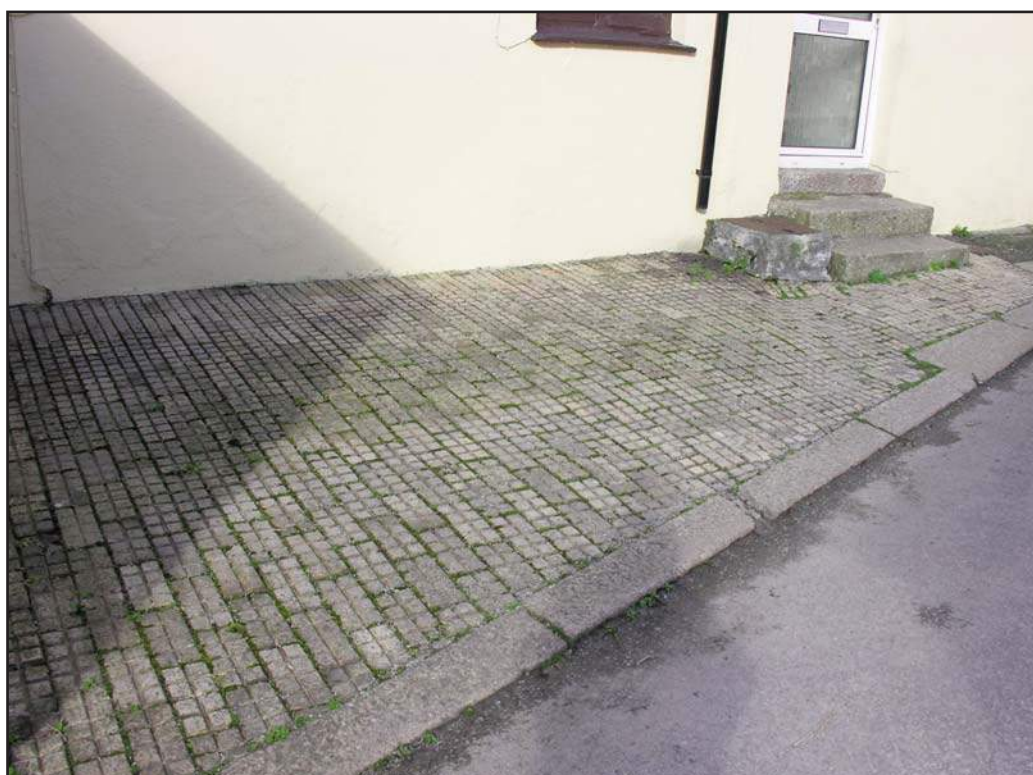
Figure 30 Patterned brick setts at Staddons

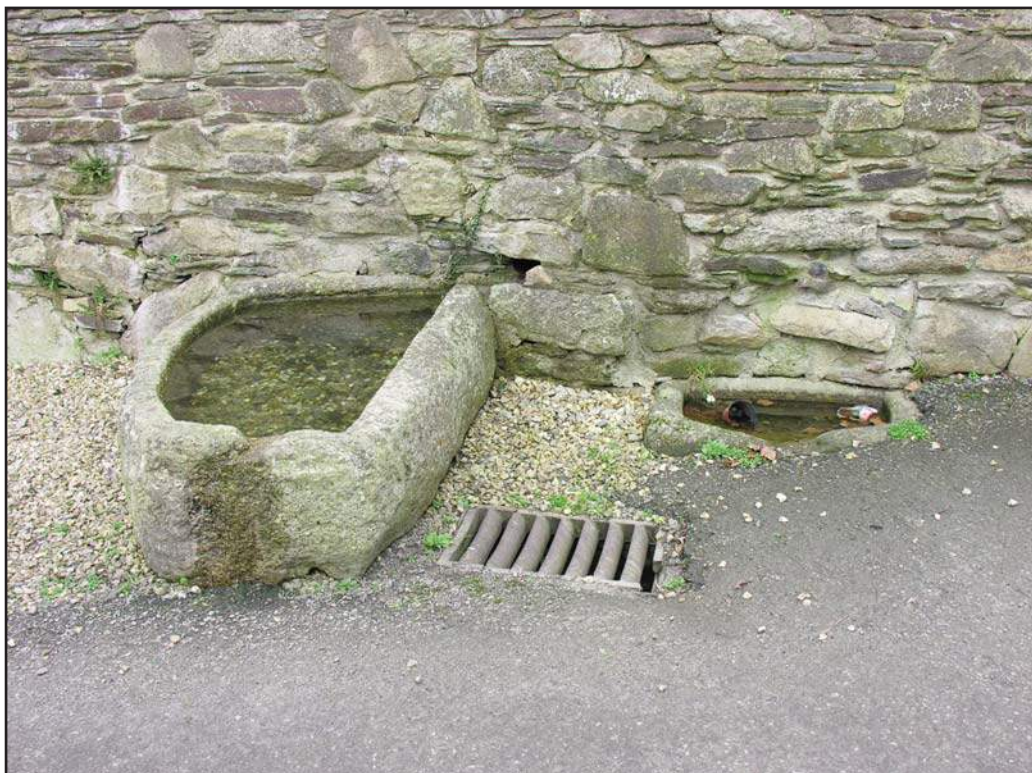
Figure 31 The granite troughs

The pair of granite troughs in front of Town Cottage are a distinctive incidental feature which adds considerably to the character of the space.

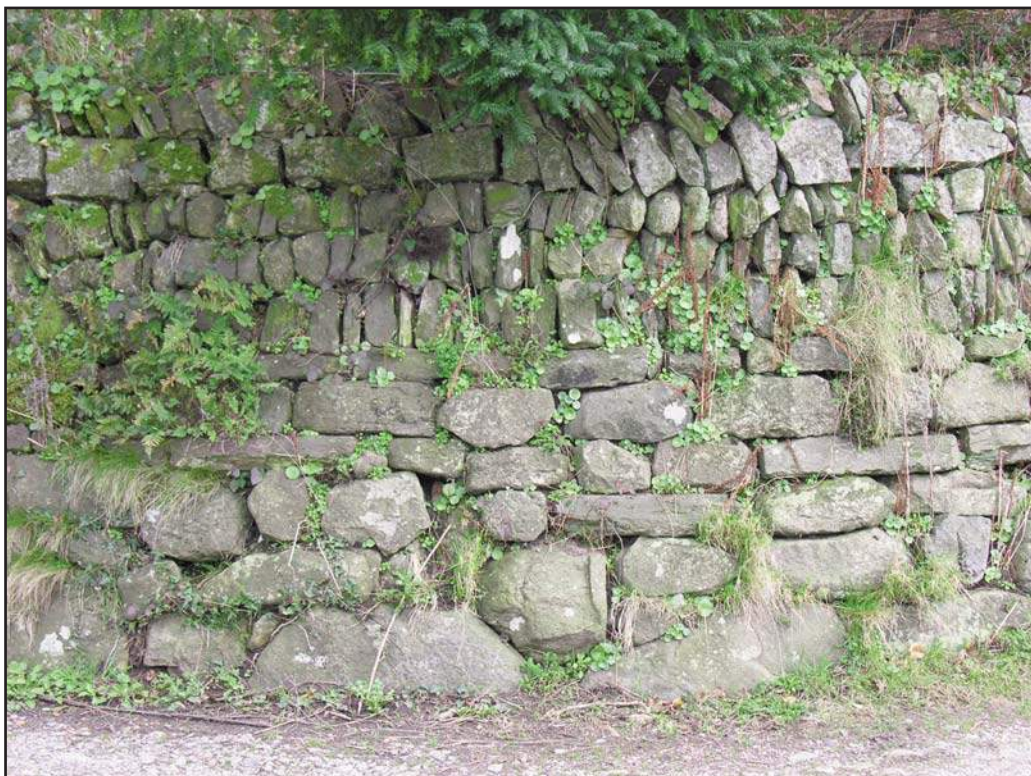
Figure 32 Stone hedge bank

Where the streetscape is not enclosed directly by the buildings themselves, it is bounded mostly by mortared stone walls. Some of these are low walls with iron railings on top and this 19th century trend is now part of the village scene, but not one that ought to be seen as a precedent for future works. Boundaries on the historic fringes of the village tend to have Devon banks, some with carefully laid stonework, and these have become incorporated into the village fabric in places. Some of the stone banks that flow out into the surrounding land may be of great antiquity and add to the landscape setting, especially between the church and the main village.

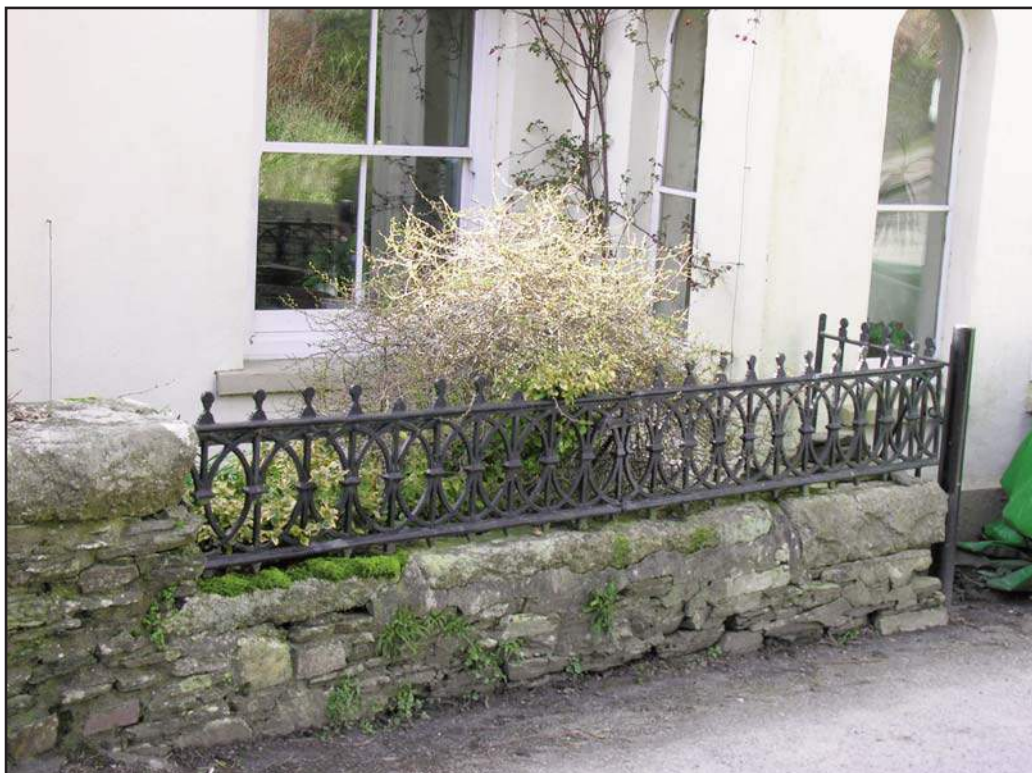
Figure 34 Low wall with cast iron railing
