Walkhampton

Conservation Area Character Appraisal

Dartmoor National Park Authority June 2017

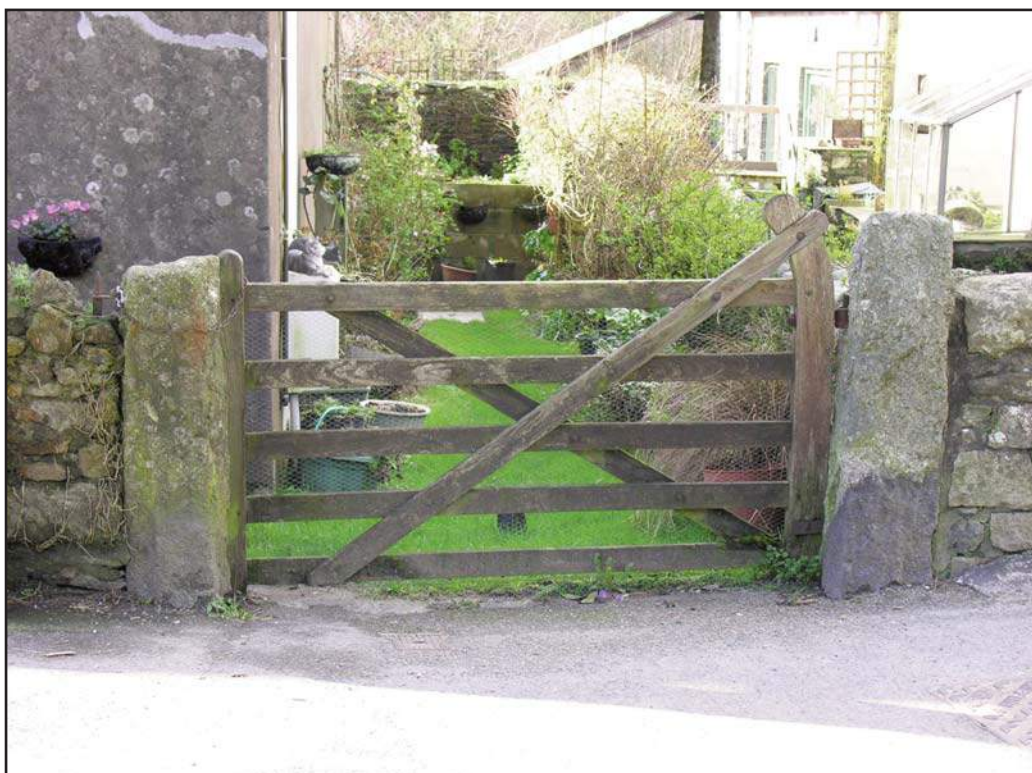
Figure 35 Traditional gateway at Brookside

Entrances are generally simple with many examples of monolithic granite gateposts. Where they remain there are usually simple gates, mostly in timber but with some iron; Brookside has a good example of a narrow cart entrance. The steps, gateway and stile at the entrance to Elbow Lane are attractive, as is the old kissing gate southwest of the churchyard. The Victorian iron fencing and stockproof pedestrian gateway by the Church House, although somewhat battered, still represent a positive feature. Like the granite cross they add to the sense of place here.

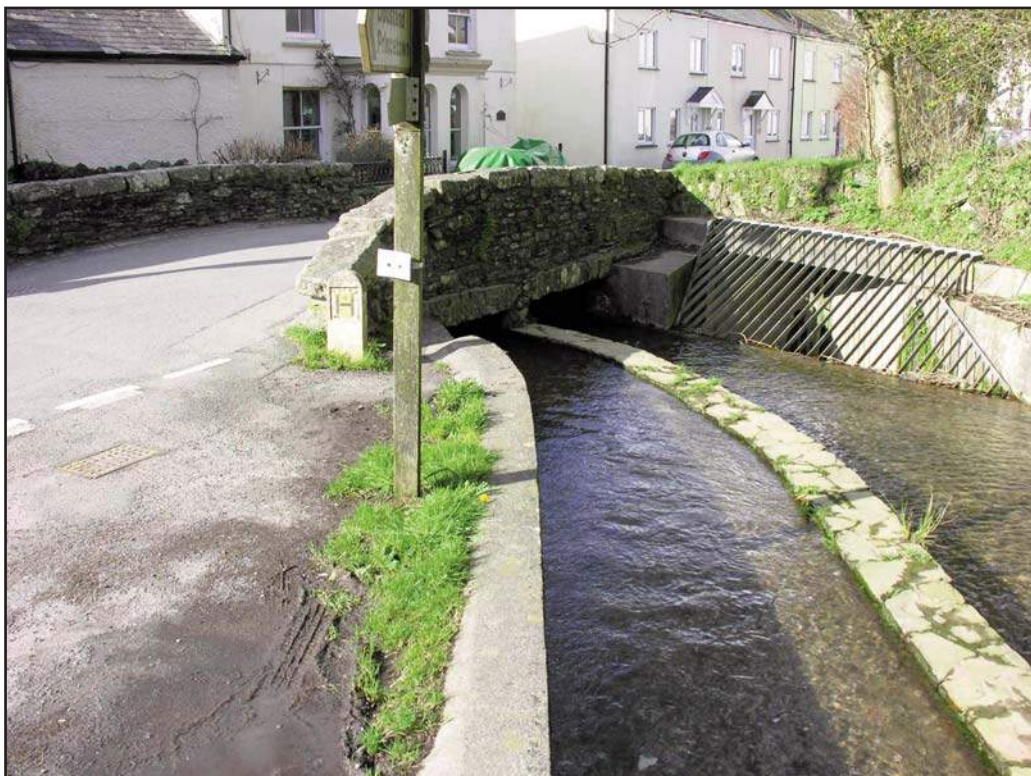
Figure 43 The bridge and leat

The K6 telephone kiosk occupies a prominent focal point by Town Farm and so it is of particular significance. At the other end of the central spine is the war memorial, a stronger and more important focal point. Between the two principal spaces is the bridge of 1842 which is an important historic feature in its own right.

The bridge was built in 1842 to replace an ancient ford.

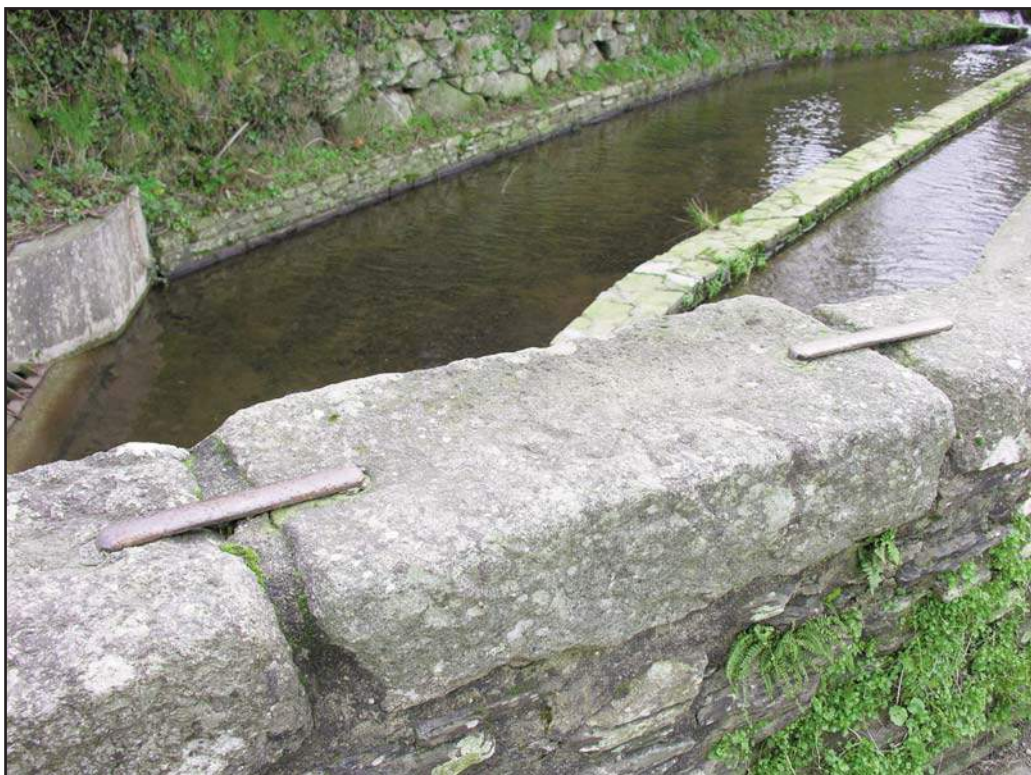
Figure 44 Coping stones to bridge parapet
