Chagford

Conservation Area Character Appraisal

Dartmoor National Park Authority June 2017

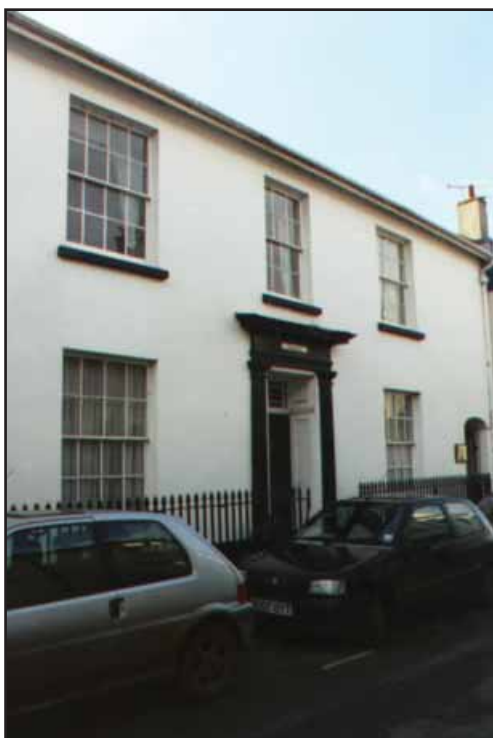
Figure 4 Belmont in Mill Street

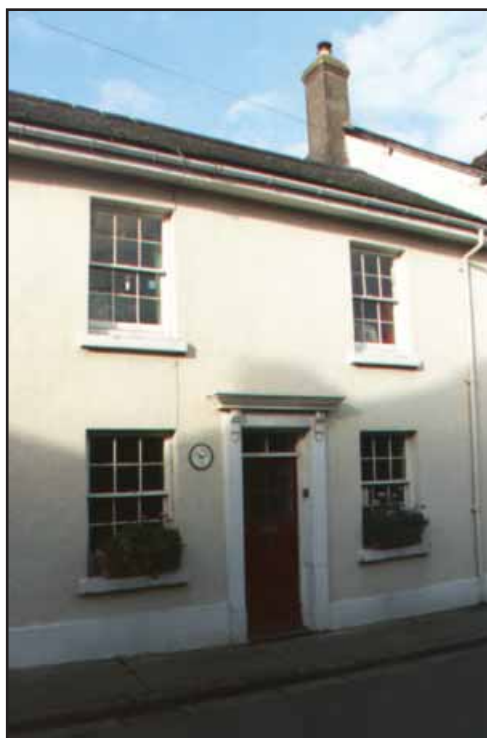
Figure 5 18 Lower Street

The buildings in the majority, however, are the more modest two storey houses and cottages of late 18th and 19th century date, which are especially prevalent in New Street and Lower Street. Most have quite a polite, town-like appearance with formally arranged sashes creating a vertical emphasis [Figure 5]. Not quite so numerous are those with casement windows, which tend to have a more rural, vernacular style. Indeed, being rather more common in Lower Street than elsewhere in the town, they tend to reflect the nature of the Street's origins as a small rural hamlet [Figure 6 below]. The style of the late medieval buildings here is vernacular too, with either casements or mullions the norm, but as if to demonstrate the differing origins of New Street, the late medieval buildings there have mostly had 'town-like' sash windows inserted – matching most of the houses around them. Whether sashes or casements, however, windows in historic buildings, which are still in their original form, are made of timber; painted not stained, and subdivided into smaller panes by slender wooden glazing bars. Single paned windows, and windows with small quarter lights, are 20th century and therefore look incongruous in buildings of 18th or 19th century age. 20th century windows of plastic or aluminium, including those with plastic inserts intended to mimic multi-paned glazing patterns, similarly erode their original character.

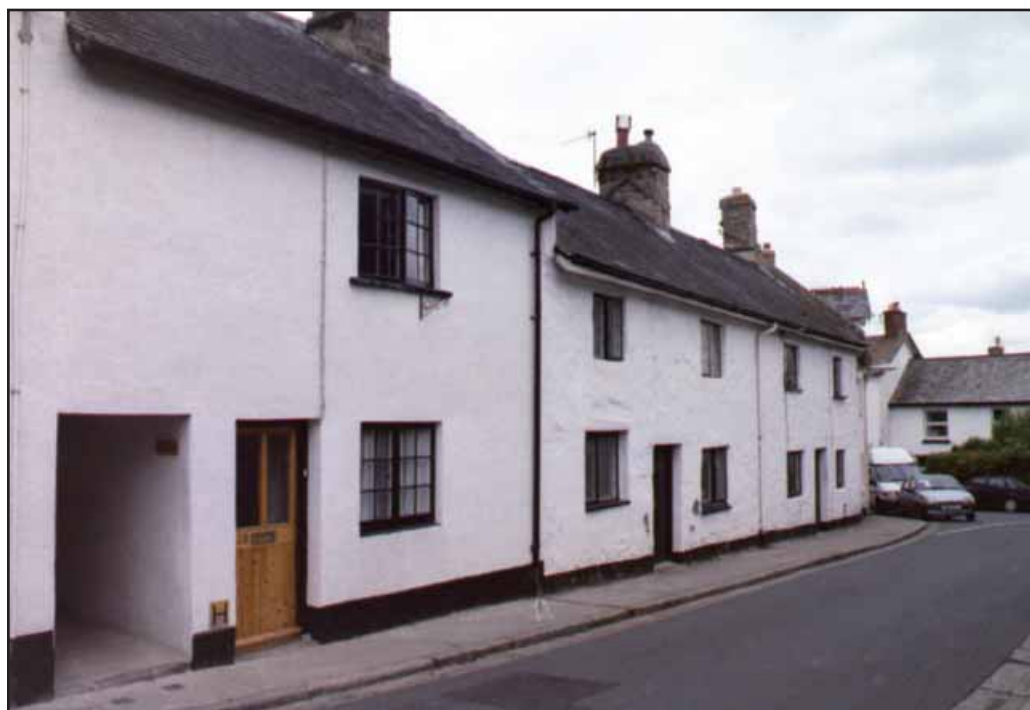
Figure 6 Vernacular styled cottages in Lower Street

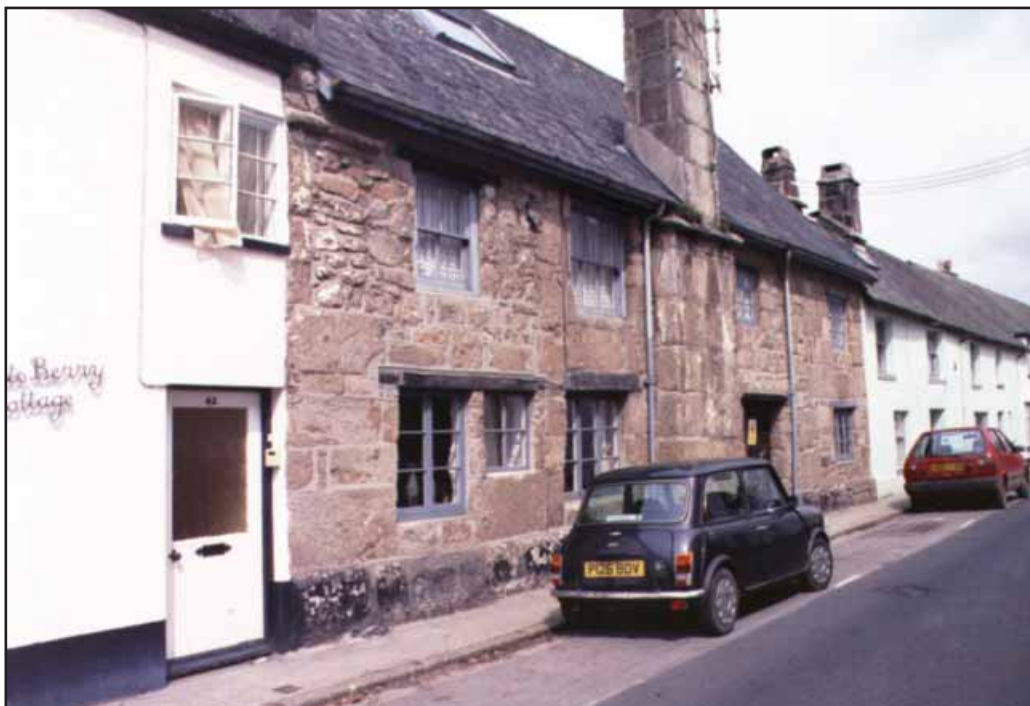
Figure 7 41 New Street

For the most part roofs run parallel with the street, but the topography, the periodic rebuildings, and the piecemeal replacement of thatch with slate, mean roof lines and pitches vary. The many chimneystacks surviving add variety and interest too, and help to identify which roofs were originally thatched. The more recent stacks are usually brick, and the oldest granite with quite massive proportions – the most impressive of all being the lateral stack of 41 New Street, which projects forward of the front elevation and up through the eaves in a manner unusual for this part of Devon [Figure 7].

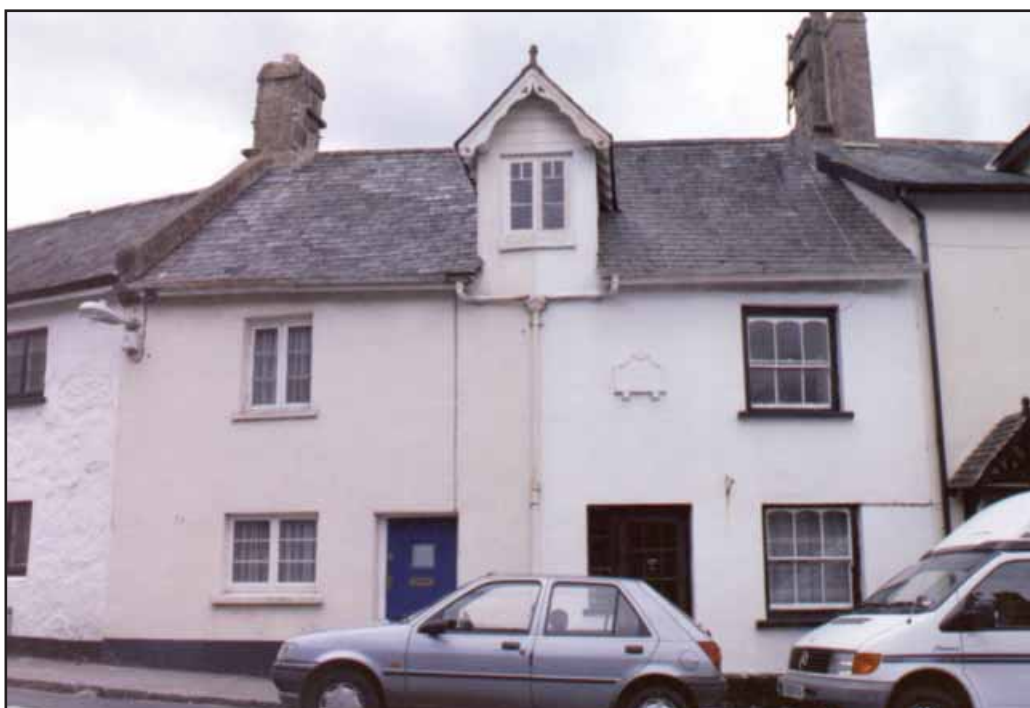
Figure 8 A Cottage pair seem to share a dormer in Lower Street

Adding further skyline interest in a localised way are the numerous dormers introduced around the turn of the 20th century – on existing buildings as well as on new. The more visually prominent are those planted directly onto front elevations rather than in the roof slope [Figure 8 above]. Most are treated in a decorative way, with ornamental strapwork, bargeboards and decorative tiles along the ridge (some with pinnacles on the gables). Main roofs built or renewed around this time have decorative ridge tiles as well, but their numbers are relatively few.

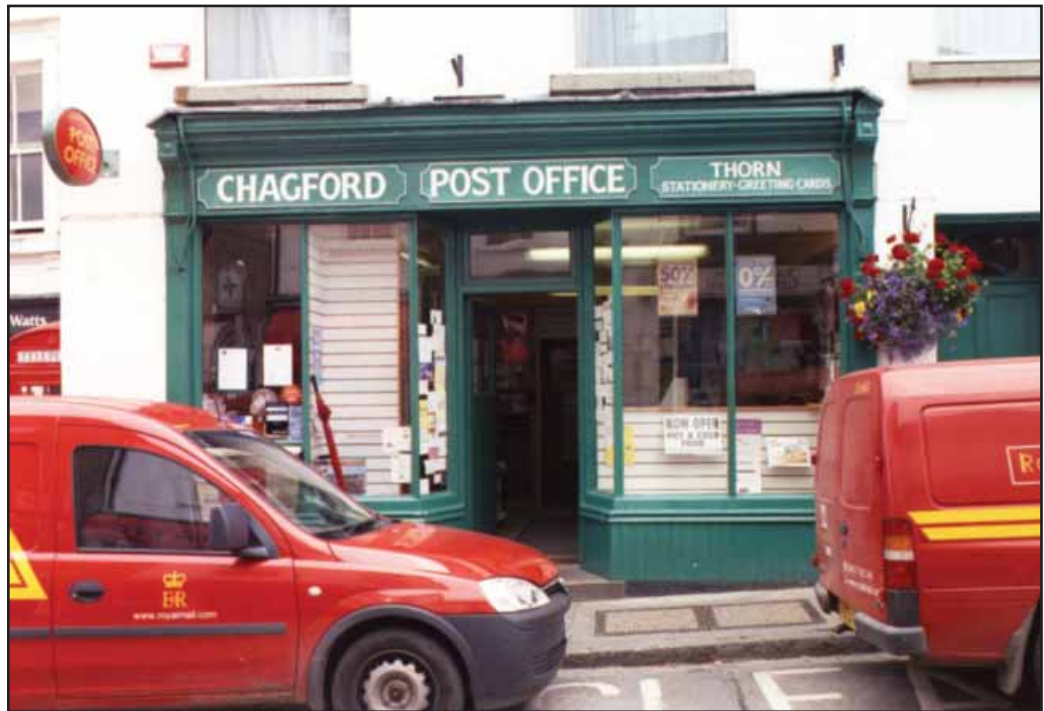
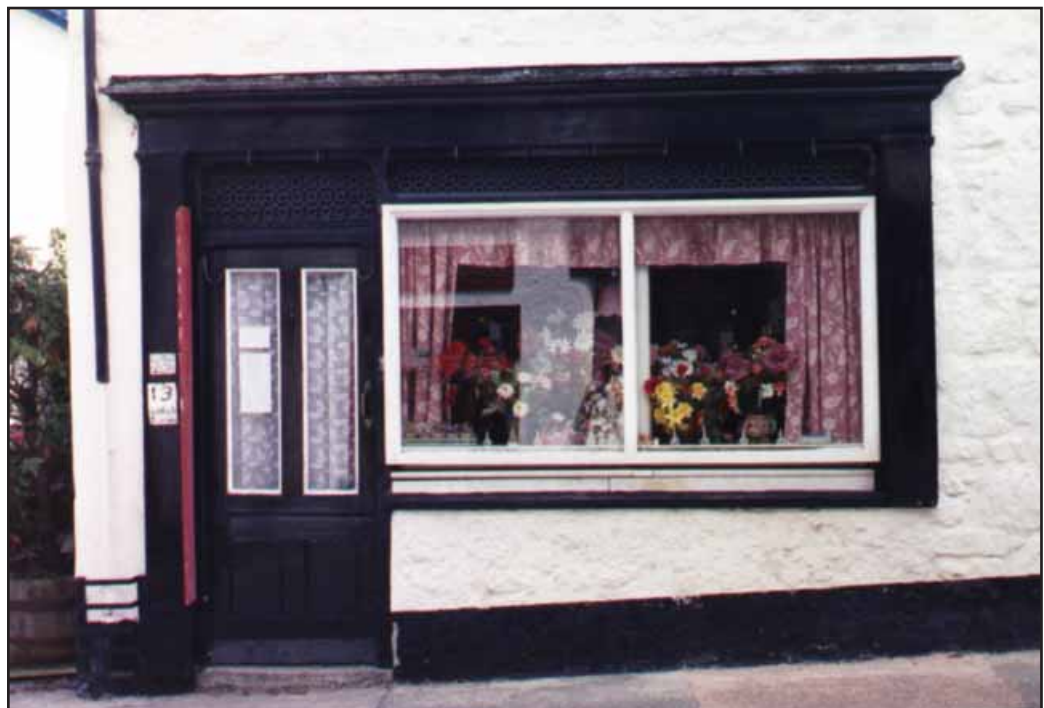
Figure 12 The Shopfront to the former Post Office

Figure 13 Shopfront in North Street

There are some good shopfronts in Chagford of 19th and early 20th century date that are purposefully designed in a traditional, classical style with pilasters and mullions that support a fascia with cornice above to create a characteristic vertical emphasis. Those whose appearance has not been compromised by 20th century changes (such as the addition of non-traditional Dutch blinds) contribute a great deal towards the historic and architectural character of the centre [Figures 12 and 13].

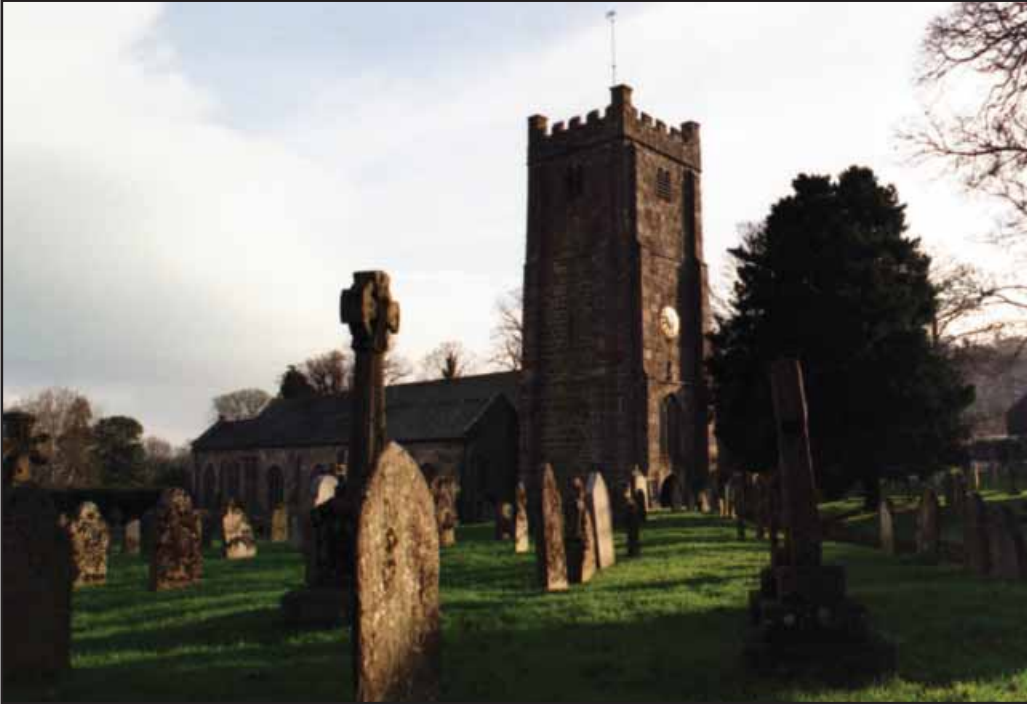
Figure 14 Church of St Michael

Church of St Michael: grade I

The original, 15th century, Perpendicular style of the Church survived the late 19th and early 20th century restorations, albeit with the loss of the four pinnacles that formerly adorned the tower. While not dominant in the townscape, the Church is nevertheless the focal building of High Street where the dominance of granite ashlar walling and the mix of Church Gothic and domestic Tudor styling creates a most homogenous composition.

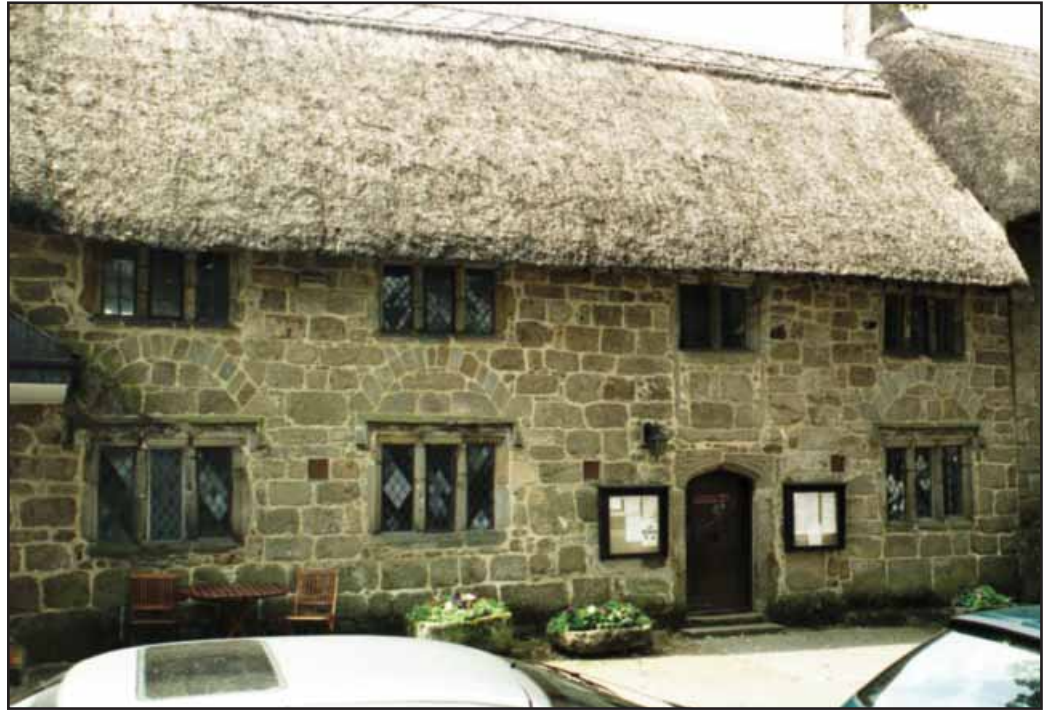
Figure 15 Endacott House in High Street

In the immediate setting of the Church, this late 16th century pair is of very considerable value to the centre of Chagford, both in terms of their historical significance and their architectural quality. Their granite ashlar walls, stone mullioned windows and thatched roofs are exceptionally attractive and contrast with the materials and architecture prevalent elsewhere.

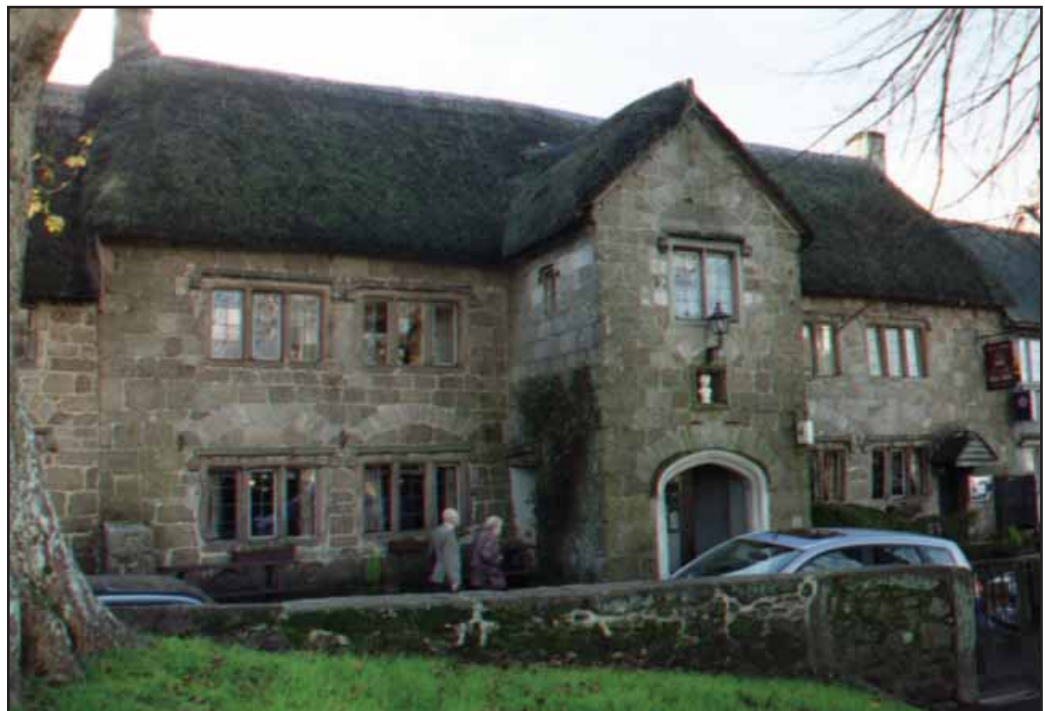
Figure 16 The Three Crowns in High Street

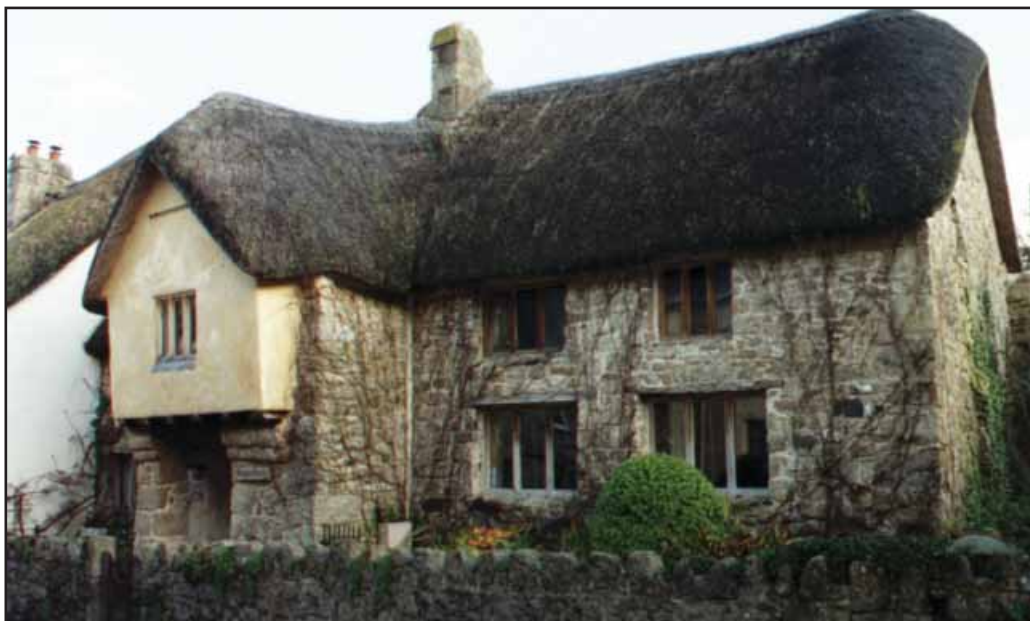
Figure 17 *The Bishop's House, Lower Street*

The Bishop's House, Lower Street: grade II

With its thatched roof, mullioned windows and added two-storey porch, this is the most striking and best-preserved example of the earliest houses surviving in the town dating from the early 16th century (the others at 8 Lower Street and 31, 41, 47 and 49 New Street are key buildings in themselves, although all are now slated, have later windows inserted, while none had the space for the addition of a porch). Their similar plan forms, and the long and low proportions they create, impart an essentially rural character to the areas they occupy.

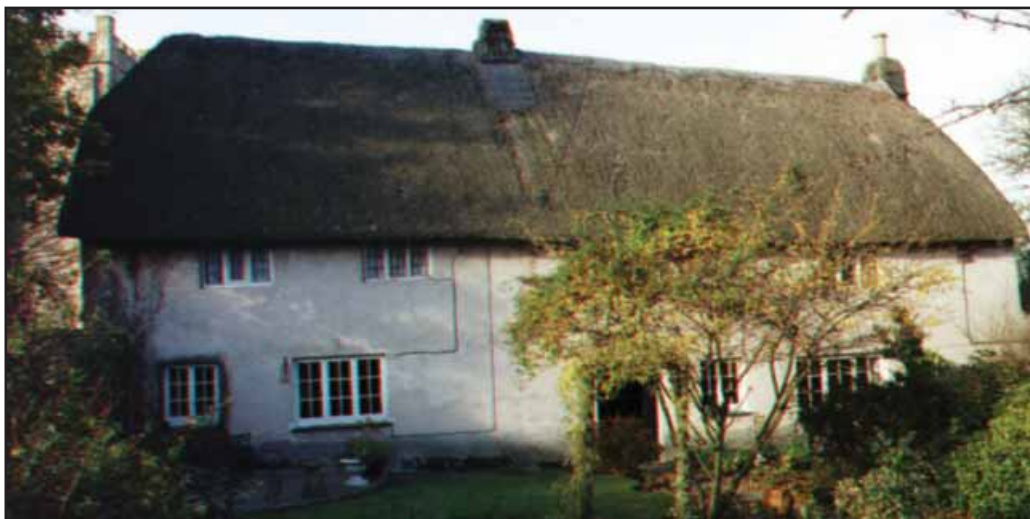
Figure 18 *1 and 2 Bellacouch Cottages: grade II*

1 and 2 Bellacouch Cottages: grade II

Originally a single house when built in the late 16th century, its thatched roof, modest windows and long and low proportions help create a rural-looking scene adjacent to the churchyard entrance. While the ground floor windows are multi-paned, 19th century casements, those at first floor are much smaller, oak-framed mullions of 17th century date with

original iron casements and leaded panes. These add much to the building's architectural and historic character, and gain in prominence by being visible over the attractive granite wall that encloses the front garden.

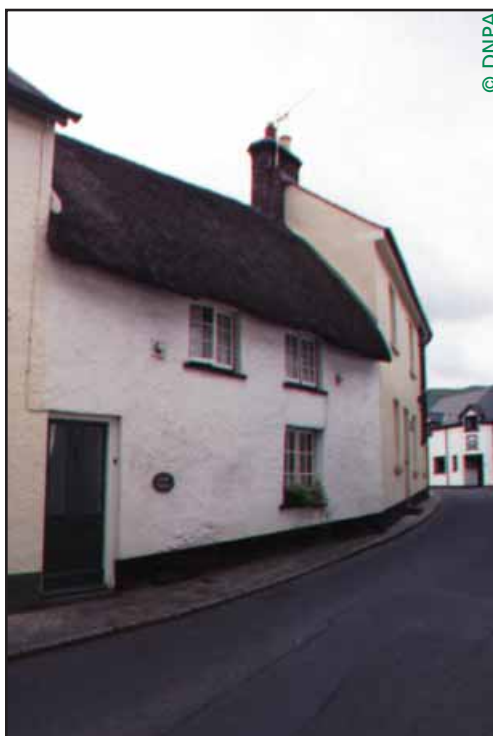
Figure 19 6 New Street

6 New Street: grade II

Small vernacular-style cottages of c1800 or earlier date, which preserve their original thatched roofs and flush-framed, multi-paned casements, are now rare indeed. They include 7+9 and 10+12 Lower Street, 10 + Chapel Cottage Mill Street and Cobwebs off The Square, while the earliest is this one at 6 New Street – being 17th century or earlier. Its roughcast render contributes towards its overall rural appearance.

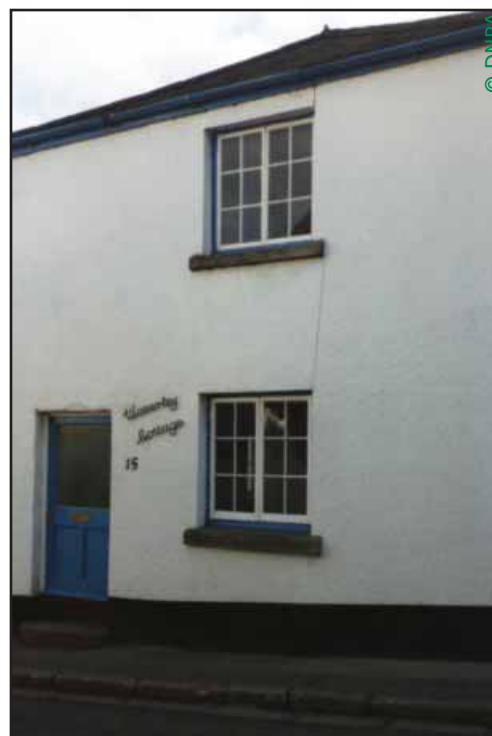
Figure 20 15 The Square (on the part also called North Street)

15 The Square

This small house is typical of many built in the 19th century with slate roofs, multi-paned casements and textured rendered walls, reflecting earlier vernacular styles and creating a rather more rural than urban appearance for example 6 New Street built two centuries earlier. While not listed, its inclusion here reflects the significance of the type, which is particularly prevalent in Lower Street.

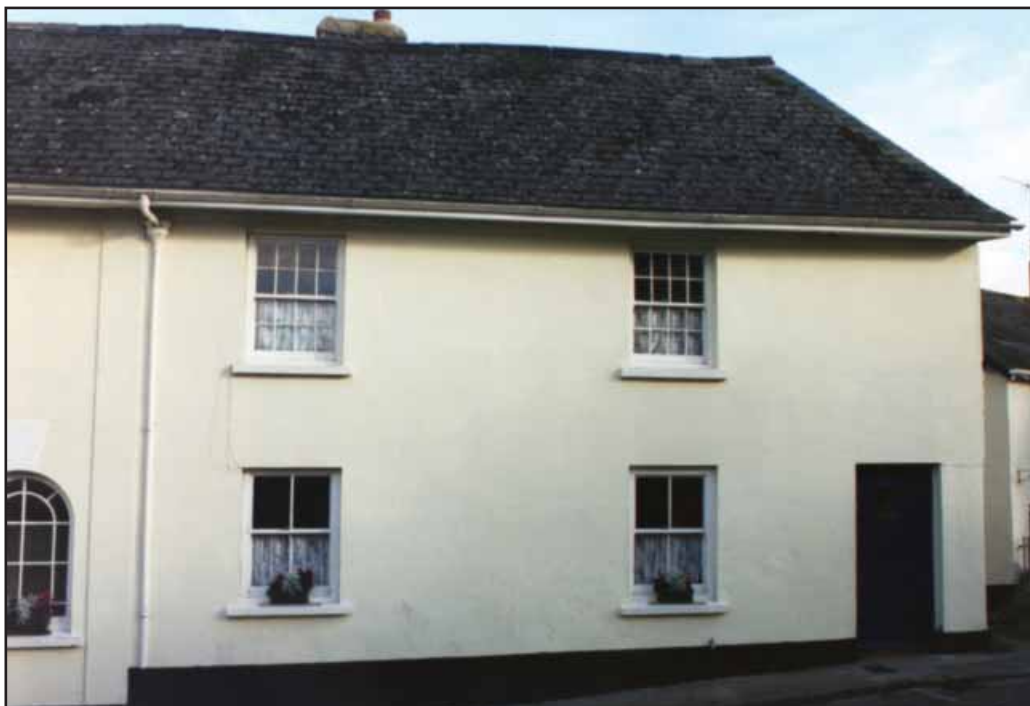
Figure 21 7 Southcombe Street

7 Southcombe Street: grade II

The appearance of this small house is typical of most built in the 19th century with slate roofs, vertical-sliding sashes of various multi-paned patterns, and smooth rendered walls – all creating a more town-like character compared with those of the type exemplified above by 15 The Square. Adding to this, but now only just visible, is the ashlar lining applied to the render to give it the appearance of finely jointed stone.

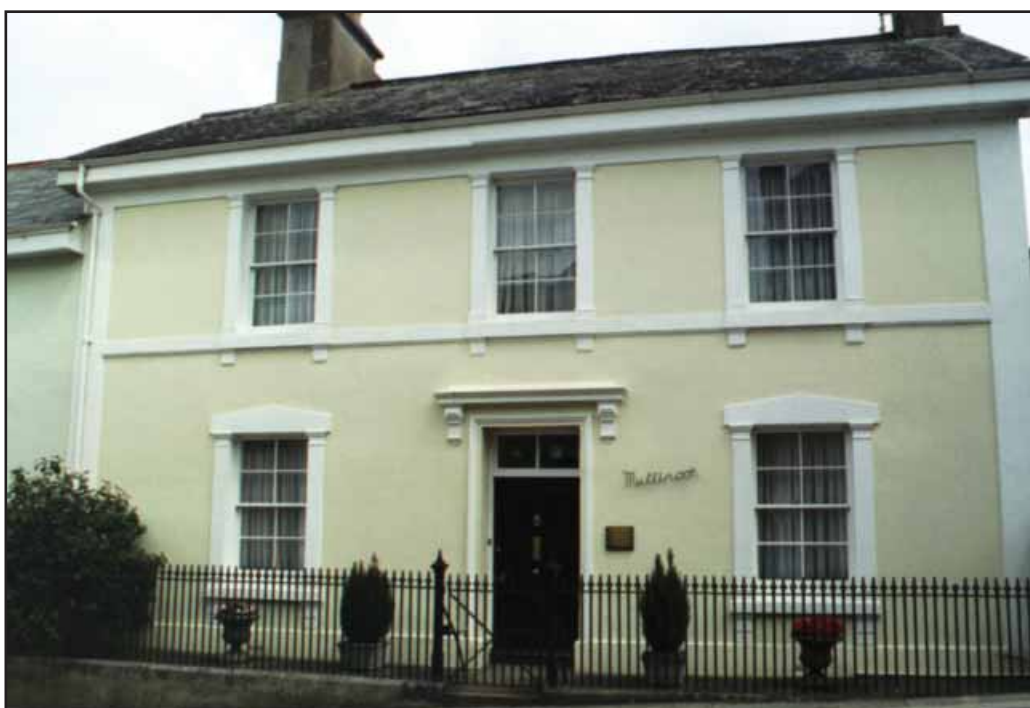
Figure 22 Millbrook, Mill Street

Millbrook: grade II

This more substantial two-storey house is one of several built (mainly in Mill Street) in the 19th century with polite, classical styling typical of the period. It is more elaborately decorated than most, but like the others is characterised by its slated roof, smooth rendered walls and vertical-sliding, multi-paned sashes. Common to most, and adding dignity to the street scene, are the forecourt areas at the front that are protected by cast-iron railings and gates.

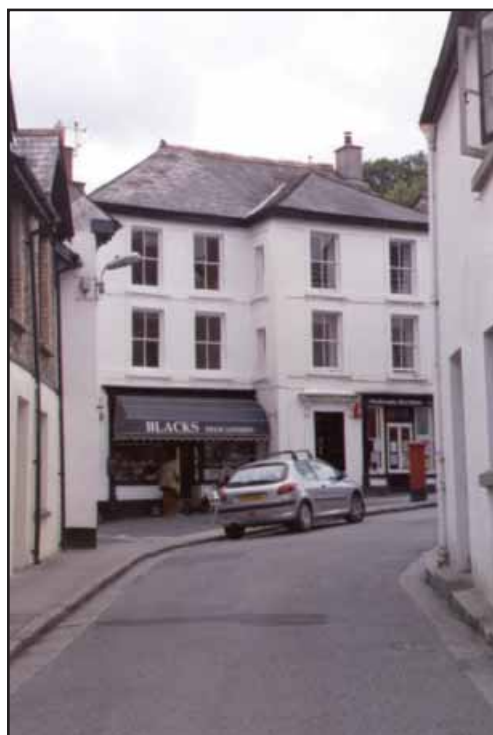
Figure 23 28 and 30 The Square

28 and 30 The Square

This pair comprises one of the even more substantial three-storey houses built in the town in the 19th century. Although few in number, they tend to be sited, as here, in locations that emphasise their presence and increase their impact. Its decorative features and characteristics are not unlike those of Millbrook above, although being painted in a single colour it appears somewhat less elaborate.

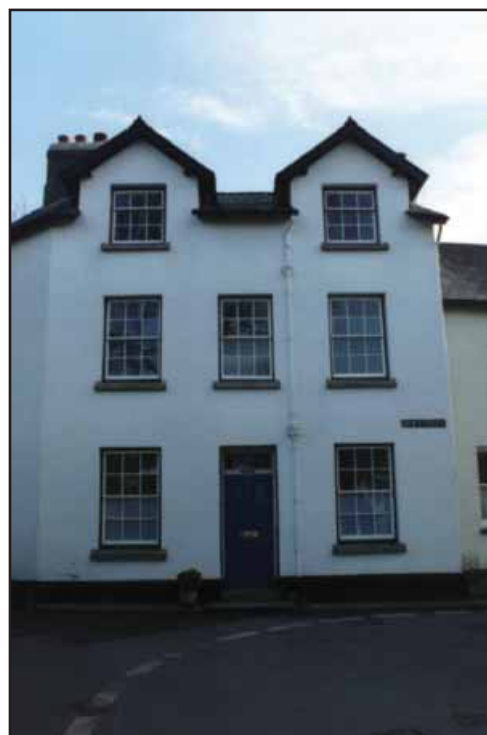
Figure 24 Ceylon House, New Street

Ceylon House, New Street: grade II

Similarly occupying a prominent location that closes the view along High Street, this 19th century house is not a full three-storeys in height, but nevertheless achieves a similar stature through the addition of half dormers rising flush off the front elevation. Indeed, because this arrangement characterises a significant number of similarly aged buildings in the town, the appearance created is locally distinctive.

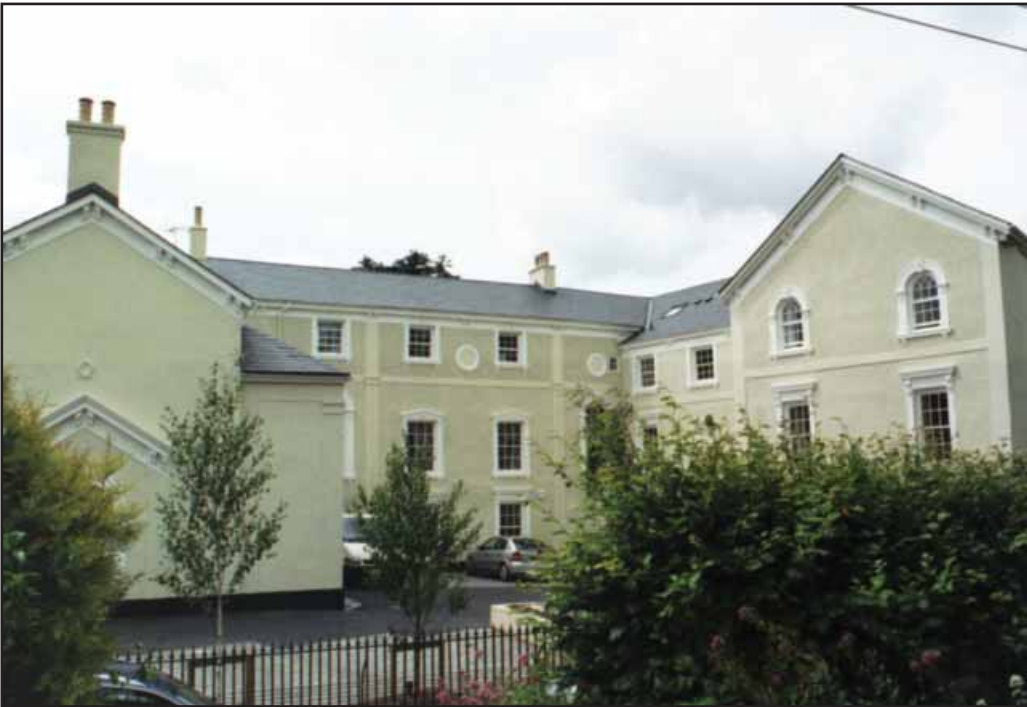
Figure 25 Moorlands, Mill Street

Moorlands, Mill Street

Although ranging from two-storeys to three, and having an unusual F-shaped plan, the appearance of this building defies its origins as a cloth-making mill. Converted to an hotel in 1848, it is something of a landmark in the town, although the exuberance of its Italianate style reflects more the cosmopolitan nature of its new use than the architectural traditions of a small country town.

few have windows dressed with stuccoed architraves, their polite, classical styling is generally restrained. Millbrook's elevation is perhaps the most elaborate of all, with its added pilasters and string bands [Figure 22] although none come close to matching the rather exuberant ornamentation applied to Moorlands when it was converted from factory to hotel [Figure 25].

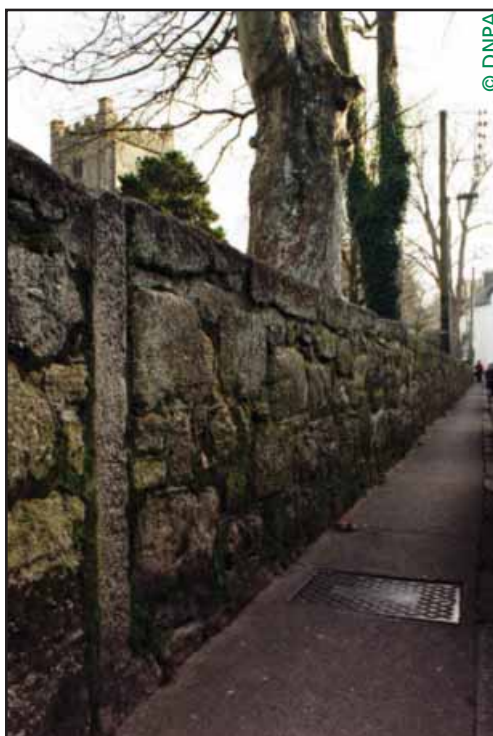
Figure 26 The churchyard wall

Although the majority of buildings in Chagford are on the back of the pavement and have no front garden areas to protect, granite boundary walls are nevertheless significant in many streets where they enclose and define the public space. In the centre, the roadside wall retaining the churchyard in High Street is perhaps the most significant [Figure 26 below], linking with the garden walls of Bellacouch and the former Rectory grounds close by. Outside the centre the most noteworthy walling is that which characterises the 19th and early 20th century development in Mill Street, westwards from beside its junction with Manor Road. Similarly distant from the centre, some good stone walling still survives bounding the field on the west side of New Street at its south end [Figure 43], and indeed around some of the adjacent fields.

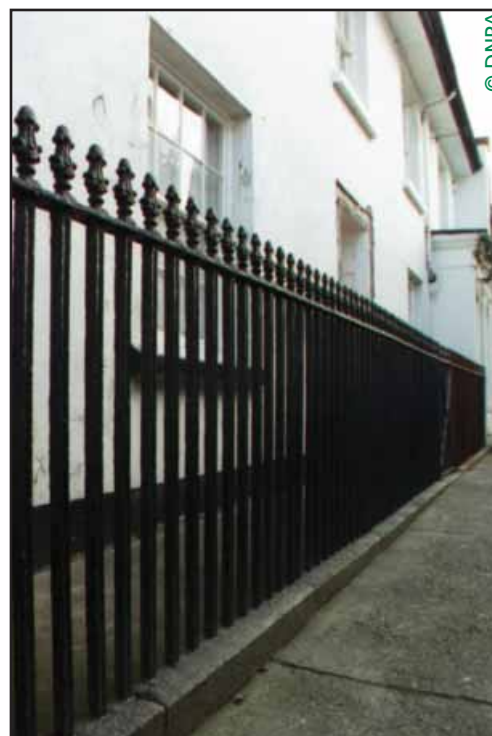
Figure 27 Railings in front of Dolphin House in Mill Street

More common, however, in the built-up area of the town, are cast-iron railings and gates, which tend to add a dignified air to the character of the buildings behind them. Mostly 19th century, they are particularly prominent in Mill Street in association with Moorlands and the more substantial houses located there [Figure 27 above]. Other significant lengths are in front of Lydstone on The Square and the Globe Inn on High Street, while the most ornamental is in New Street, in front of No. 24, the Old Schoolmaster's House [Figure 28].

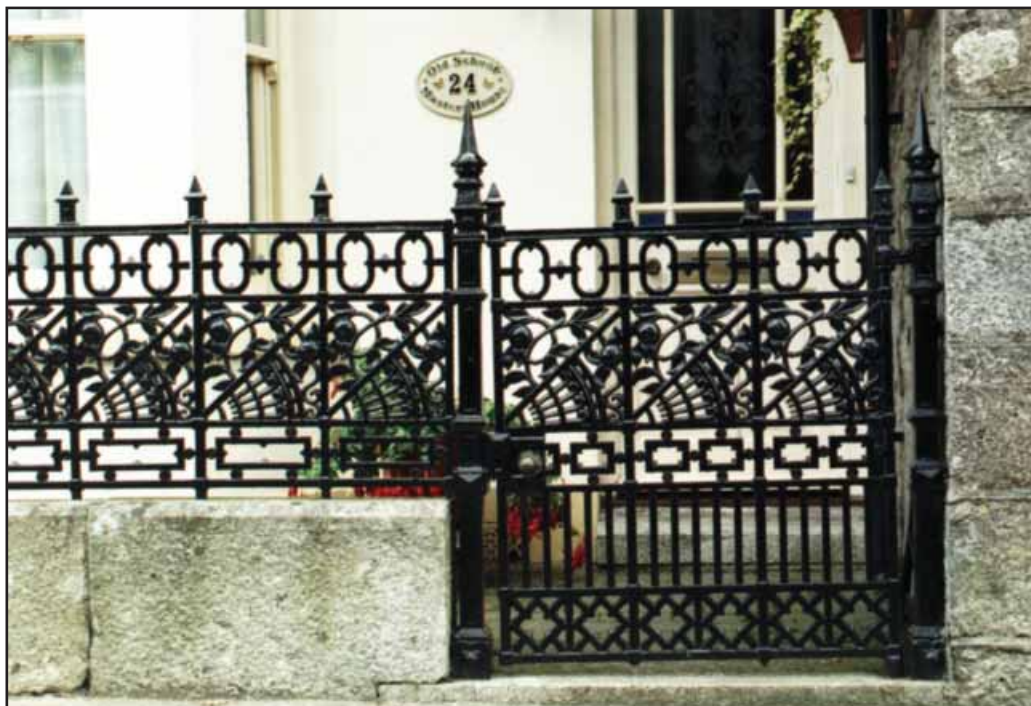
Figure 28 Gate and railings of the Old Schoolmaster's House, New Street

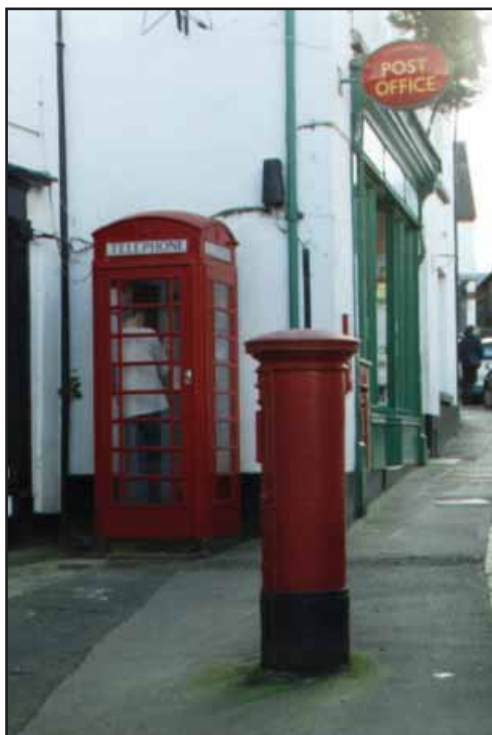
Figure 29 The K6 telephone kiosk and letter box

Other iron artefacts that add historical and visual interest are the K6 telephone kiosk and free-standing letterbox beside the former Post Office [Figure 29]. The old-style lamp standards set in the pedestrian refuge in The Square are new, however, and quite unlike the original, 1891, example that once stood here.

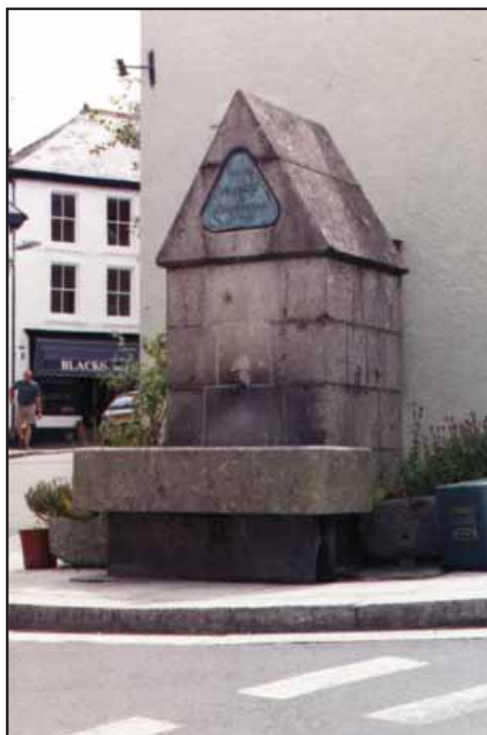
Figure 30 The Jubilee Pump

Granite structures adding interest and character are several, including the Jubilee Pump with its trough (dated 1889) at the north end of The Square [Figure 30 above]. Remnants of the older system of leats which served the town survive too, with some raised channelling near Brook House in New Street [Figure 31] and some that is sunken opposite the former School, where granite pieces have been grooved to take sluice boards to direct and control the flow [Figure 32].

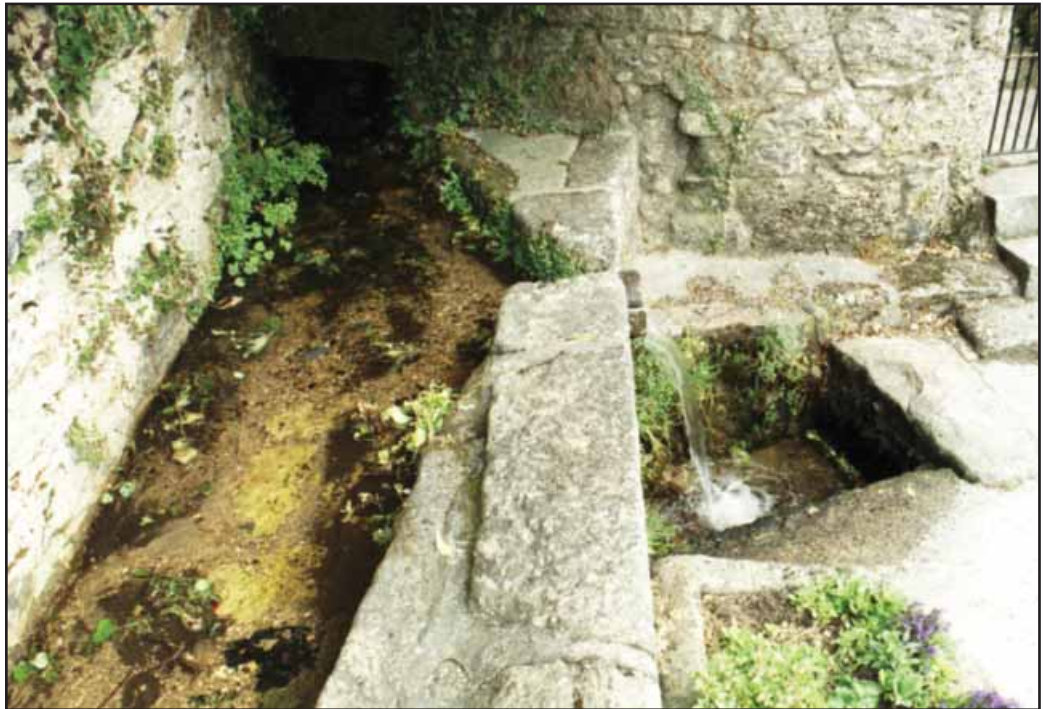
Figure 31 The leat near Brook House, New Street

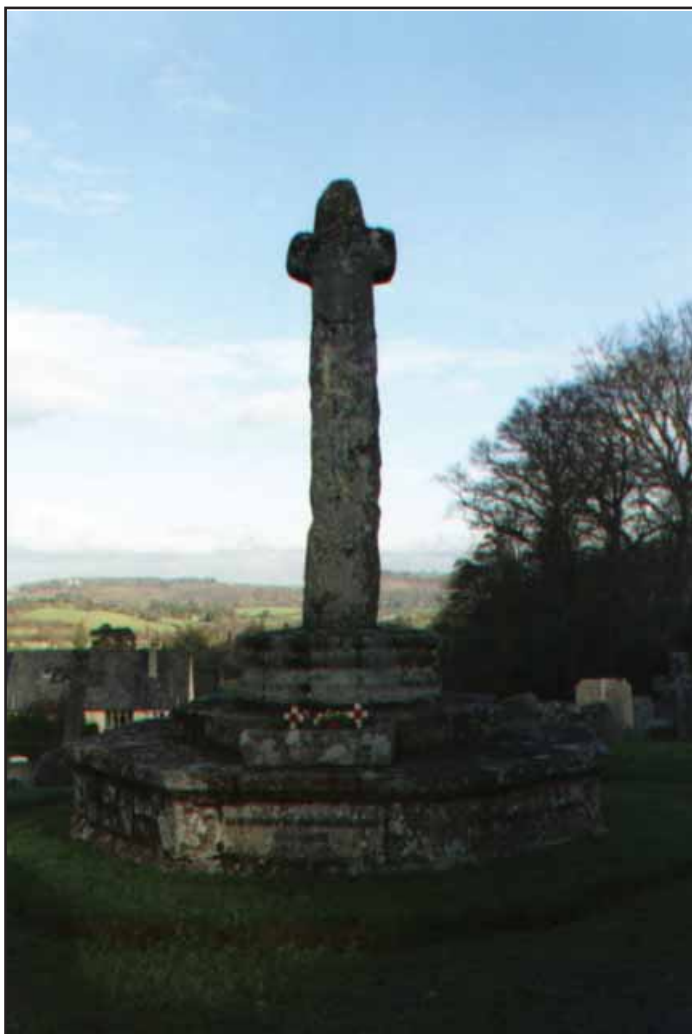
Figure 33 *The War Memorial*

Other granite structures are mainly in the churchyard, including the War Memorial erected in 1928, which incorporates fragments of medieval crosses [Figure 33]. This stands in the centre of the 1920 extension to the churchyard, while within the original enclosure several chest tombs are a source of architectural as well as historical interest. The oldest, in fact, dates from the 16th or early 17th century [Figure 34].

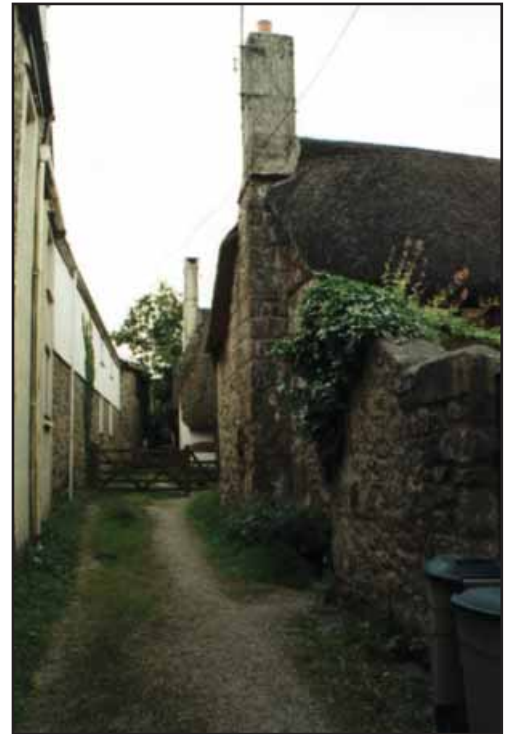
Figure 36 The lane off Mill Street serving No.10 and Chapel Cottage

The Lychgate at the entrance to the churchyard off The Square is a most attractive granite structure, with unusual ironwork gates and granite steps leading up to a cobbled apron. The concrete roof tiles appear most inappropriate, however, in the foreground of the 15th century church tower [Figure 35 above]. Although kerbstones and gulleys are mostly granite, historic paving surfaces are otherwise rare, with in situ concrete and tarmac the norm – except for some of the narrow lanes leading off the main streets, whose treatment with compacted gravel appears in keeping with their informal ‘subordinate’ character [Figure 36 above].

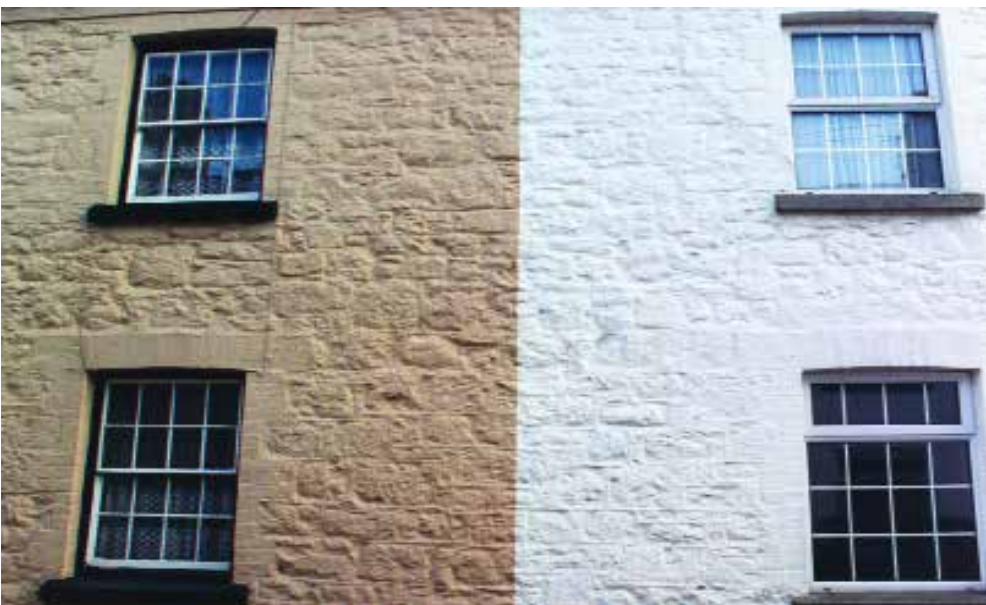
Figure 46 Traditional (left) and modern (right) windows

Equally unfortunate are the modern developments that have eroded the distinctive qualities and characteristics of the historic buildings themselves, which are fundamental to Chagford's attraction. The loss of original windows and doors is particularly harmful, especially so when replaced in designs and materials which are unsympathetic. Those made of uPVC or aluminium, which have fake glazing bars and open in a non-traditional way (below in Figure 46, compared with originals on left), are perhaps the most inappropriate since they appear incompatible with the historic nature of both building and setting and the natural materials that otherwise prevail. The insertion of large, modern rooflights on prominent roof slopes has a harmful impact as well, while in the commercial heart of the town, the impact of just a few modern shopfronts, in non-traditional designs and materials, has adversely affected the historic qualities of what is the town's most significant space.
