# 5.0 SITE ANALYSIS, CONSTRAINTS AND OPPORTUNITIES

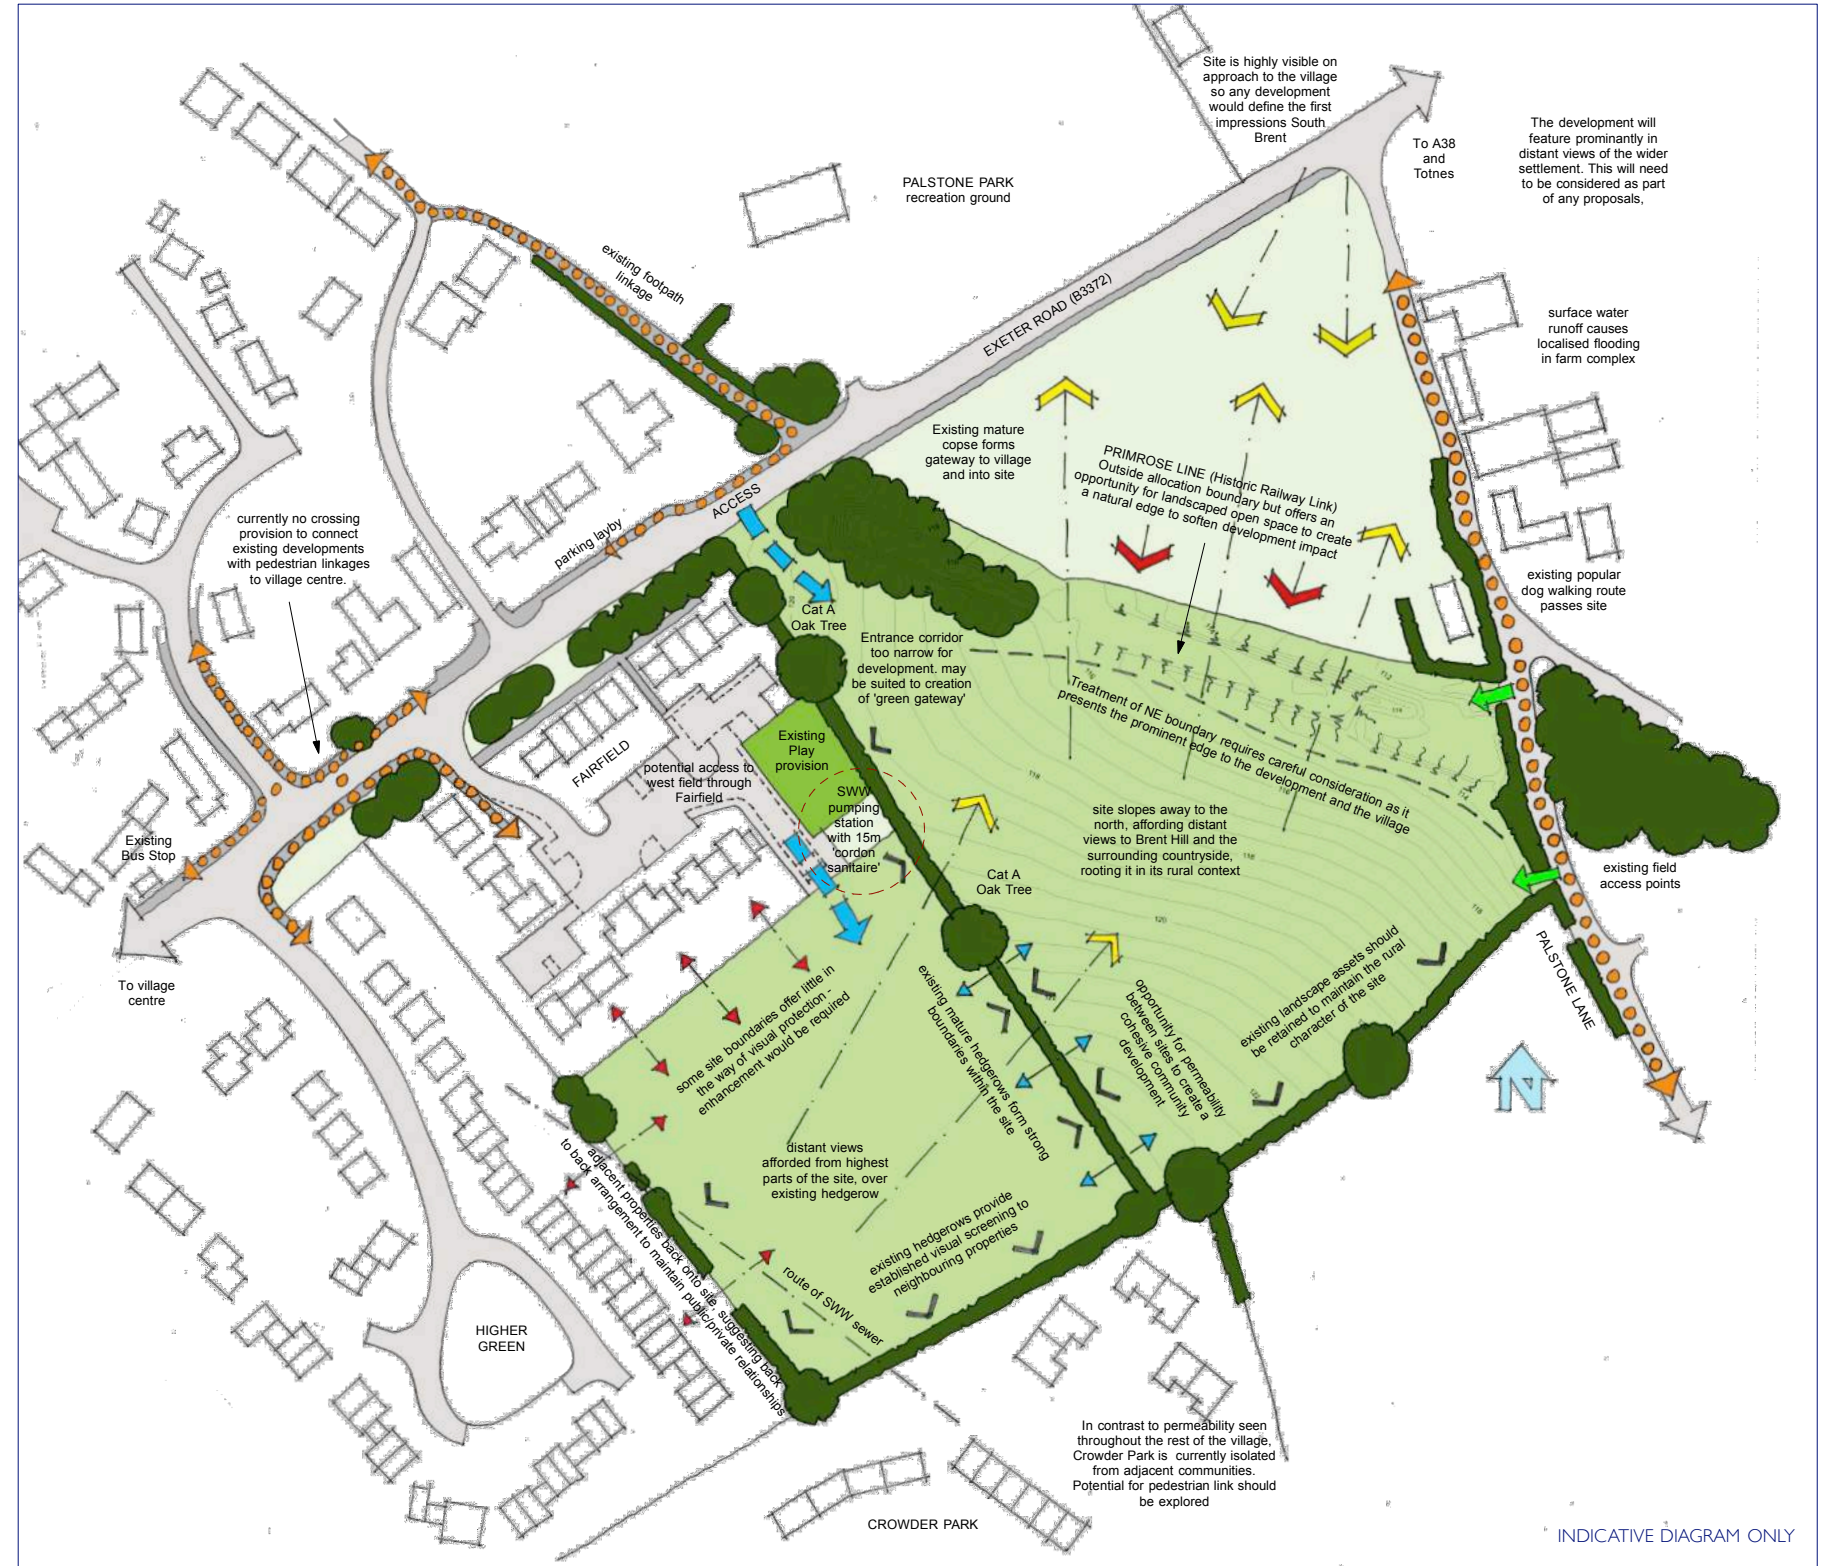
Fig 04. Site Constraints and Opportunities Diagram

INDICATIVE DIAGRAM ONLY
