Sticklepath

Conservation Area Character Appraisal

Dartmoor National Park Authority June 2017

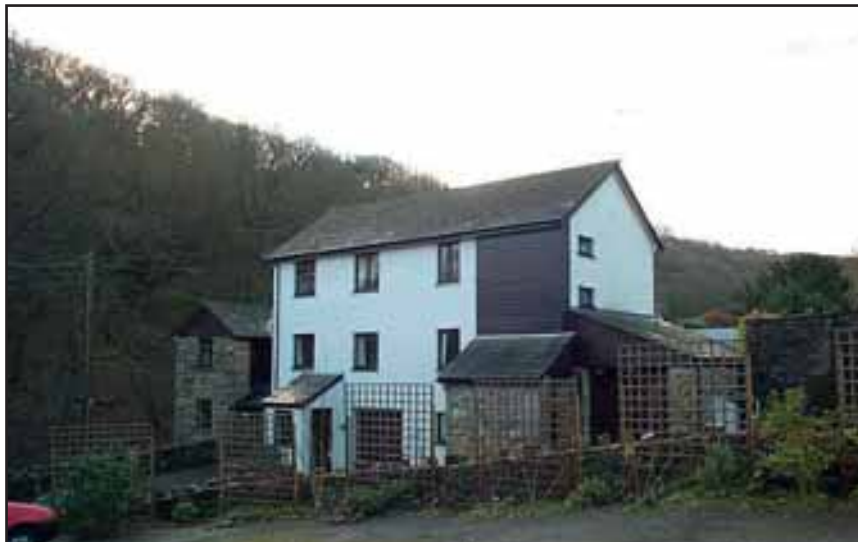
Fig 1 Cleave Mill – now converted to a modern dwelling.

Almost certainly on an early mill site, in 1795 it is described as Wilmott's or Curzon's Mill and in 1803 the mill burnt down. In 1810 it was bought by the Pearse family who established a successful woollen mill. Following its sale in the mid 19th century it became a grist mill.

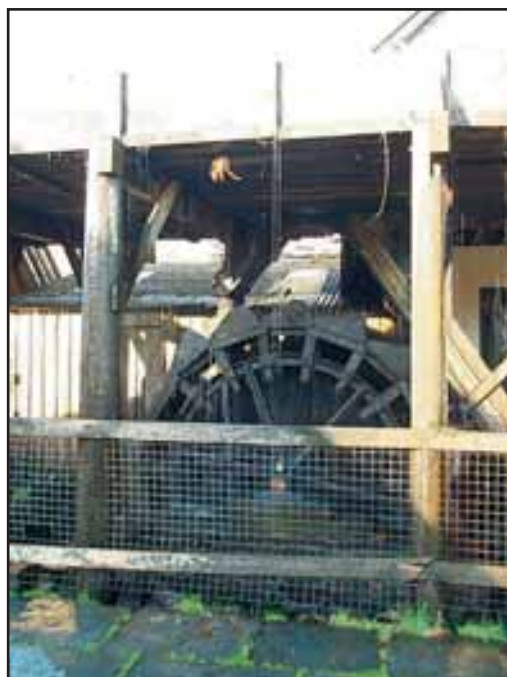
Fig 2 The elevated leat and one of the wheels at Finch Foundry

In 1814 William Finch took over the cloth mill and adapted it as a tool making works. In 1835 the corn mill was taken over and became a tool-grinding house. A saw mill and stable block were added to the rear along with a rope workshop and reed store.

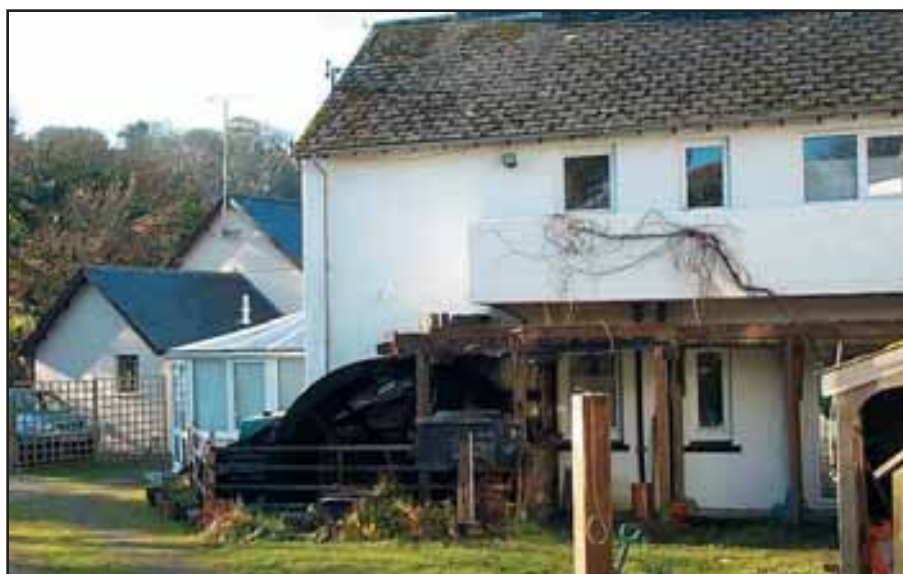
Fig 3 Albany House and the wheel as it is now

The mill building was drastically altered and converted to a dwelling around 1950, now known as Albany House. The wheel seen today was installed in 1972 to generate electricity for the house.

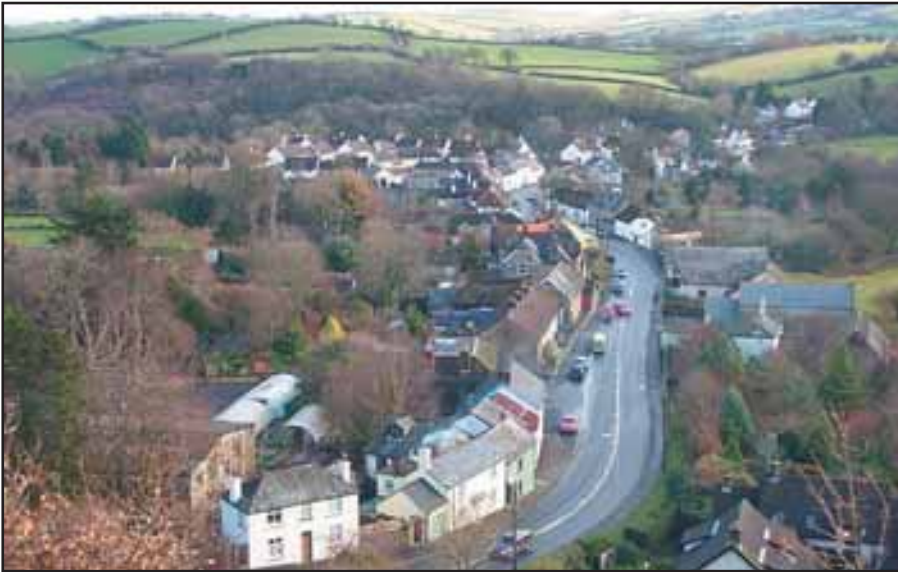
Fig 4 A linear village running east - west

The plan is essentially linear, running along the main road from east to west. It appears, however, that the original settlement was more nuclear, focussed on the central area between the junctions with Back Lane. The oldest properties, dating from the 16th century and possibly earlier, are located here and are aligned with the burgage plots. The road widens in front of the Taw River Inn, perhaps suggesting that this was intended as a planned square. The gap site that is now the car park of the Devonshire Inn was clear at the time of the Tithe Map [map 2]. The fact that it straddles two burgage plots suggests that there were dwellings here that have been abandoned or lost, rather than the site being one that wasn't taken up in the early years.

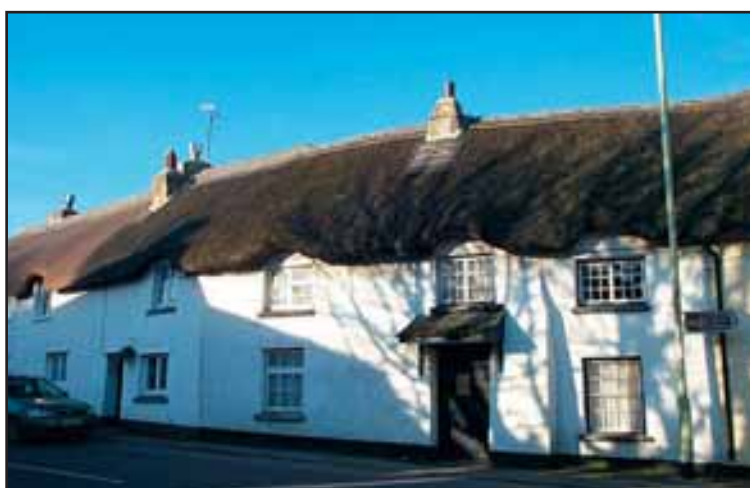
Fig 7 Archetypal vernacular dwellings of the 16th and 17th centuries.

Rendered cob and thatch were also the characteristic materials for dwellings and the oldest properties in Sticklepath have this construction. Homes of the 16th and 17th centuries may be identified by having lower eaves heights than those of the 18th century onwards. There remains a distinct sense of harmony and continuity on thatched roofs, with the ubiquitous finish being flush wrapover ridges.

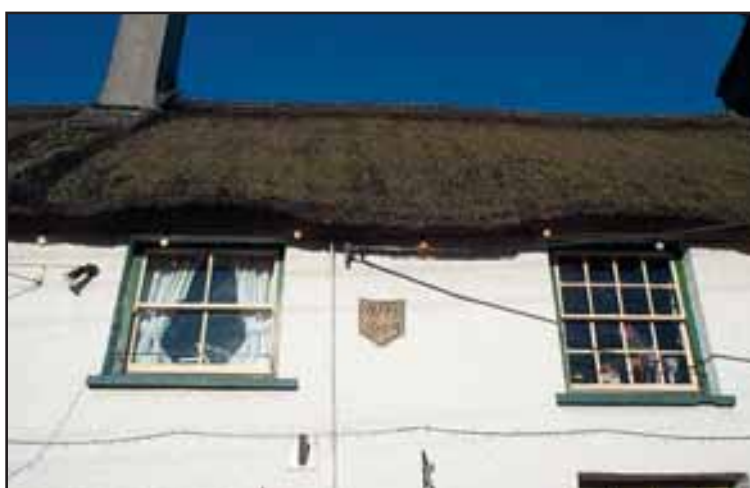
Fig 8 WH 1694 – One of the datestones on The Taw River Inn

The houses in the centre of the village clearly demonstrate status and quality in their construction, notably the two carved granite date stones on The Taw River Inn and the dressed granite chimneys seen in this group of buildings.

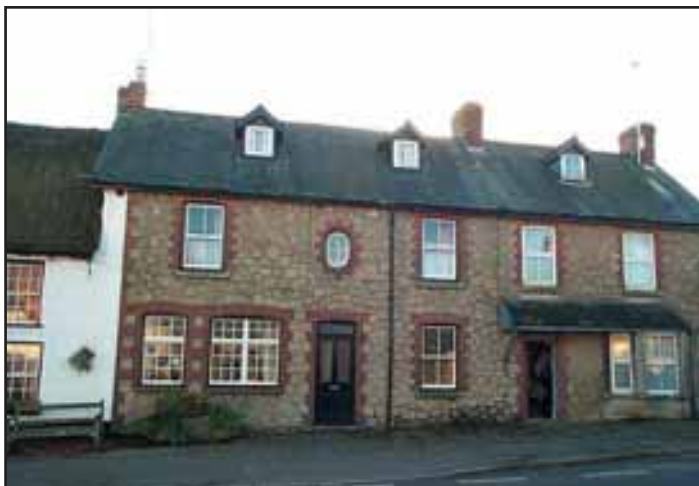
Fig 9 Victorian stone construction with a timber lean-to

Later dwellings are generally taller and more likely to be built entirely of local rubble stone. This is sometimes left exposed by design, on both homes and community buildings. Local metamorphic and igneous rocks are used for the mass of walls with dressed granite for quoins, lintels and other features. Several houses are detached and many have small front gardens; some have sheds or workshops on the street frontage incorporating timber construction and weatherboarding.

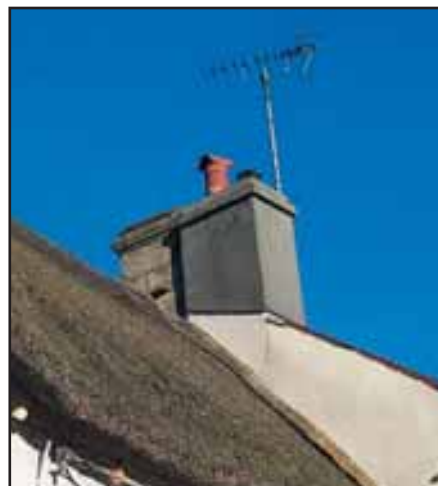
Fig 10 Dressed granite chimney at the Taw River Inn, partly obscured

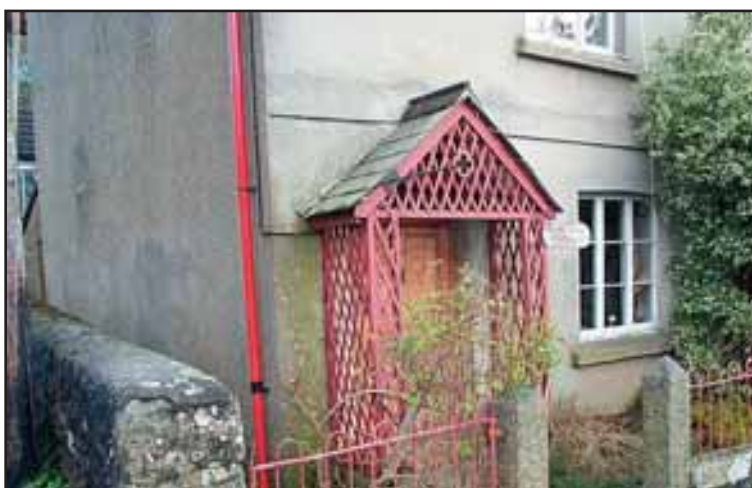
Fig 11 Trellised entrance at Ska View Cottages

Most residential properties have painted panelled doors, but boarded doors are found on cottages and ancillary buildings. Entrance porches and canopies are not a characteristic feature in Sticklepath, with the notable exception of Ska View Terrace next to Cleave House. They have, however, been widely incorporated in 20th century developments and where they have been added onto historic buildings the result has mostly been detrimental.

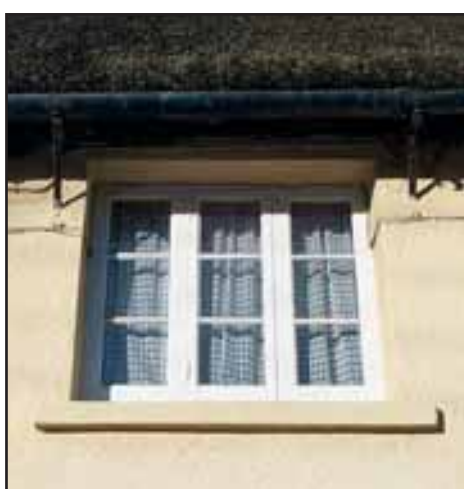
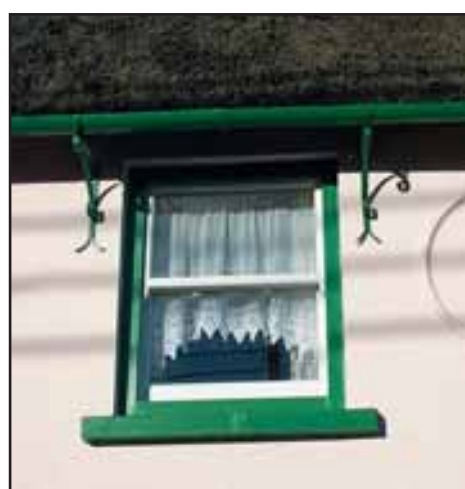
Figs 12 and 13 Cast iron gutters on thatched roofs are a feature in Sticklepath

Where original rainwater goods survive they are of cast iron with half round or ogee gutters. There is an unusually high number of thatched properties with guttering in Sticklepath and it must be considered something of a local custom. Where it is found on properties fronting the street it could be put down to thoughtful neighbourliness, but gutters are also seen on thatched properties with gardens.

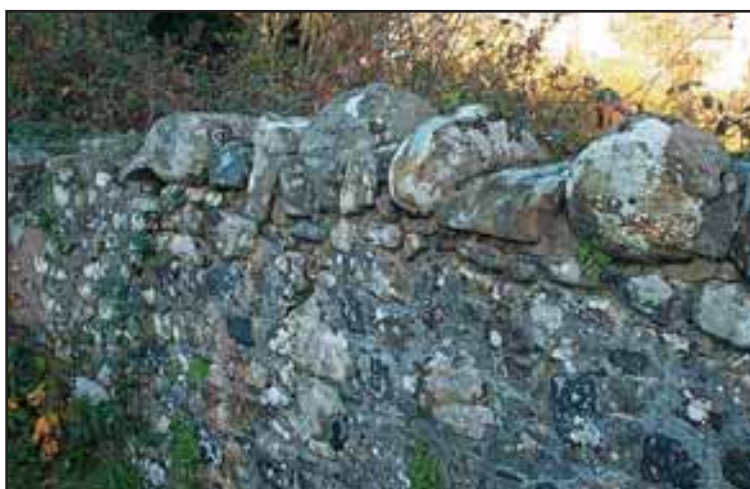
Fig 14 Rubble stone wall by the Burial Ground

Enclosure is most commonly provided by rubble stone walls and they are an harmonious character feature throughout. Iron railings are seen occasionally, notably at Ska View Cottages. To the rear of properties or towards fringes of the settlement there are more hedgerows or Devon banks.

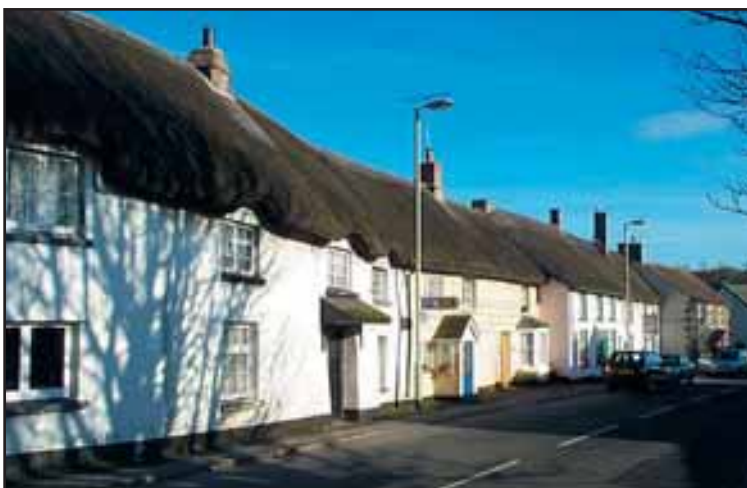
Fig 15 The Taw River Inn group of dwellings

This informal terrace of thatched homes incorporates the oldest properties in Sticklepath; most have 16th century origins with various adaptations and changes in the 17th – 19th centuries. Their group value derives from a delicate balance between continuity of form and materials, combined with subtle variety of positioning, roofline and details, especially chimneys and windows.

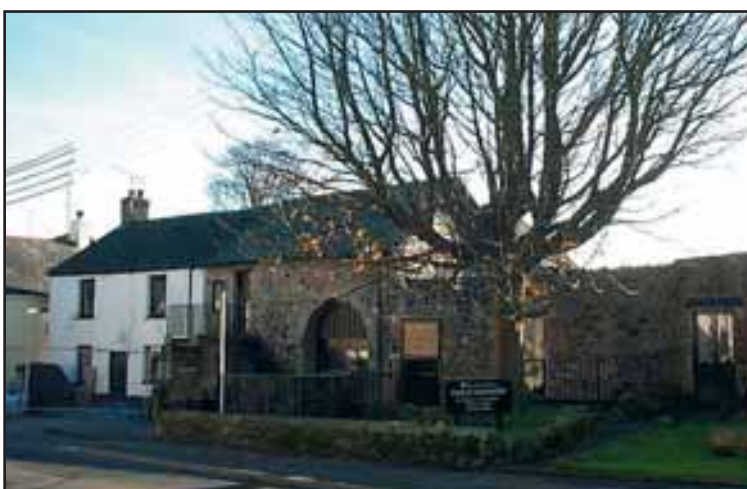
Fig 16 Finch Foundry and Foundry House

Finch Foundry: Grade II*

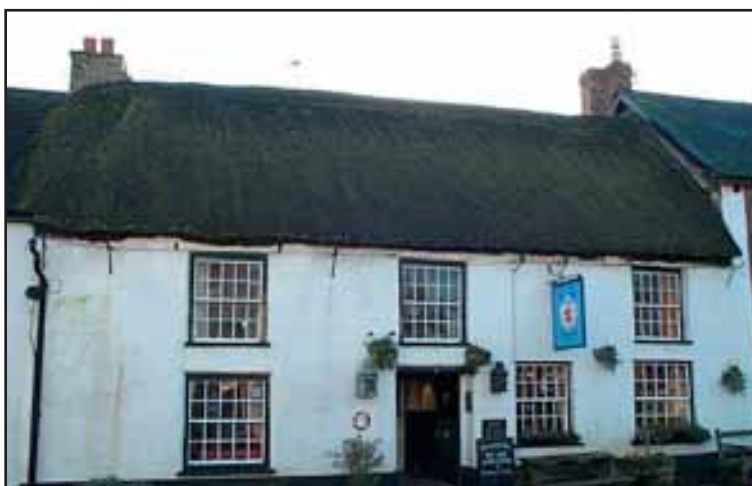
Fig 17 The Devonshire Inn

The Devonshire Inn: Grade II

A local inn built in the 17th century, given a Georgian makeover c1800 and further modernised in the 20th century. Its character reflects these phases of change and they are part of its charm. As a product of increased traffic and movement of goods and people, this building captures how the road changed the fortunes of Sticklepath.

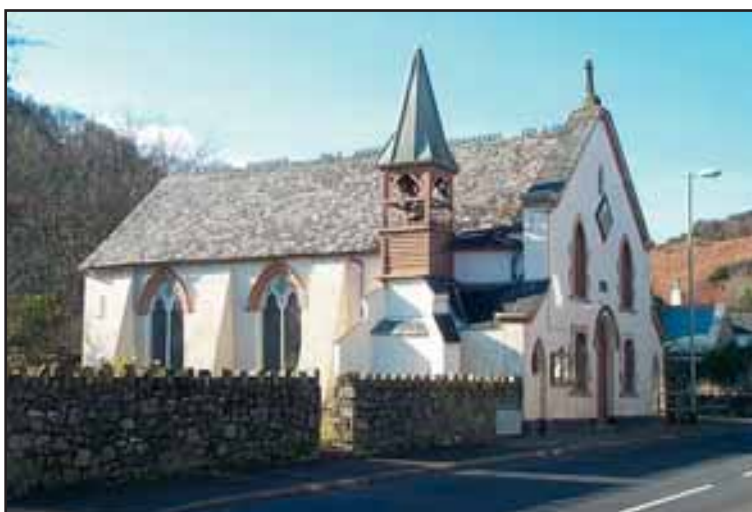
Fig 18 The Methodist Chapel

The Methodist Chapel: Grade II

A substantial and remarkably ornate chapel of the early 19th century – the bell tower is especially unusual on a non-conformist chapel. A focal point both literally and socially in Sticklepath, its location in a less developed area remains apparent looking west.

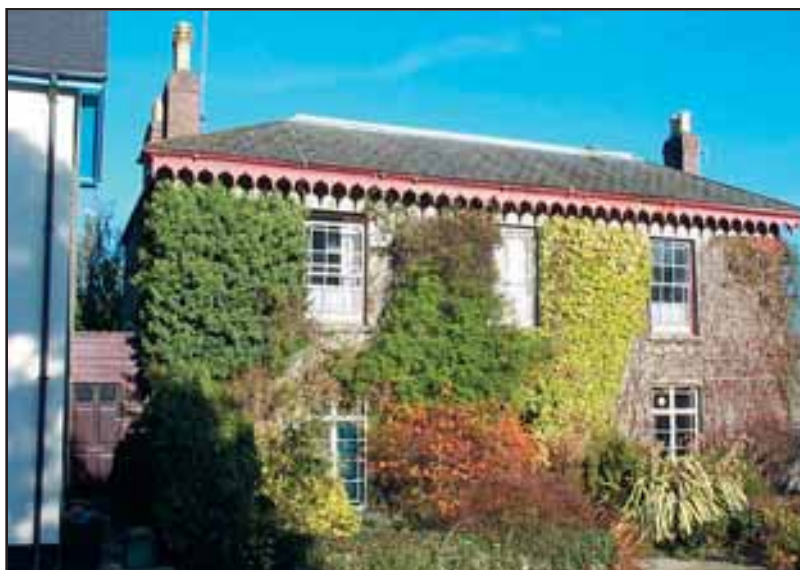
Fig 19 Cleave House

Cleave House: Grade II

A fine and unspoilt example of late Georgian / early Victorian domestic architecture. The elaborate eaves design and elegant window patterns are a bold statement in a rural situation. Originally the front garden would have been enclosed by decorative iron railings.

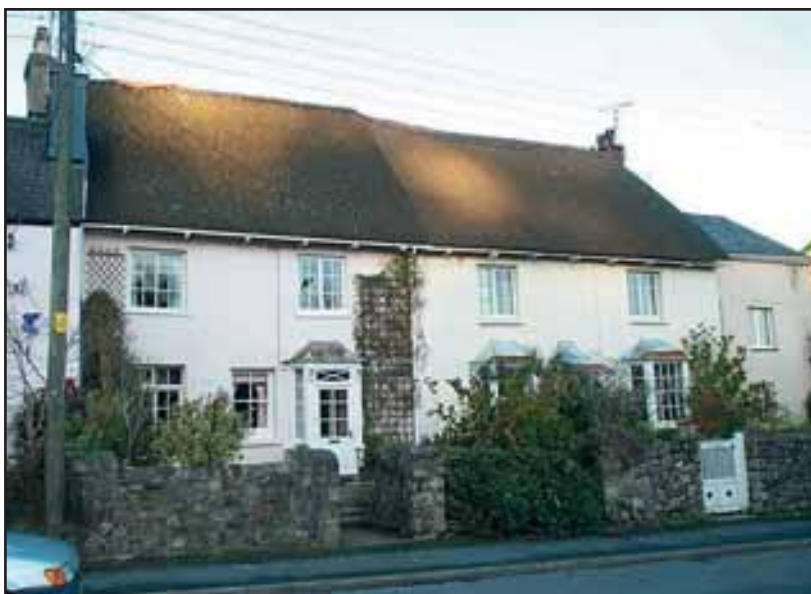
Fig 21 Stapler and The Heritage are taller thatched dwellings with horizontal sliding sashes and decorative lead-topped bay windows.

The Heritage and Stapler are quite late thatched properties, dating from the later 18th century, which appear to have undergone fashionable alterations in the early part of the 19th century. They mark the end of 500 years of vernacular building in the village. By the mid 19th century homes like the adjacent Sunnyside were being built to pattern book designs. The unlisted pair of cottages immediately west of The Heritage add to the group value.

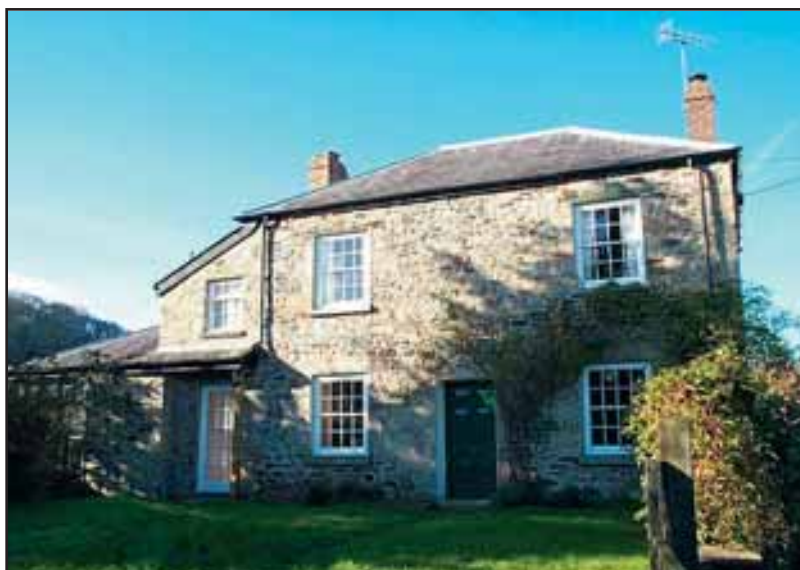
Fig 23 Primula House

A charming 19th century house, well proportioned and nicely constructed in stone. Perhaps by this stage in the development of Sticklepath the road had become so busy it was considered desirable to present a blank side wall to it. The attractiveness of the stonework, rising from the contiguous garden walls, reduces the blankness that would be apparent if it were rendered.

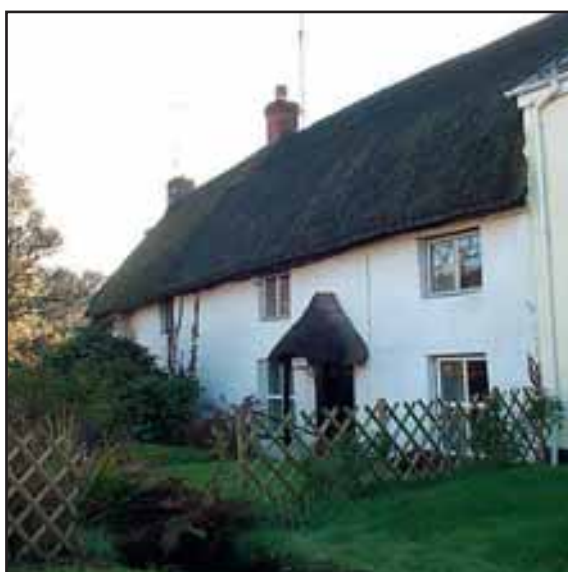
Fig 24 Mill House, Taw Leat and Silverlake

Taw Leat and Mill House are thatched and form a group with Silverlake, which is slated. Mill House retains some historic windows from the 18th or early 19th centuries and Silverlake has original early 19th century horizontal sliding sashes. The whole group, with Albany House, is unique in being set behind the leat and it is attractively bridged by granite slabs to give access to these cottages.

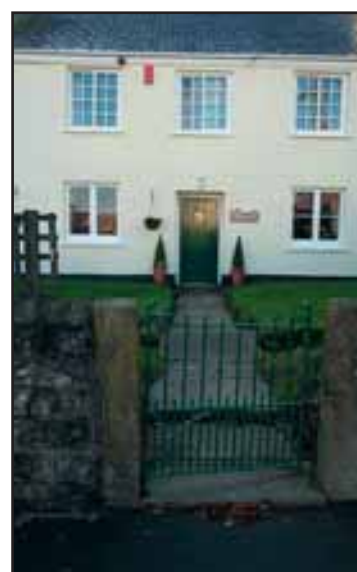
Fig 25 Silverlake with attractive gateway, bridge and rare horizontal sliding sashes

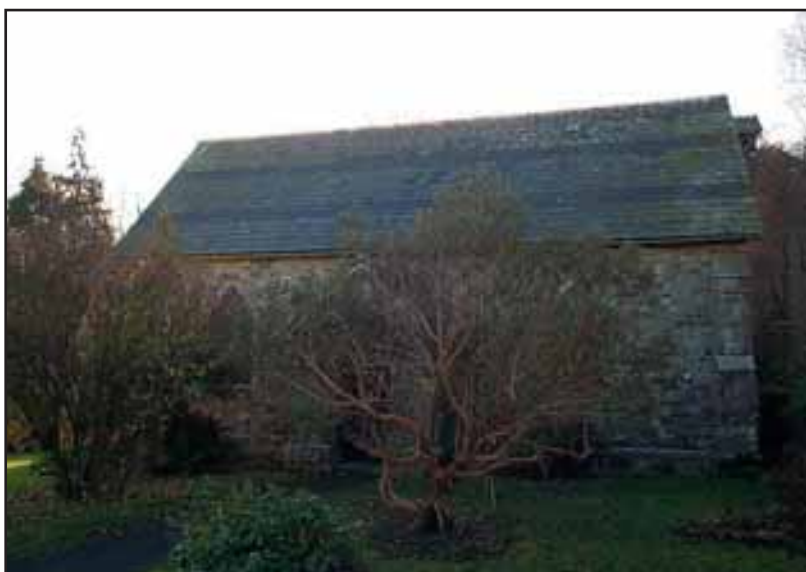
Fig 26 St Mary's

A solidly constructed Victorian replacement of the original thatched medieval chapel of ease. Modest in form, scale and location it gains character from being built mainly of local stone.

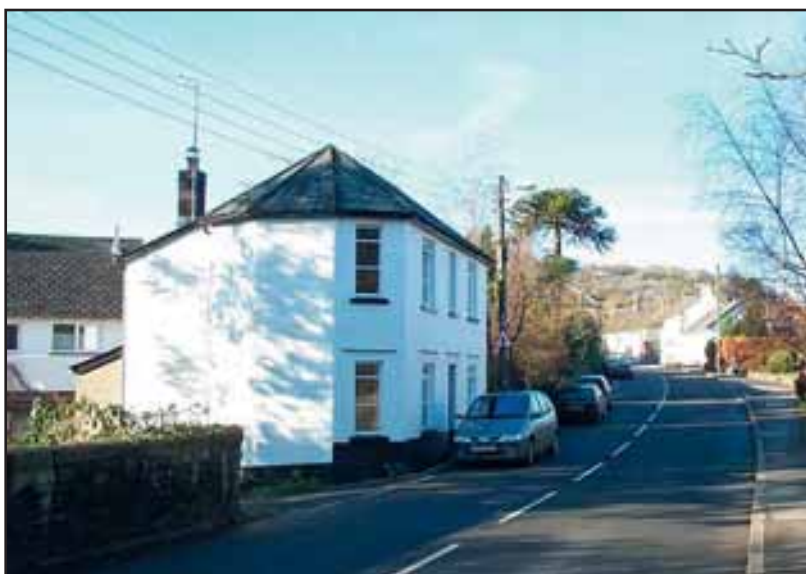
Fig 27 Former Toll House by bridge

Although substantially extended, the faceted end elevation facing the bridge reveals this to be an old toll house. As such it is another reminder of the significance of the main road in the development of Sticklepath and the phases of improvement and widening that took place over the centuries.

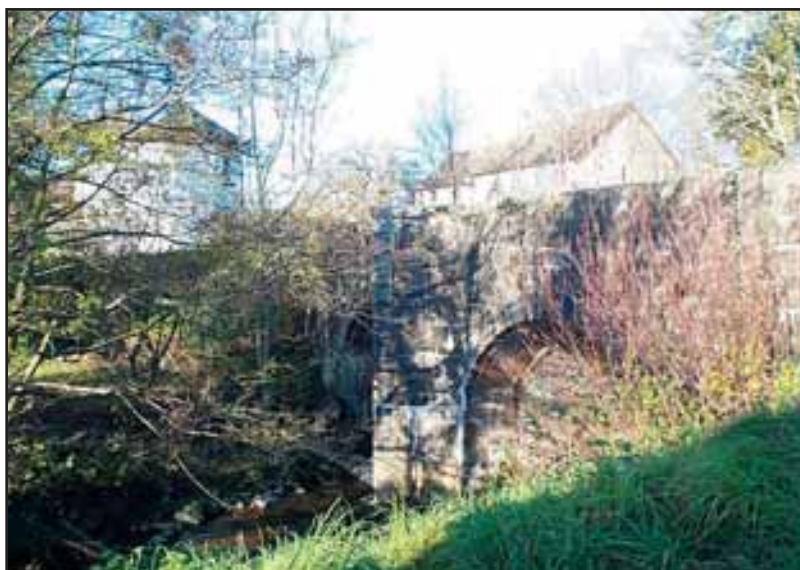
Fig 28 The Bridge

This marks an important crossing point but quite when bridge superceded ford is uncertain. The present structure is probably 18th century in origin but was widened in the earlier 19th century and again in 1928.

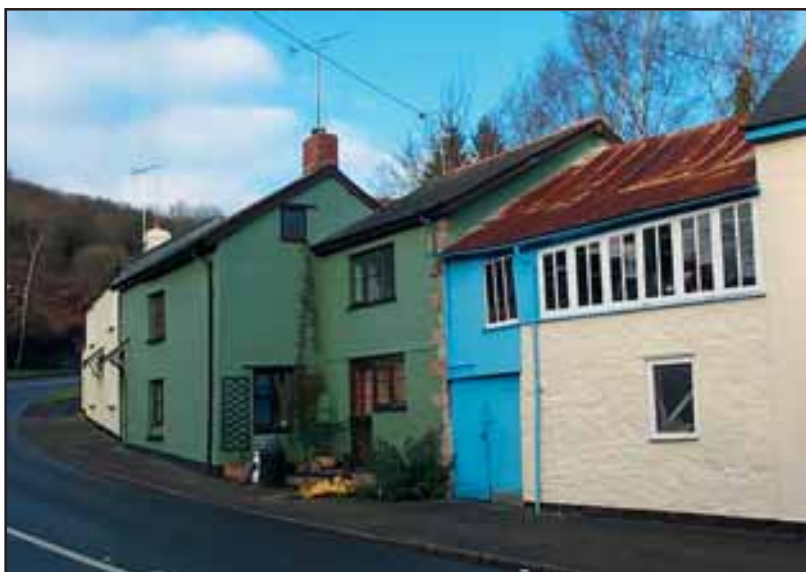
Fig 30 The former smithy is a rare survival

A utilitarian structure but an increasingly unusual survival – it is recorded as a smithy on the 19th century OS maps. The rusty corrugated iron roof and overlapping glazing on the upper floor have character and it makes a positive contribution to the streetscene.

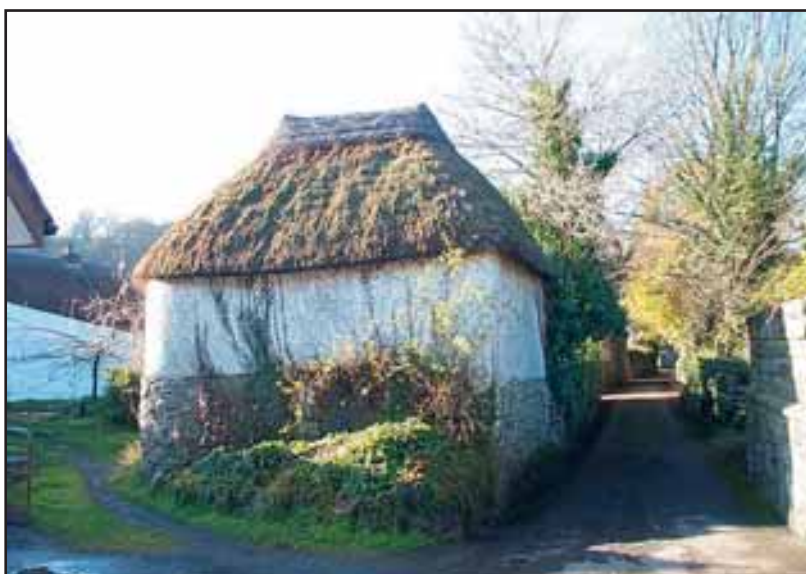
Fig 31 Old thatched barn on Back Lane

The best remaining unconverted agricultural building in Sticklepath - it epitomises the historic vernacular character of the village. Constructed of rendered cob on an unrendered stone plinth, it is the last outbuilding here to retain its thatch. All the more important for its location in the ancient heart of the settlement.

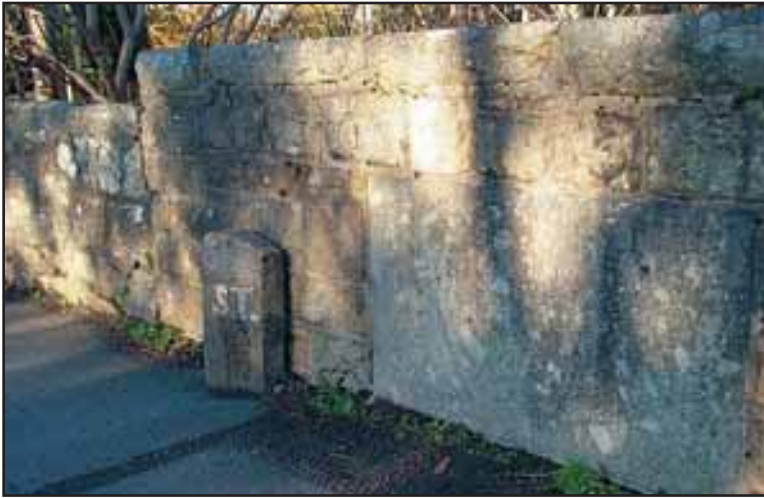
Fig 33 Plaque and boundary stone on the bridge

The pavement width varies tremendously and on the south side of the main street it comes and goes, which is likely to be a legacy of the road widening and improvement schemes that took place when this was the A30 arterial route. The bridge widening of 1928 is recorded on a commemorative plaque and next to that is an old granite boundary stone. At the back of the pavement opposite the Devonshire Inn is a Grade II listed K6 Telephone kiosk in need of some maintenance. Back Lane has a very different character, being tight with no pavement to speak of and having indistinct edges in places.

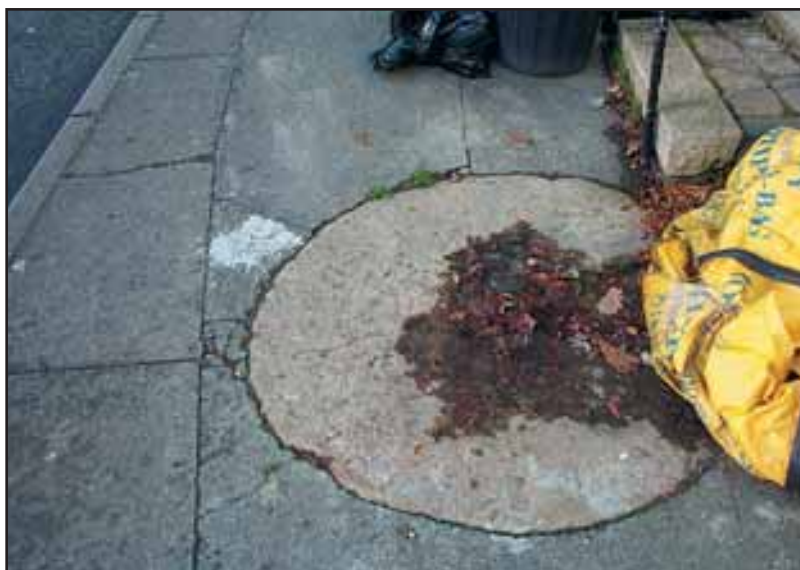
Fig 35 Millstone near the old smithy

Just to the west of Cleave House is a neglected granite millstone set in an area of cracked concrete. This, like Cleave House and the cottages, is an important reminder that this end of the settlement was greatly influenced by the ownership of Cleave mill. A millstone was also incorporated as a focal point in the design of the Millennium feature at the other end of the village and another is sited in front of Finch Foundry.

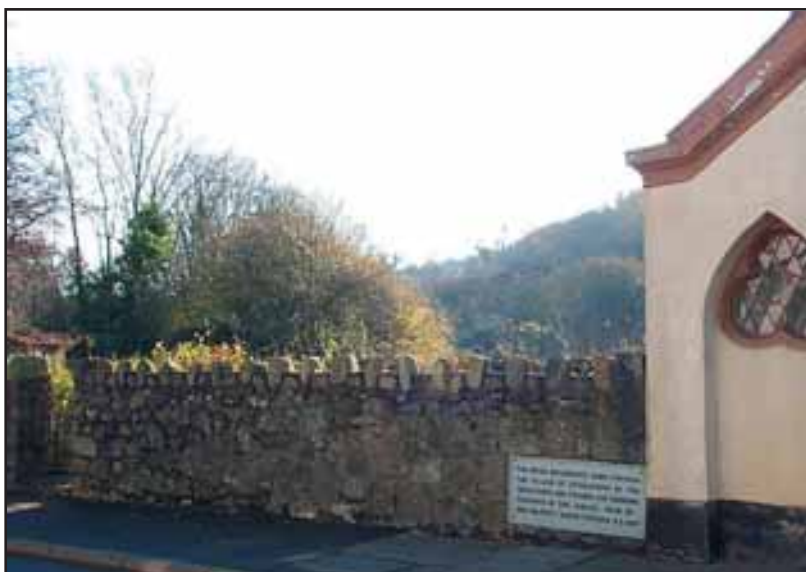
Fig 37 Stone wall and plaque adjacent to the Methodist Chapel

Stone walls are a very significant feature, notably on the south side of the road heading west past the Methodist Chapel. A commemorative plaque is built into the wall adjacent to the Chapel. There are substantial stone walls, some dry others mortared, that form boundaries to the rear of properties.

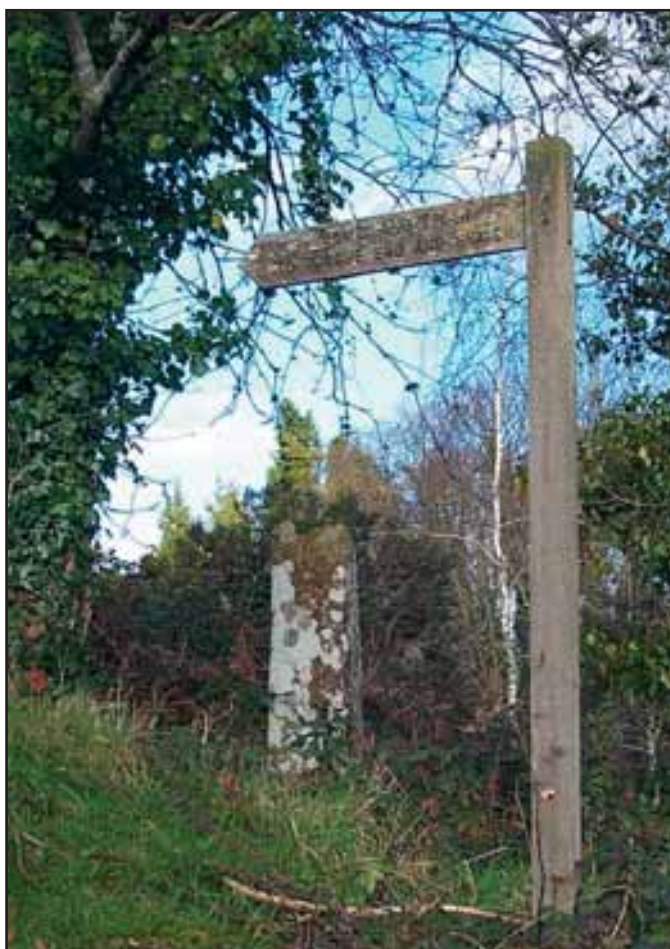
Fig 40 Boundary stone

At the west end of the main street are a pair of significant historic features, the Lady Well and the incised boundary stone. Whilst the former is clearly celebrated the latter, which is outside the Conservation Area, is obscured from view.

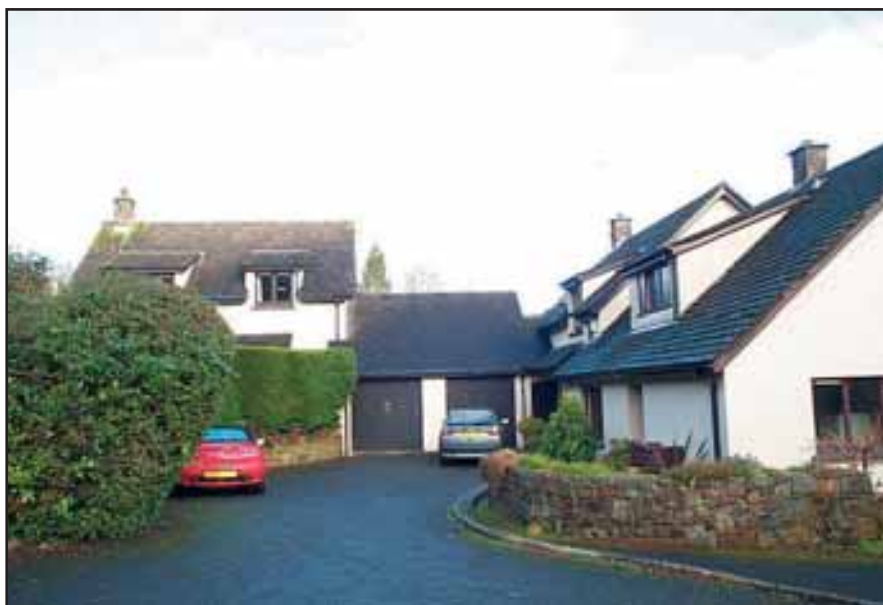
Fig 51 Part of Grove Meadow

There are two significant 'estate' developments in Sticklepath. The smaller Grove Meadow group is discretely located and fits in quite well, though better quality natural slate roofing would have made it more successful. This also applies to the larger Oak Tree Park which balances standard details with a grouping and simplicity that at least suggests local references. As most of the estate is set well back from the main road the impact on the village as a whole is lessened.
