MIDDLE VENTON DREWSTEIGNTON

HERITAGE APPRAISAL, IMPACT ASSESSMENT & SUGGESTED RESOLUTION IN CONSIDERATION OF UNAUTHORISED WORKS

Dartmoor National Park
Authority

September 2014

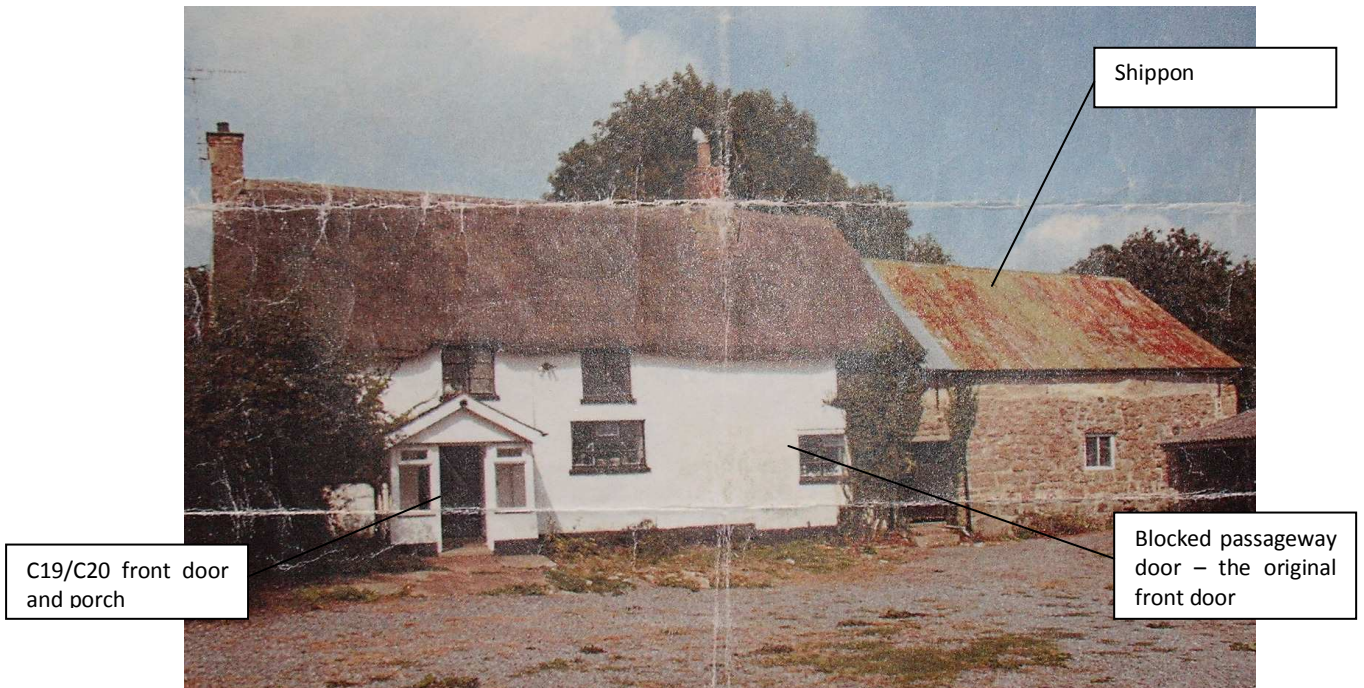
Figure 12. Middle Venton – photograph from sales particulars 2005, reproduced by kind permission of Mrs Sowrey

In 2005/2006 it is clear that Middle Venton was a building of two parts by virtue of the different roof finishes and height of the ridges: high and thatched over the house, low and tin over the shippon, figure 12. Today that difference is virtually non-existent as the whole building is thatched and the ridge is nearly of the same height along its entire length. Whether the ridge height is because of a taller roof structure being provided for the shippon than was approved or a thicker depth of thatch being provided is not clear. The shippon has at least had its roof repaired and it is thatched in the local tradition. To lower the ridge of the shippon would be a major task. Longhouses elsewhere do have similar ridge heights over house and shippon due to the nature of the build up of thatch over the years. **On balance because of the difficulty in remedying the matter, because longhouses elsewhere do have similar ridge heights over the house and shippon and because the shippon is at least now thatched, the matter is not considered worth pursuing.**

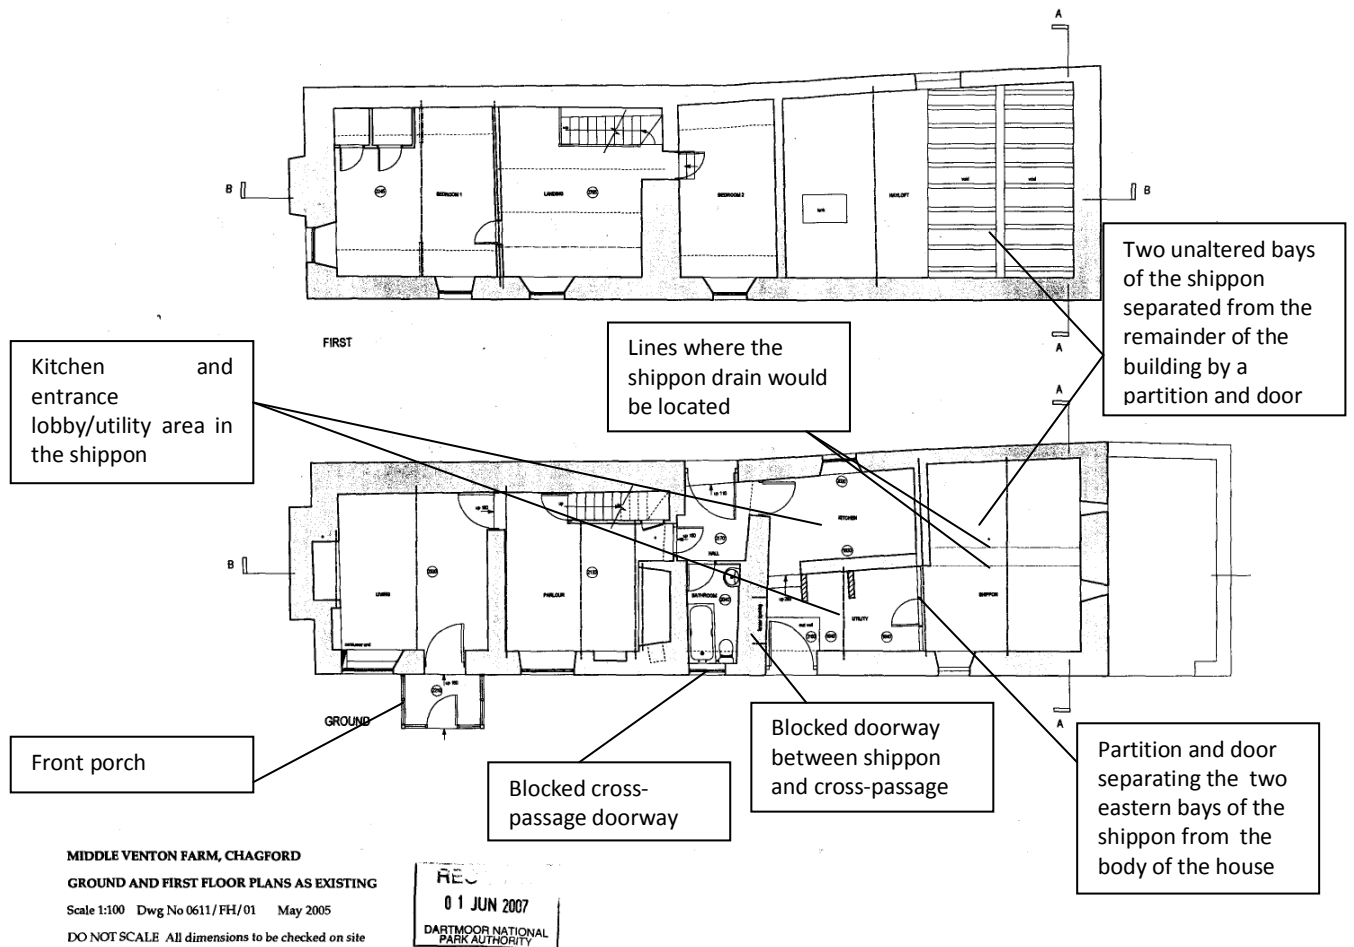
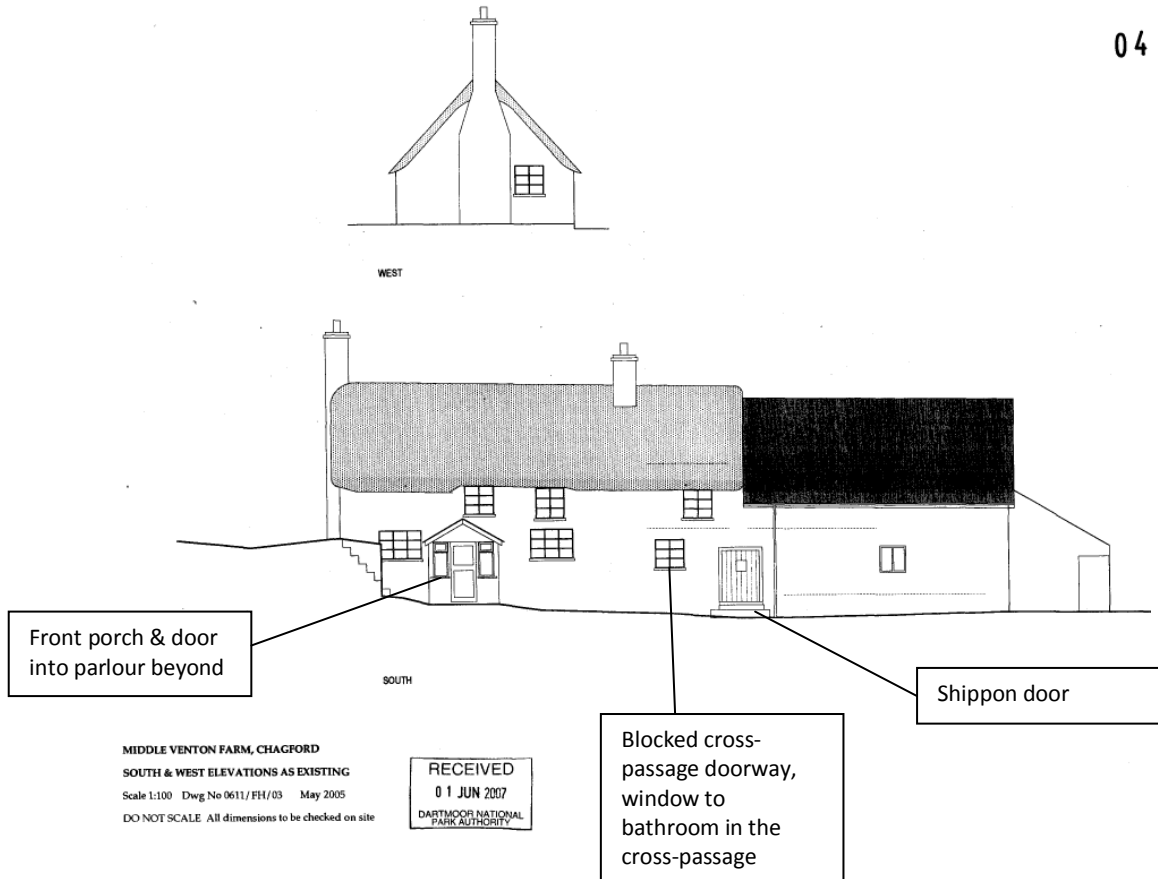
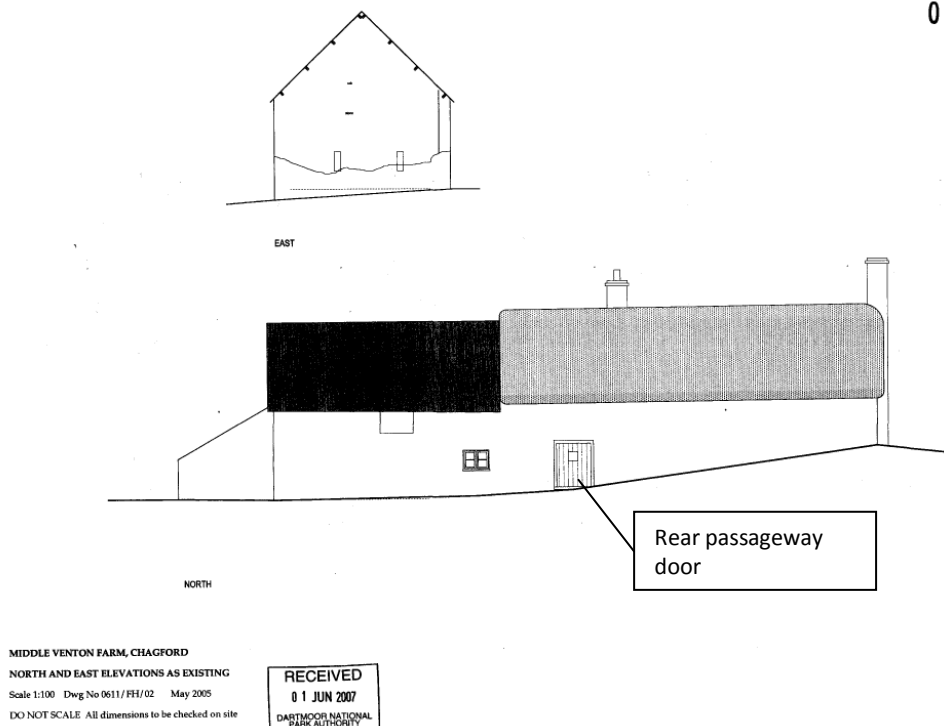
Figure 13. Measured survey of ground and first floor plans and elevations 2005

The measured survey of 2005, figure 13, has two lines drawn on the floor of the shippon at the centre of the floor running parallel with the south and north walls. These lines would be where a drain in the centre of the floor would have been located. There is a photograph in the archaeological assessment of 2006 of a stone lintel above where a drain hole would be located in the east gable and the archaeological assessment confirms the presence and function of that stone. The assessment advises that below the debris on the floor at a depth of 20 – 30 cm would be the drain. Subsequently the floor was excavated but apparently no drain was found. The approved drawings state that the earth and stone floor would be reinstated. Today the shippon has been excavated and filled with concrete with a limecrete edging to a depth of about 30cm around the edge of the

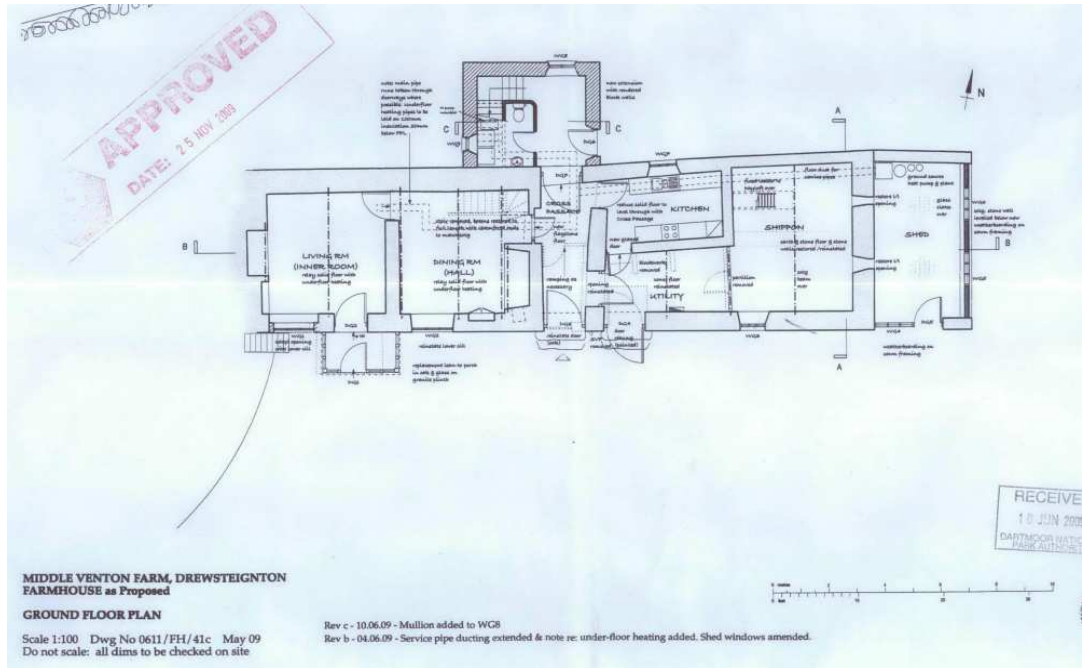
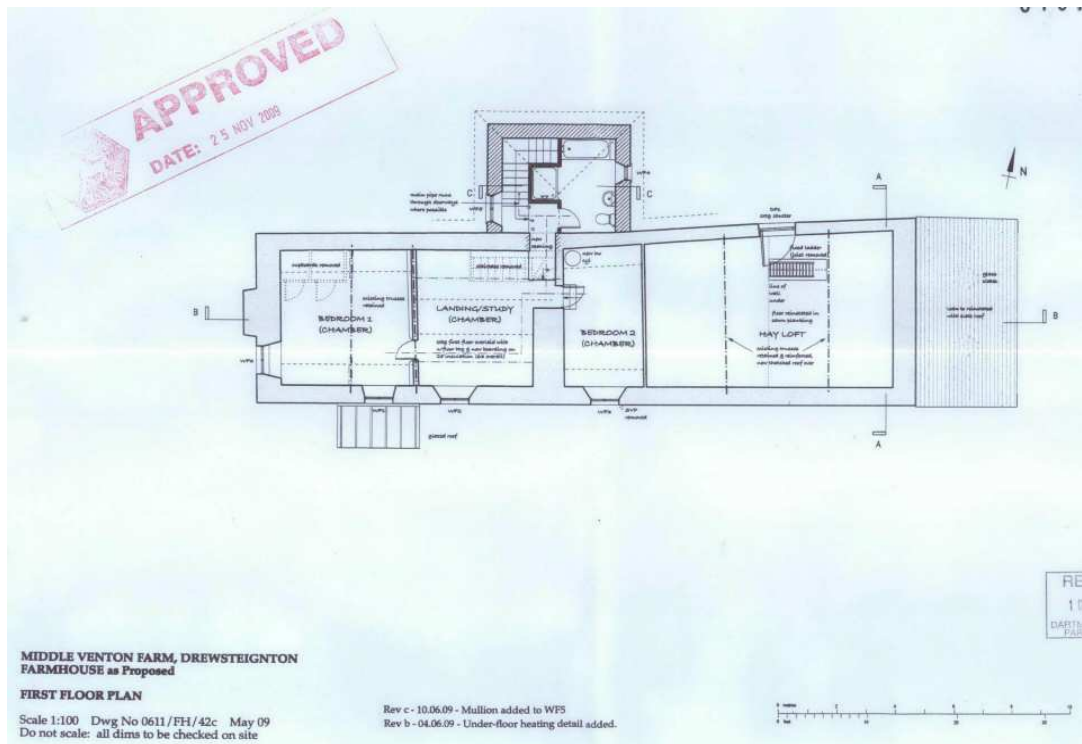
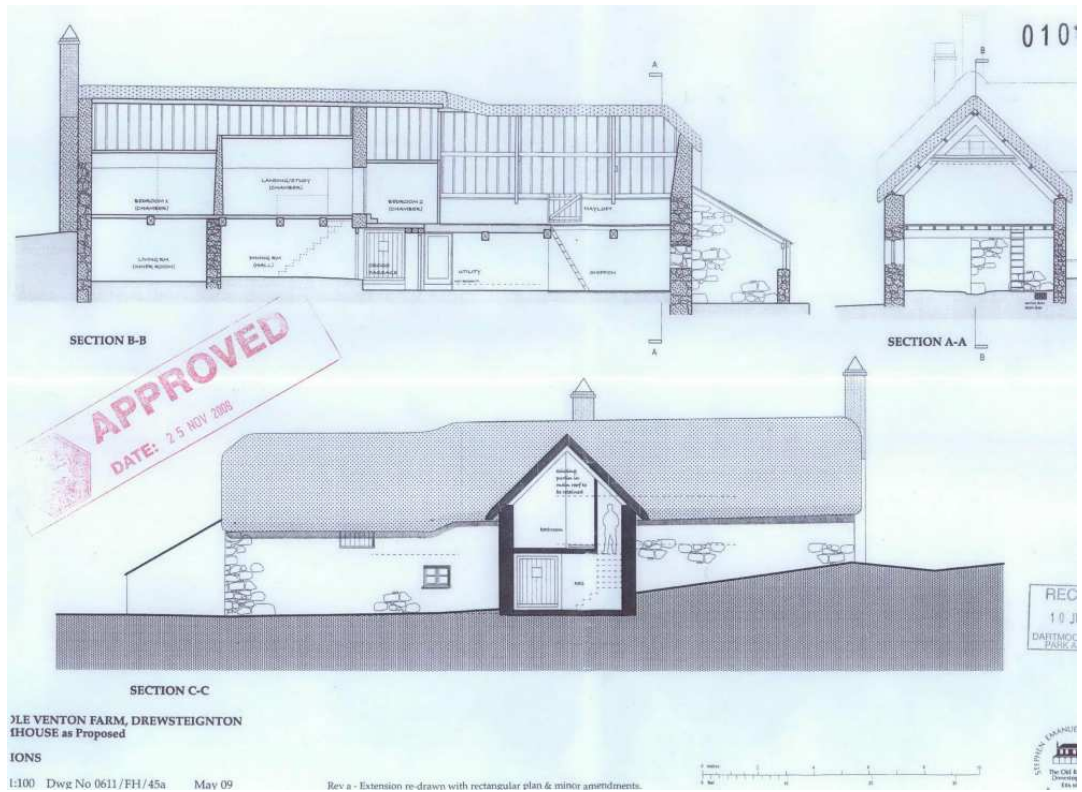
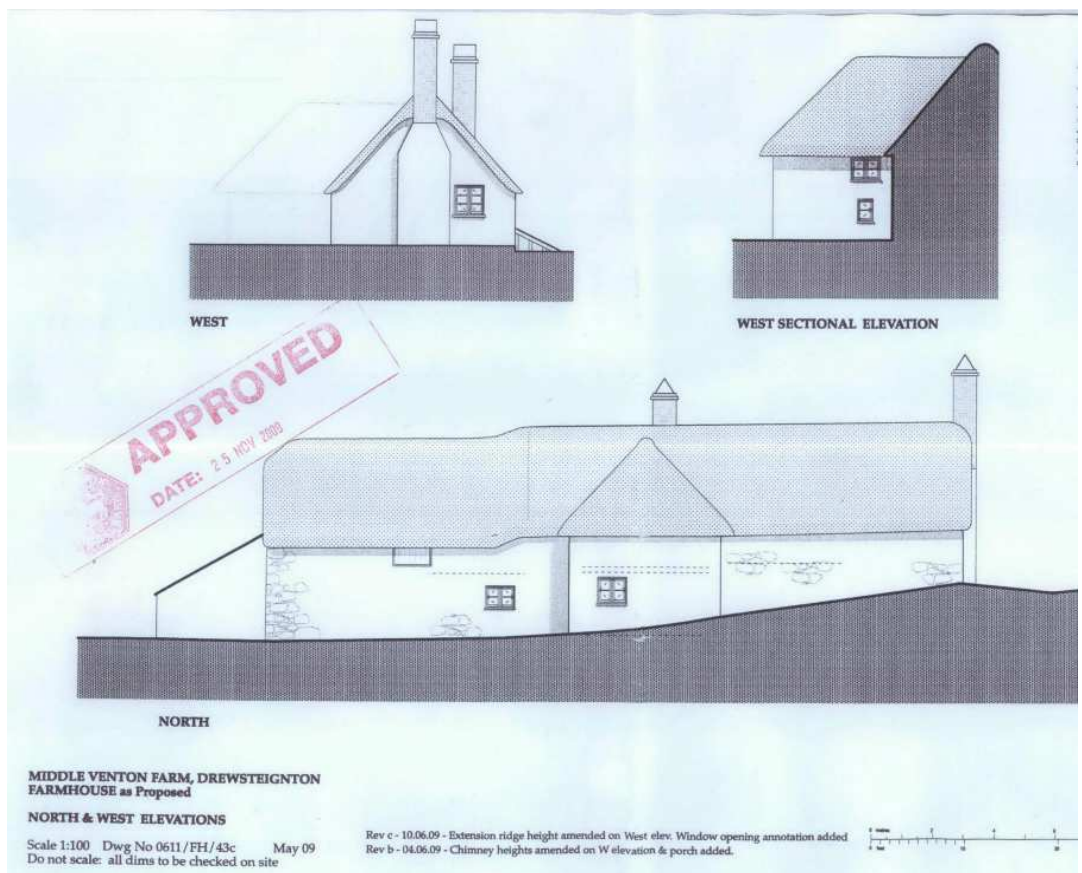
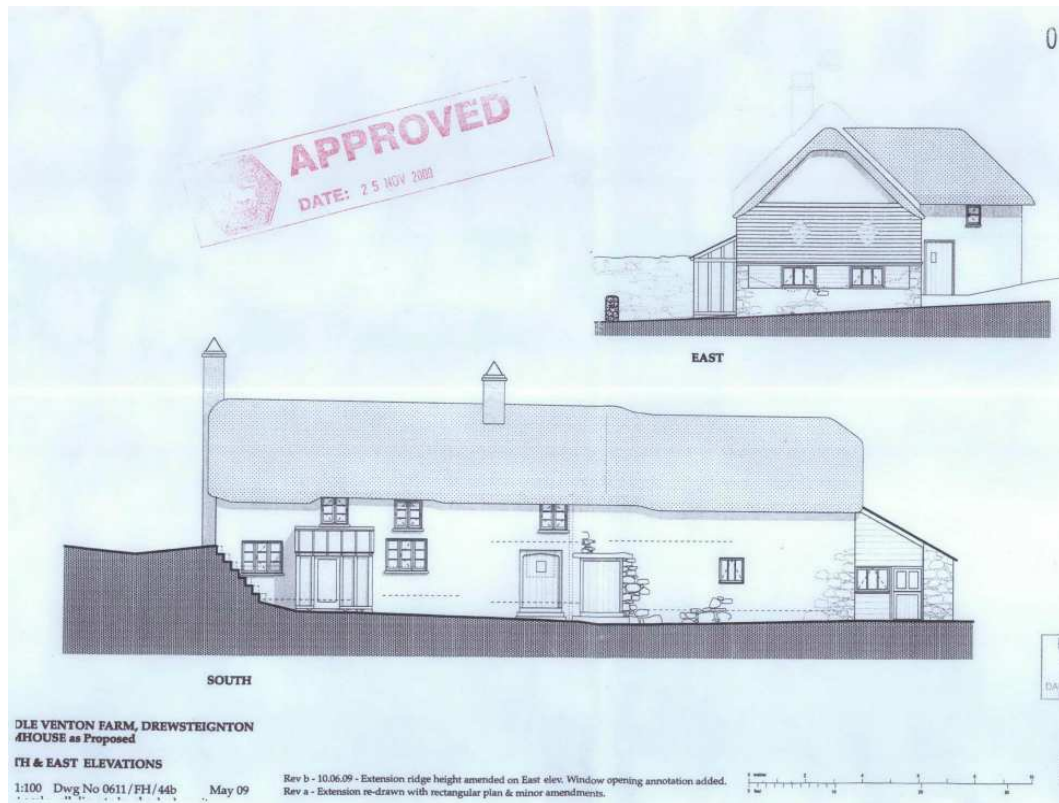
Figure 15. Approved drawings from approvals 0100/09, 0101/09

While the design of the rear extension door which gives access to the garden was approved in application 13/543, granted after the fitting of the door, its design of three vertical strips of glass is found to be discordant with the character of the listed building and it is quite different from the simple plank door shown on the approved drawing,

figure 15. However the detail of the door has been approved and it is at least associated with modern fabric so this matter is not pursued in this report.

The 2009 approved drawings indicate that the existing door was to be re-hung and painted and would open outwards. The current door is oak, unpainted, with three, vertical glazed panels, similar to the rear extension door, with a fixed, glazed, side light. The door is well fitted within a frame; the close fitting nature serves to reduce draughts into the shippon. The door is not the design that is shown on the approved drawings, figure 15. The door is found to be discordant with the character of the listed building by virtue of its glazing pattern, fixed side light and oak finish. In addition, and crucial to the current way in which the shippon is used, the close fitting nature and draught proofing of the door enables the internal environment of the shippon to be kept comparatively draught free and therefore a few degrees warmer than would otherwise have been possible if the original plank door that was approved had been fitted. In addition the glazing to the door and its side light makes the lobby area to the shippon lighter than the approved plank door would have permitted. These matters are discussed in section 5 of this report.

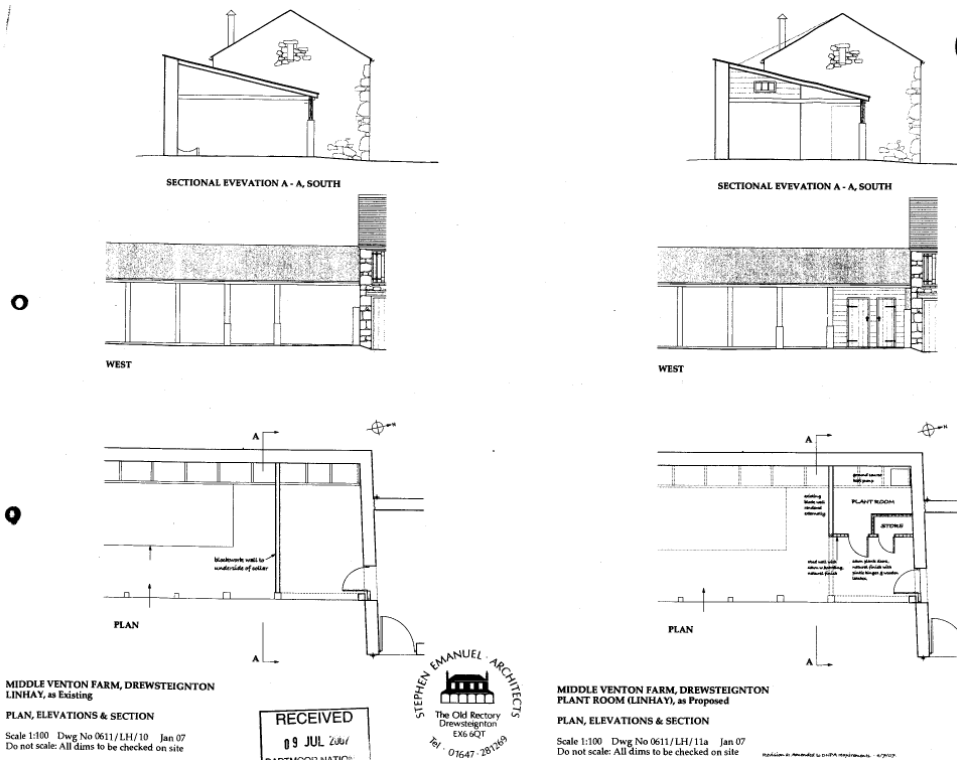
Figure 17. Unconditionally approved drawings, application ref: 0157/07

The approved scheme shows a shutter structure over the window, figure 17, this has not been fitted. **The first floor window that has been fitted as part of the overall conversion is not found to harm the heritage significance of Middle Venton and it is therefore recommended that the amendment is accepted by whatever means is considered appropriate.**
